Bat Survey of Colesdale Farm Cuffley

**John Dobson B.Sc
Essex Mammal Surveys**

May 2018

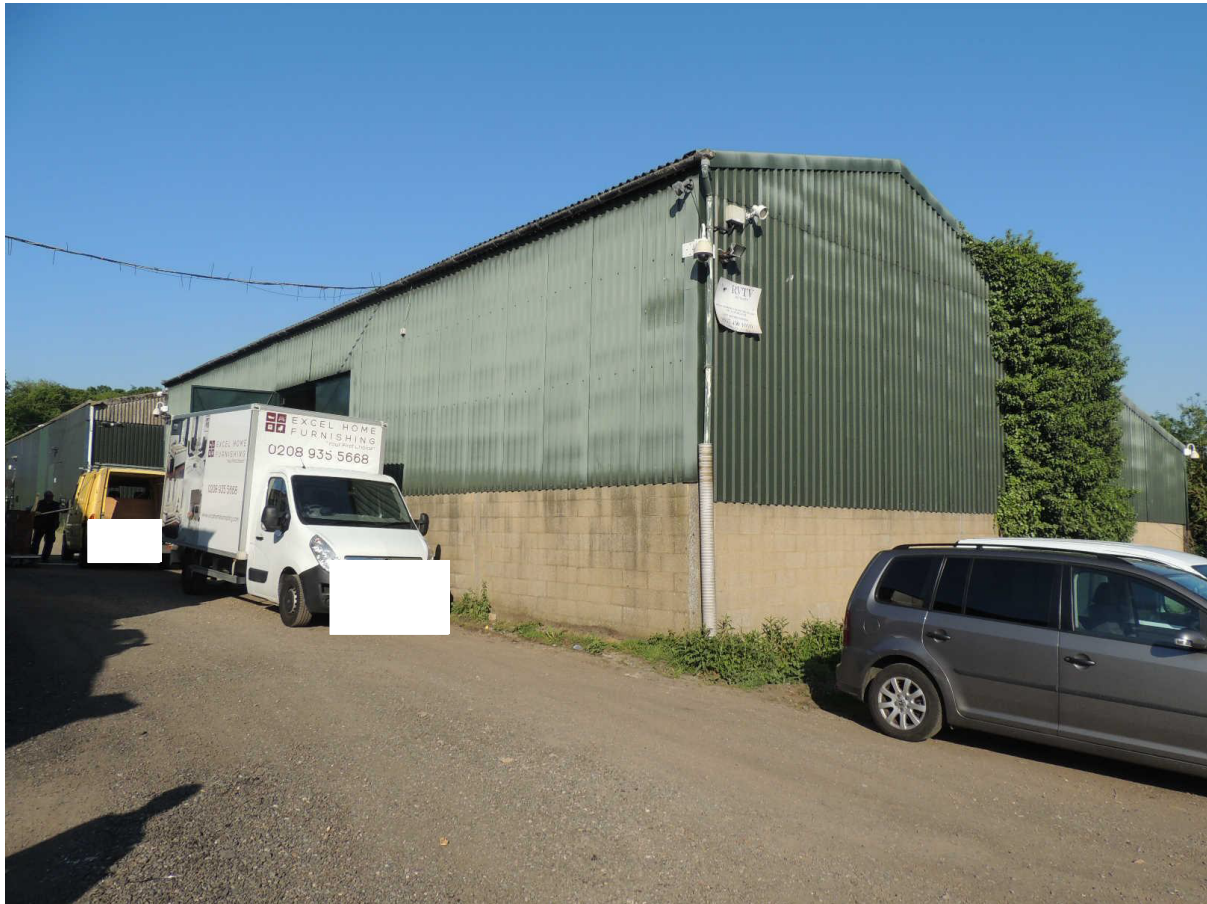
Photo 1: Building 2. The buildings at the site comprised warehouses and open barns used for storage

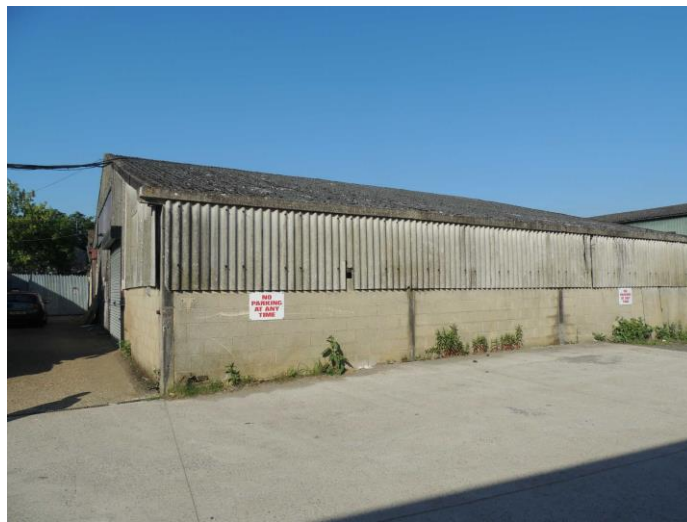
Photo 2: Building 1

This is a large, single-storey building with block walls and corrugated asbestos cladding and roof. Although access was not gained to this building, there were no cavities on the external walls that might be occupied by bats.

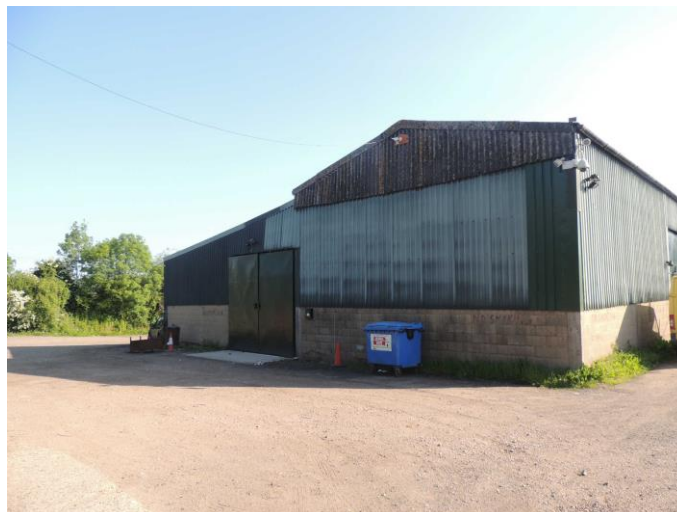
Photo 3: Building 3

This is a large, concrete-framed warehouse with a corrugated asbestos roof and metal sheet walls. A large lean-to area has been added to the north-western side. The interior receives daily disturbance and artificial illumination from ten strip lights in the lean-to section and three spot lights in the barn area. Such a level of disturbance, together with a lack of cavities meant that this building was unsuitable as a roosting place for bats.

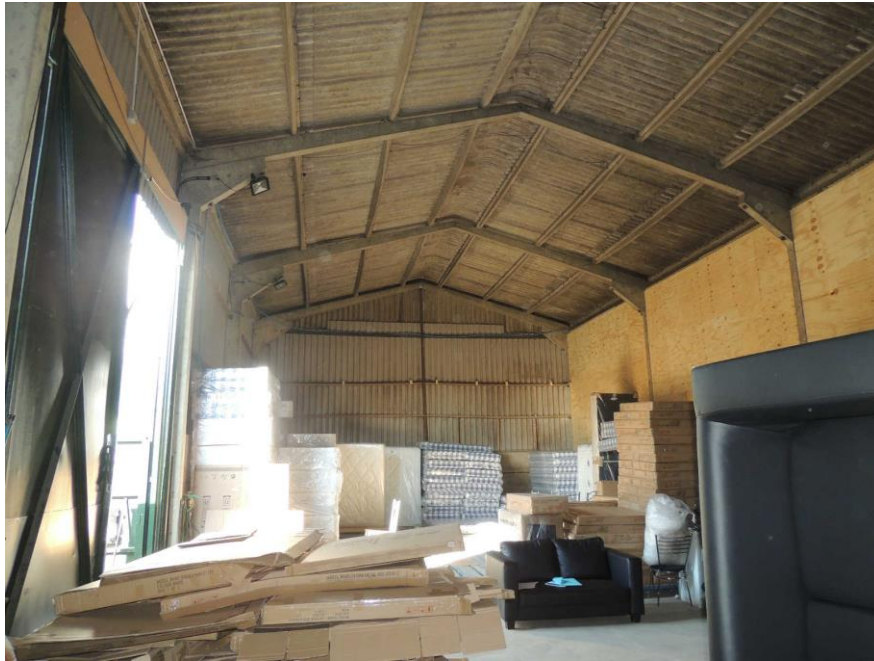
Photo 4: Looking south-westwards in Building 2

This is a large concrete-framed warehouse with metal sheet walls and a corrugated asbestos roof. The interior receives daily disturbance and lacks features that might be occupied by bats. No evidence of their presence was found to be associated with this building.

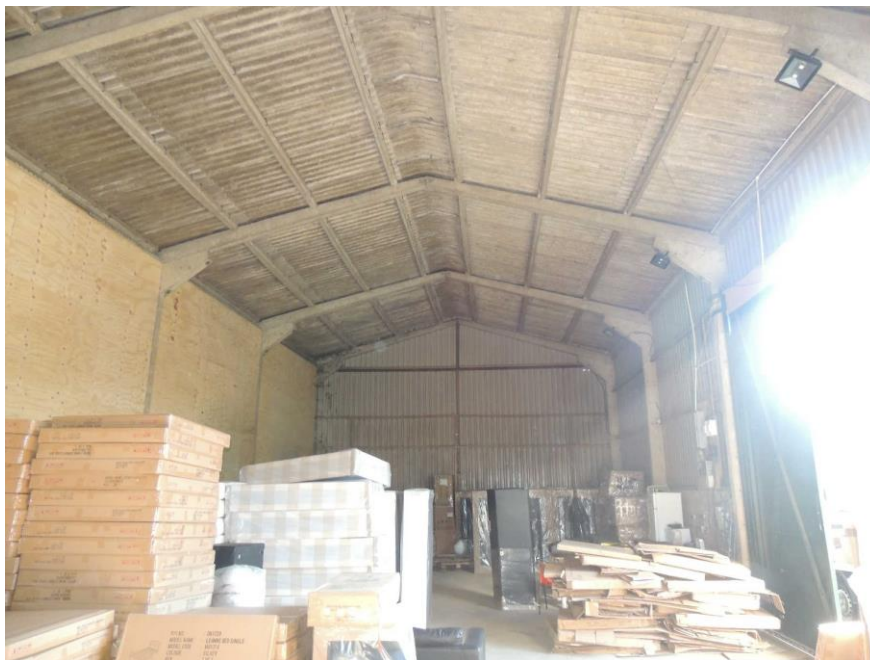
Photo 5: Looking north-eastwards in Building 2. Note lack of features that might be occupied by bats

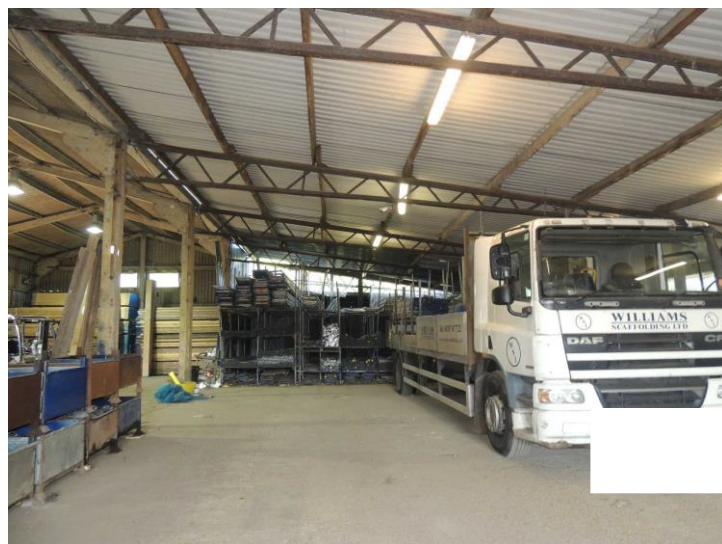
Photo 8: The lean-to area had a metal sheet roof

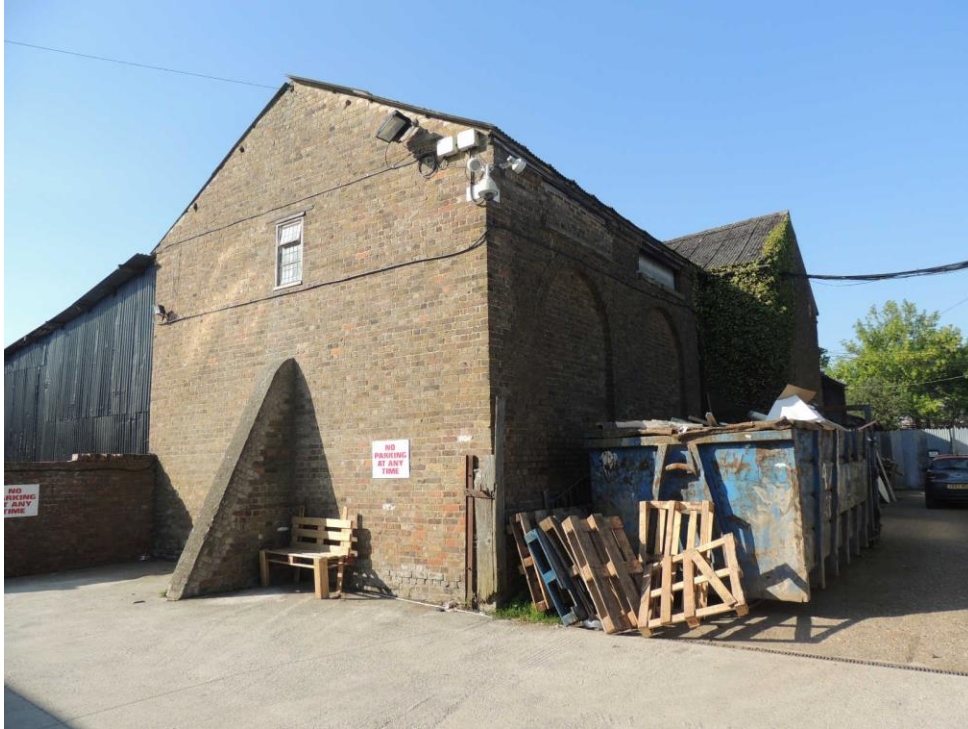
This is an existing brick barn with an asbestos roof that is currently used for storage. The interior receives regular disturbance and has artificial lighting installed to allow evening working. There were no features that might offer potential roosting places for bats.

Photo 9: Note security light that would deter roosting or foraging by bats

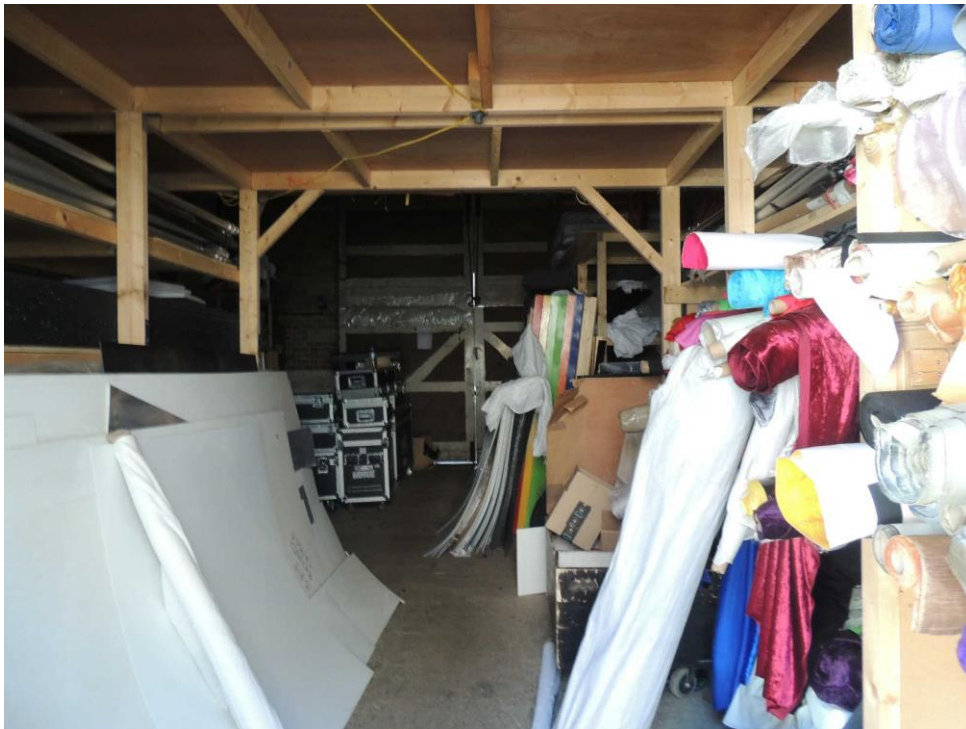
Photo 10: The interior is used for storage

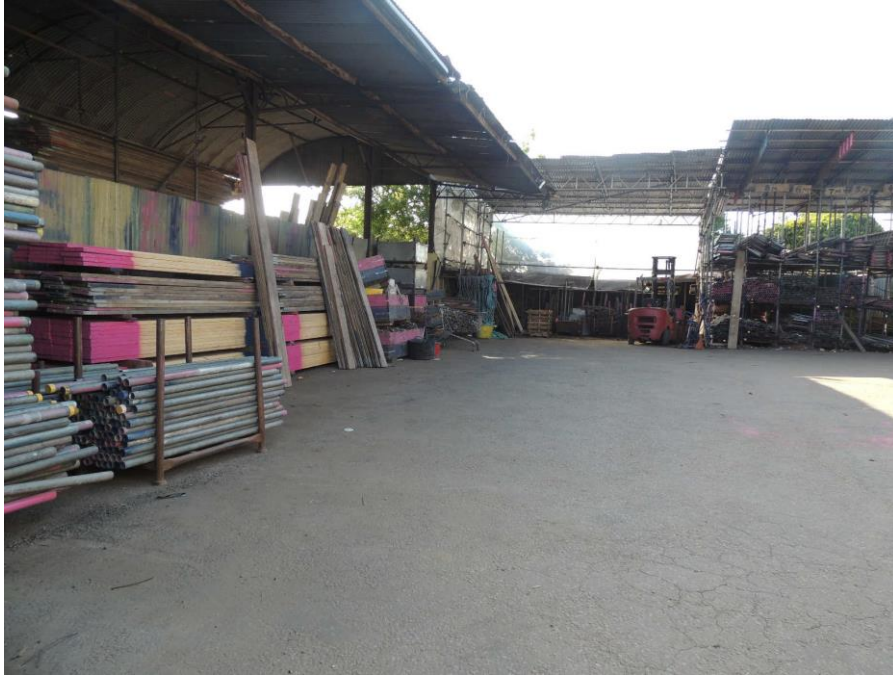
Photo 11: Building 6

This is an open-sided, metal-framed Dutch barn with a semi-circular roof that acts as a canopy for the scaffolding materials stored within. This building was exposed to wind and rain and had no potential as a roosting place for bats.

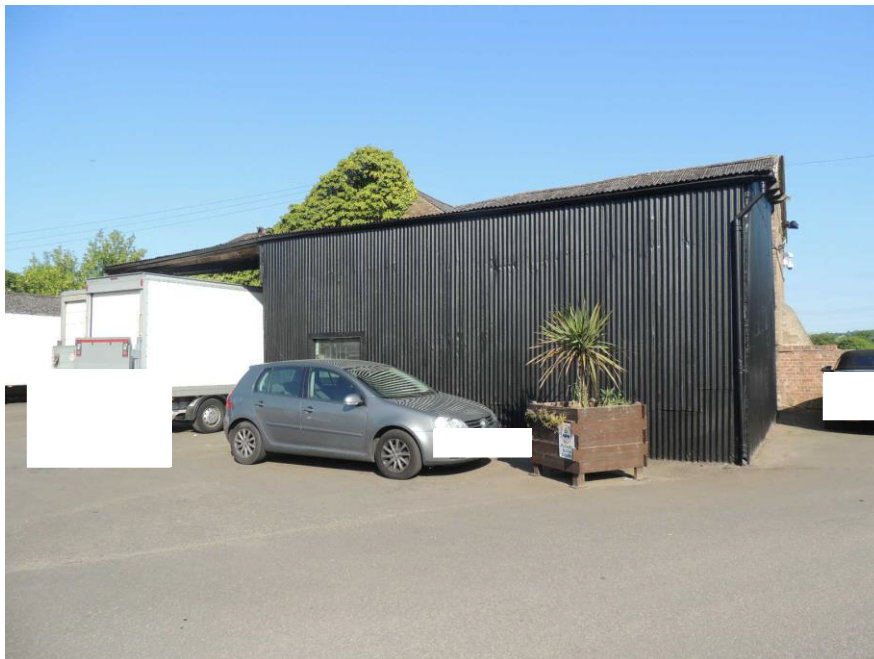
Photo 12: Building 7

This is a structure with a sloping roof of corrugated tin and corrugated tin walls. Although access was not gained to this building, experience gained over forty years indicates that this building would be unsuitable as a roosting place for bats.

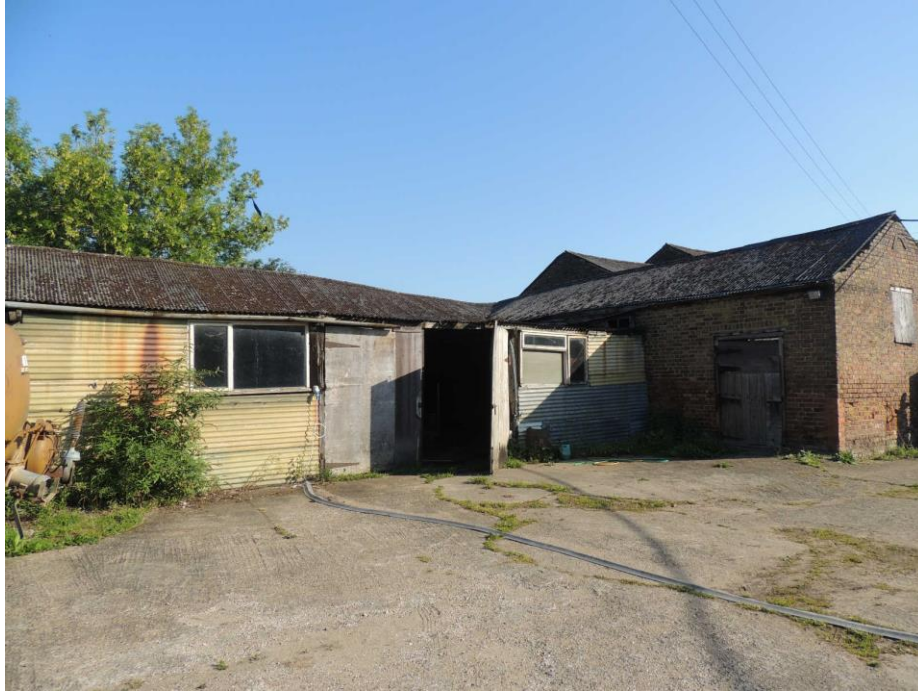
Photo 13: Building 8 & 9

This comprises a single-storey brick barn with an unlined corrugated asbestos roof. A large lean-to area has been added to the south-eastern side. This part of the building has a sloping roof of corrugated tin. The interior receives daylight illumination, and there is a light covering of cobwebs on several of the surfaces. In such conditions, bats seek out dark areas or crevices in which to roost, and the lack of such features in the brick walls and sawn timber beams meant that the building was less suitable as a roosting place for bats. No evidence of their presence was found on the walls and floor of the building.

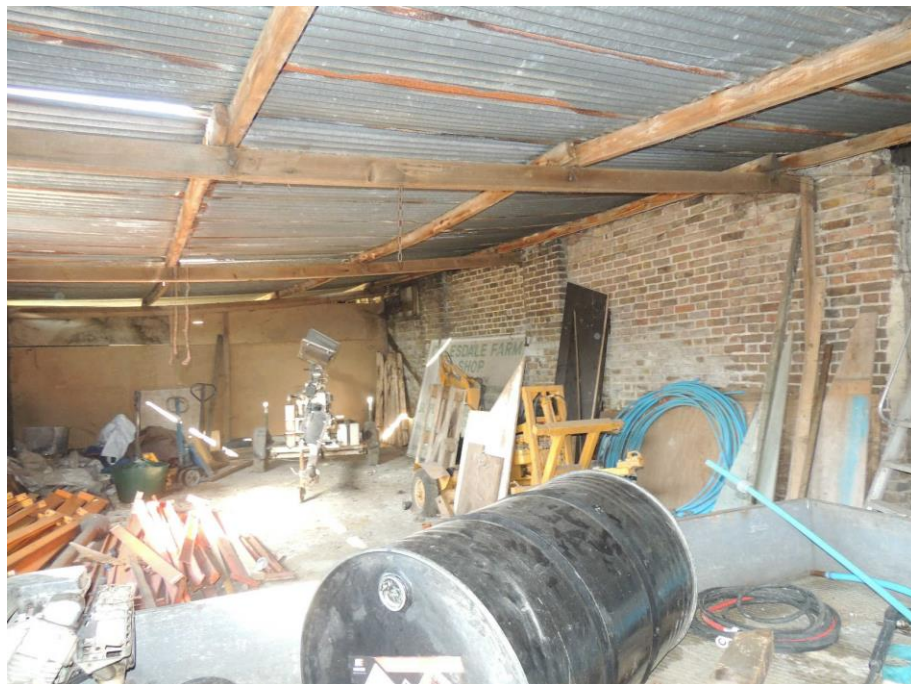
Photo 14: Area beneath the lean-to

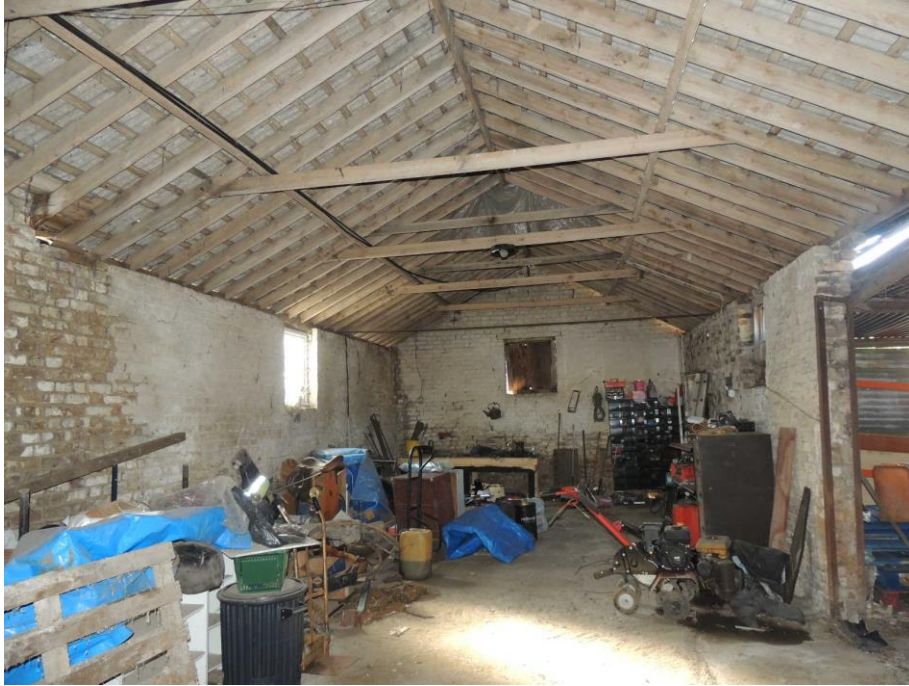
Photo 15: Looking north-eastwards along the single-storey brick barn

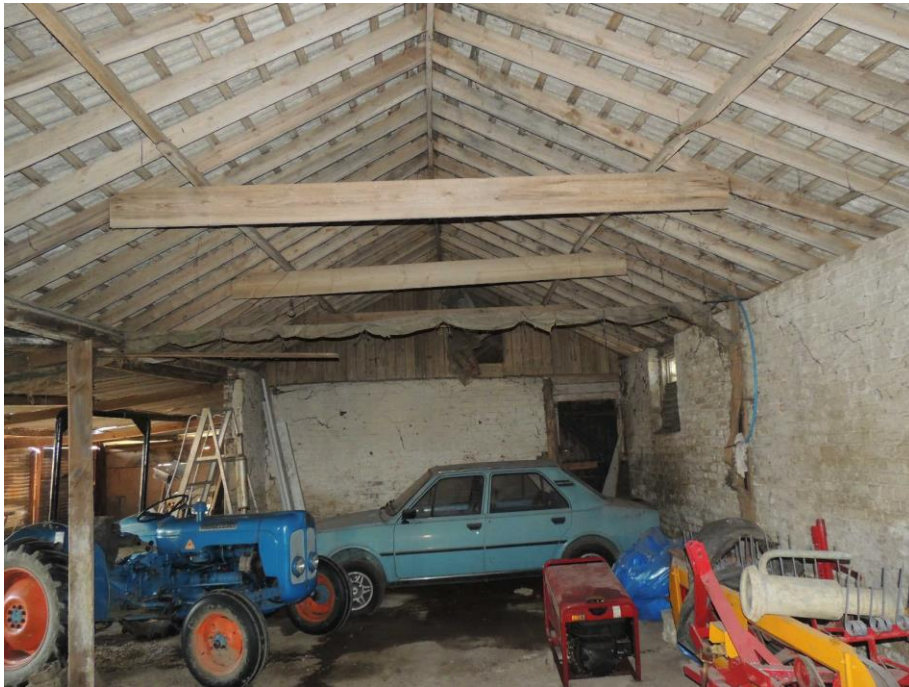
Photo 16: Looking south-westwards along the single-storey brick barn. Note lack of features that might be occupied by bats

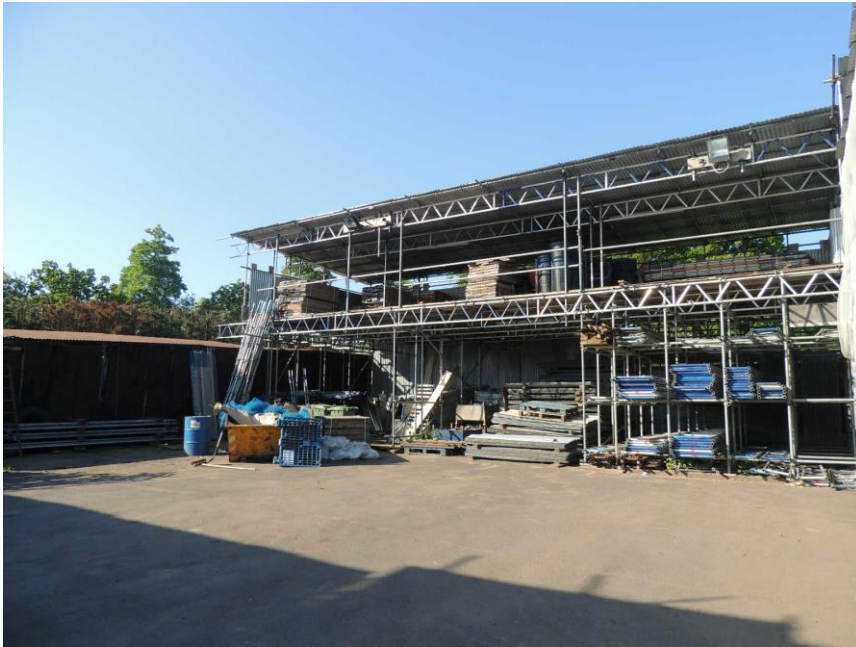
Photo 17: Building 10

Located on the western side of the site, this structure is a corrugated tin canopy beneath which scaffolding poles and boards are stored. It is exposed to wind and rain and has no potential as a roosting place for bats.
