**'NETHERWOOD'
35 CARBONE HILL
NORTHAW
HERTFORDSHIRE**

PRELIMINARY BAT ROOST ASSESSMENT

2017

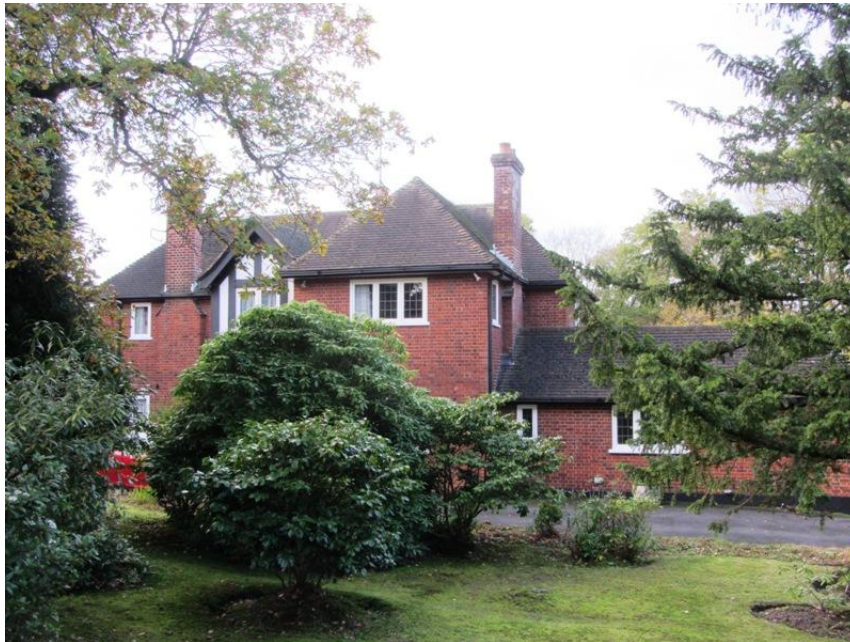
- 1.1 Amphibian, Reptile & Mammal Conservation Limited were contracted on 3rd November 2017 by Mr. Oktay Yilmaz, via Philip Dean Limited, to undertake a standard Preliminary Bat Roost Assessment of an existing vacant property (see cover photograph), known as ‘Netherwood’, 35 Carbone Hill, Northaw, Hertfordshire EN6 4PN, and situated at approximately National Grid Reference TL 2944 0390.

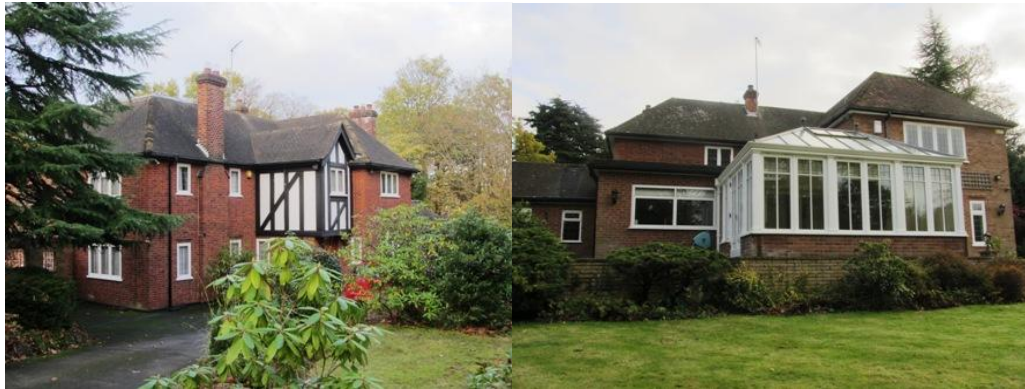
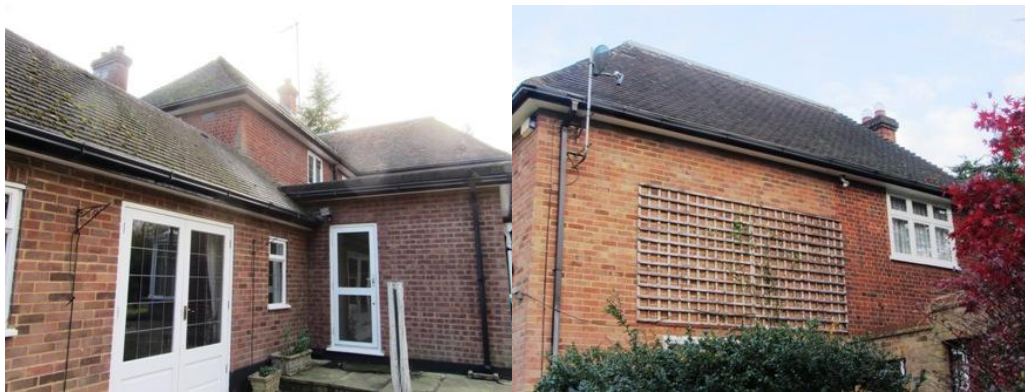
Photographs 1 – 4: Front, rear and side elevations

The site comprises a large vacant residential two-storey property (see photographs 1 – 4 below) that is brick-built with a single storey side extension to the north and a rear conservatory.

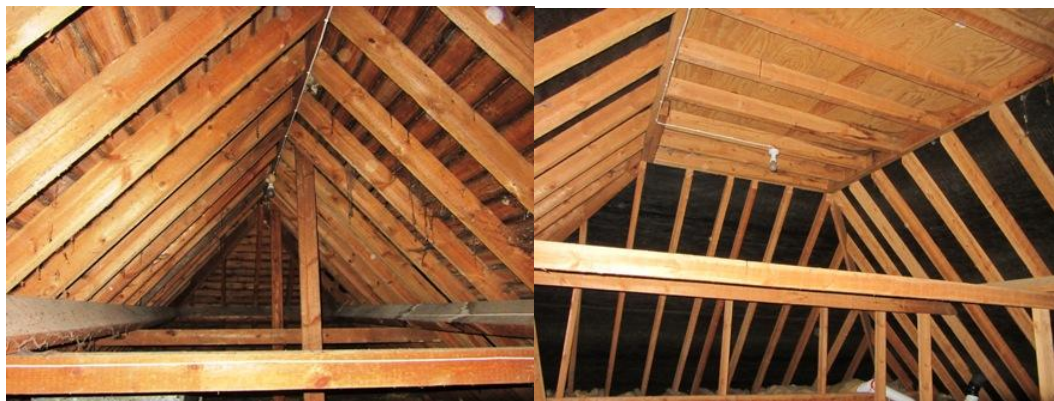
Photographs 5 – 6: Internal roof void

The roof has three chimneys and is part felt-lined and part wooden-boarded (see photograph 5 – 6 below). Old fibreglass floor insulation is also present throughout the loft void.

With the exception of an area immediately around the loft hatch, the roof space shows no evidence of disturbance for many years, thereby providing excellent undisturbed conditions for recording any past bat activity.

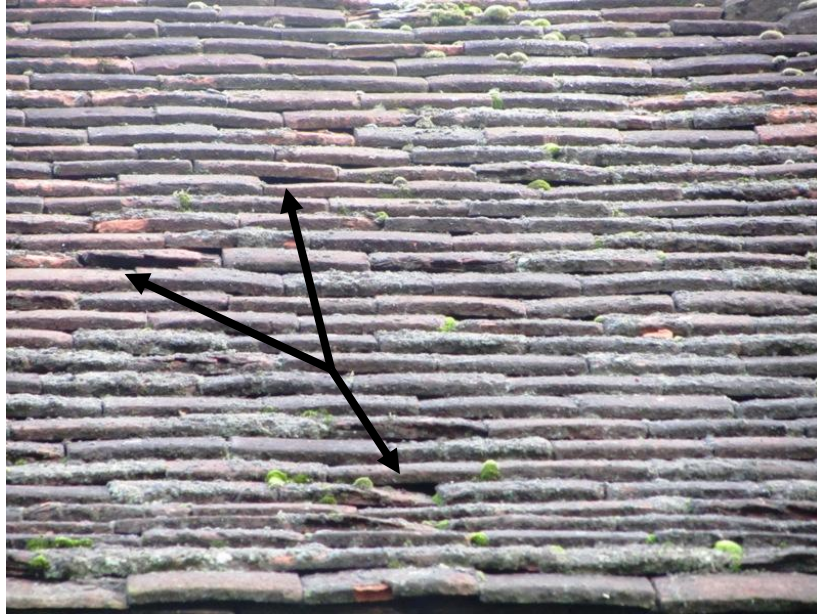
Photograph 7: Example of raised tiles on rear elevation

The building has a single L-shaped loft void below the pitched, tiled roof. The tiles on parts of the roof are old and appeared to be in poor condition with many obvious raised gaps visible from ground level, especially on the rear elevation adjacent to the conservatory (see photograph 7 below). These gaps provide a number of potential points of ingress for bats to access roof space.

As a result of the gaps in the roof tiles, the building was assessed to have a **‘high potential’** to act as a bat roost site.

5.1 The Preliminary Roost Assessment of the property categorised the building as having a '**high potential**' to support a bat roost(s) due to the structure and condition of the property affording numerous opportunities for bat ingress, such as gaps in tiles, and an undisturbed loft void for shelter.

5.4 In accordance with nationally published guidance, it is therefore now **recommended** that a series of three dusk emergence / dawn re-entry surveys are completed during the bats' forthcoming 2018 active season (between May and September inclusive).

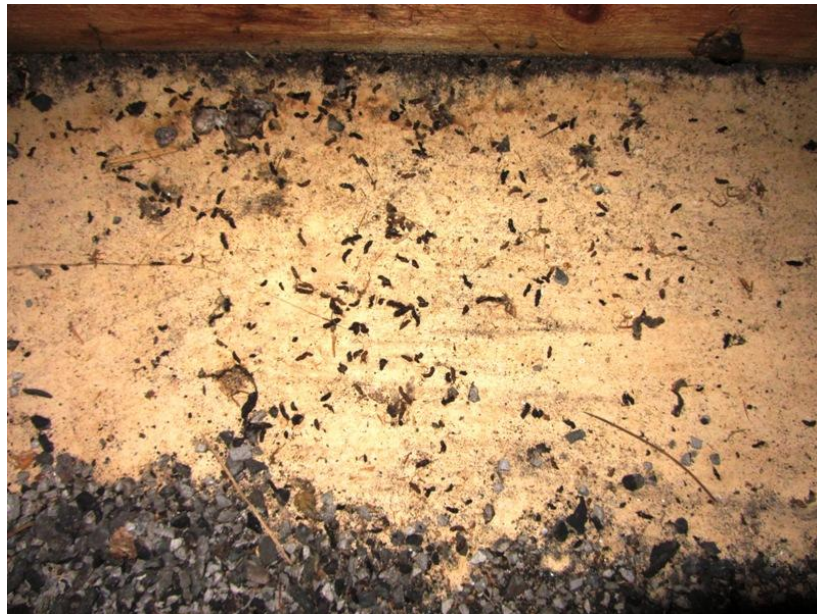
Photograph 8: Example of bat droppings in loft void

The internal inspection of the loft void located numerous Brown Long-eared Bat droppings (see photograph 8 below) throughout the main area of the L-shaped roof space: Droppings were not concentrated in any particular section of the loft void which is suggestive of pre-emergence internal flight within the roof space.

5.2 The internal examination of the building confirmed this assessment and located extensive evidence of Brown Long-eared Bat presence throughout the main loft void.

5.5 This work is required in order to identify the full species assemblage present, confirm the status of the roost (e.g. if the property is being used as a summer maternity roost) and the numbers present in order to provide the necessary data to inform any future DEFRA licence application that may be required to disturb, damage or destroy a roost of a European Protected Species.
