JAPANESE KNOTWEED EXCAVATION REPORT

Property Address: Site at 17-23 Church Lane, Hatfield, Herts, AL9 5HX

Contract No: TP/13/726

Excavation/ Treatment Start Date: 5th June 2014

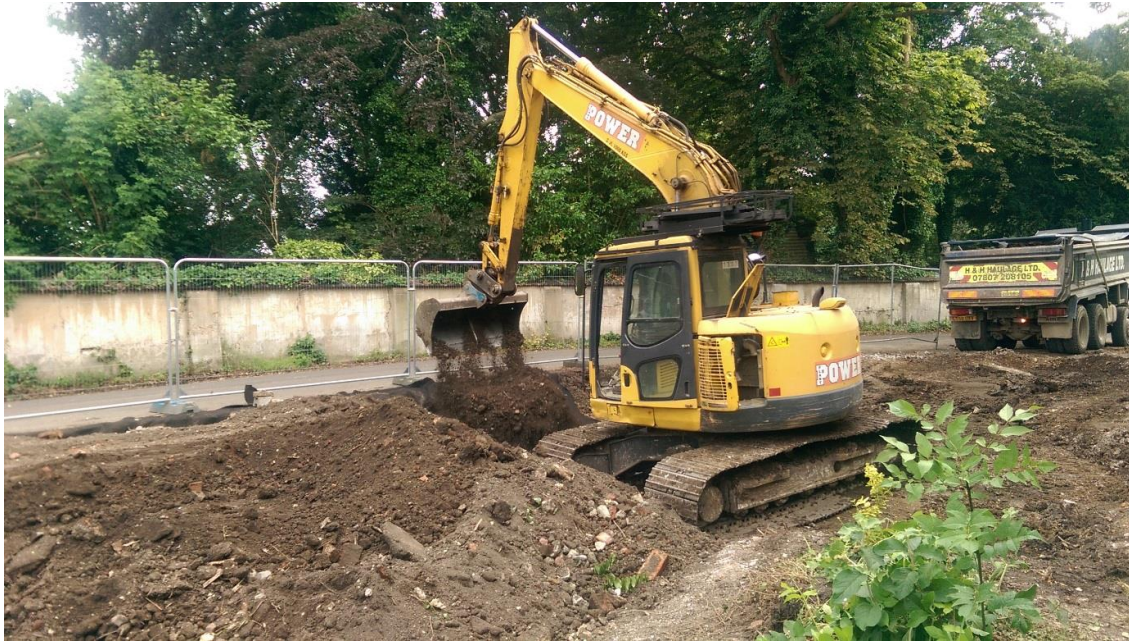
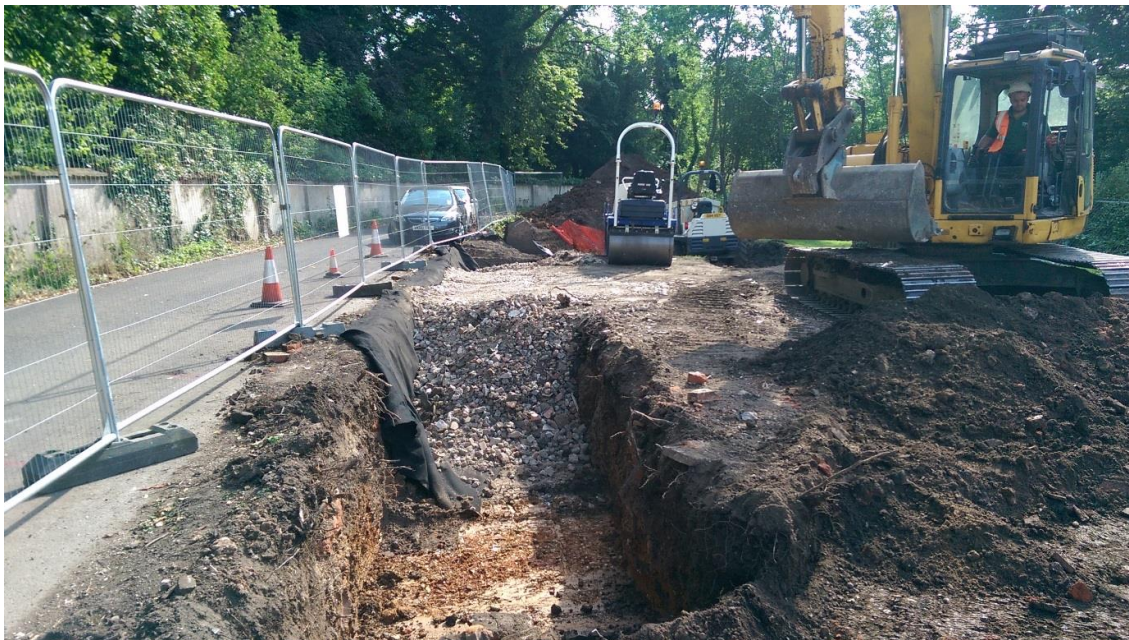
Photographs 1 & 2– *These photos show an area of the affected site being excavated by TP Knotweed Solutions Ltd.*

TP Knotweed Solutions Ltd started to excavate the affected areas of the site in stages to ensure that the adjacent road was supported throughout the works.

Once a section of the site had been excavated and removed off site, the geotextile root barrier was installed along the edge of the excavation and the area was backfilled using 6F2 Crushed Concrete and compacted using a roller. This process was carried out until the works were completed.

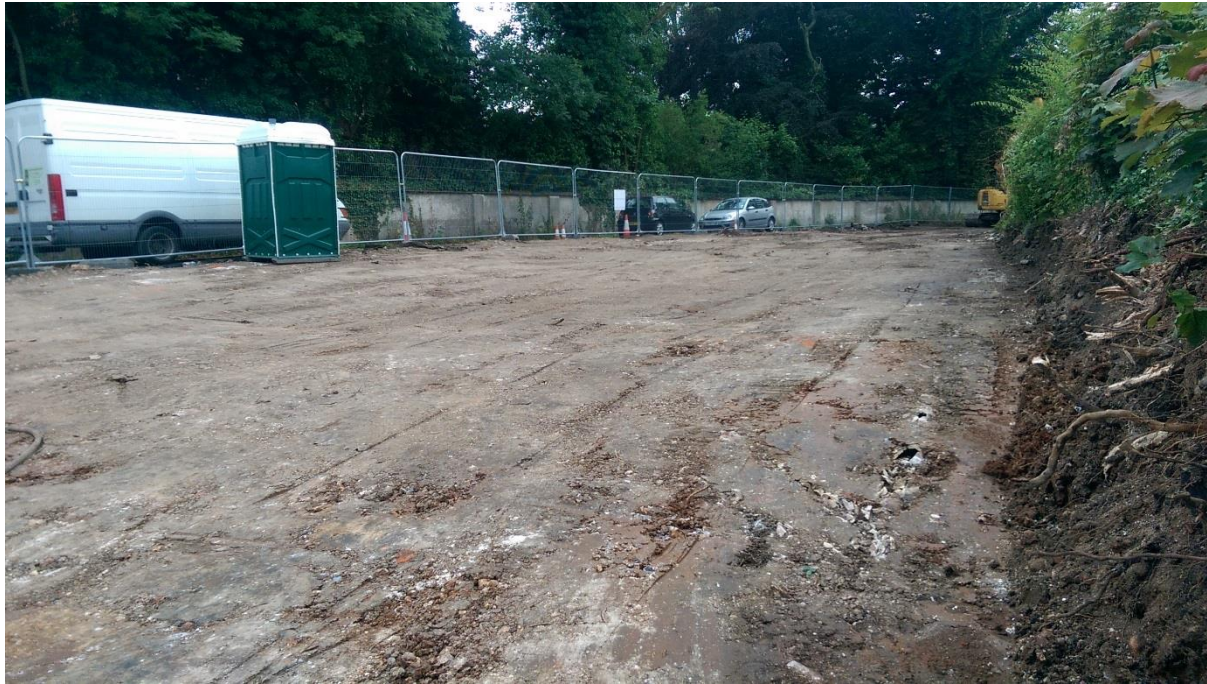
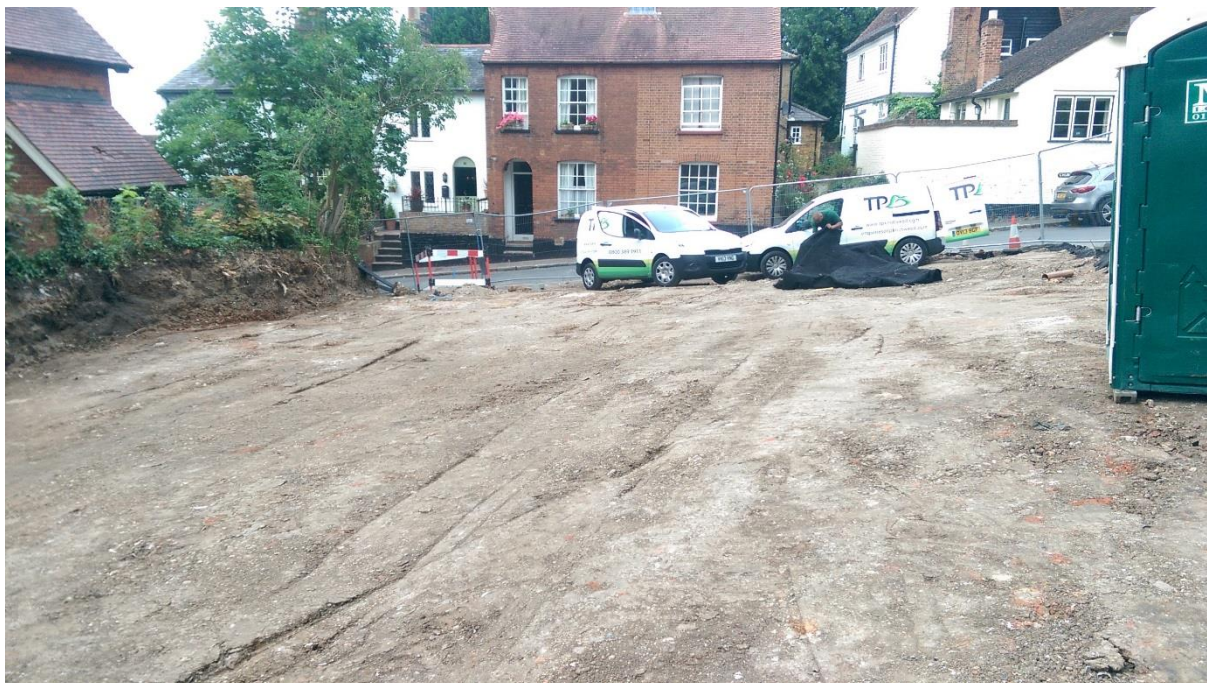
Photographs 3 & 4 - The photographs above and below show some views of the site once all of the soil containing Japanese knotweed has been removed and the areas have been backfilled.

TP Knotweed Solutions Ltd can confirm that all of the contaminated soil has now been excavated and removed from the site, to a licensed landfill site.
