Shell Welwyn Garden fuel retail station

Preliminary (Phase 1) site assessment report

Project no. 305095 R01

OCTOBER 2019

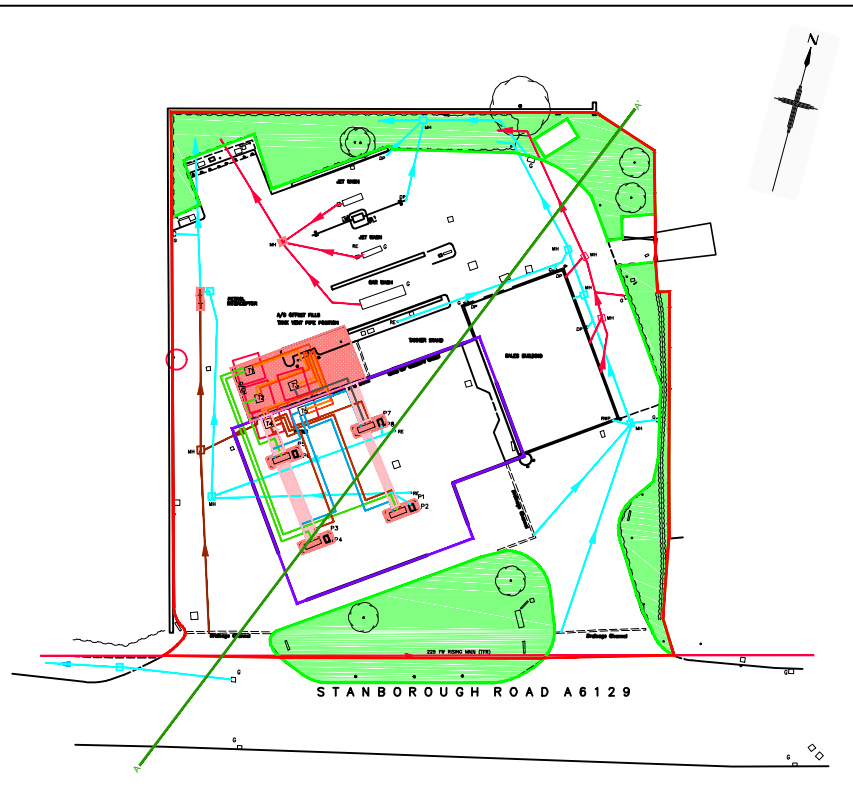
Potentially Complete Pollutant Linkages Identified Within Conceptual Site Model

Potential Sources	Potential Pathways	Potential Receptors
<ul style="list-style-type: none"> • petrol and diesel as light non-aqueous phase liquids (LNAPL) arising from potential losses from fuel storage tanks and fill lines; • petrol and diesel as light non-aqueous phase liquids (LNAPL) arising from potential losses from fuel dispensing infrastructure (underground pump lines, pump islands); • petroleum hydrocarbon COPC arising from potential losses from surface drainage interceptors and drainage; • soil impacted with retail petroleum COPC; • dissolved phase retail petroleum COPC within groundwater; • soil vapour originating from retail petroleum COPC. 	<p>Human health:</p> <ul style="list-style-type: none"> • permeation of plastic pipework; • volatilisation and subsequent vertical and lateral migration of vapours via permeable strata/along backfill to service trenches. <p>Controlled waters:</p> <ul style="list-style-type: none"> • leaching from unsaturated zone soils; • remobilisation; • lateral and/or vertical migration; and • direct input via preferential pathways. 	<p>Human health:</p> <ul style="list-style-type: none"> • workers in the site shop • the site's potable water supply • residents in properties located 5m to the north and west, and 10m to the east of the site • site users of commercial premises 20m to the south of the site <p>Controlled waters:</p> <ul style="list-style-type: none"> • groundwater within the Lowestoft Formation (a secondary undifferentiated aquifer), the Kesgrave Catchment Subgroup (a Secondary A aquifer) and the Lewes Nodular and Seaford Chalk Formations (Principal aquifers) beneath the site • surface waters in the surface water drains of the site

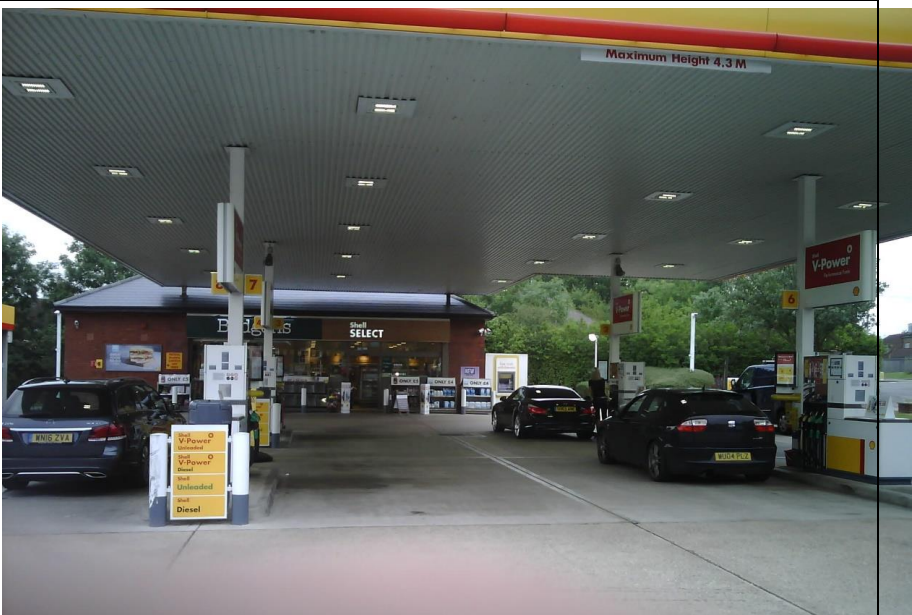
Photo no. 1	Date: 25/06/2019

Direction photo taken: East		
Description: View of the pumps and the shop

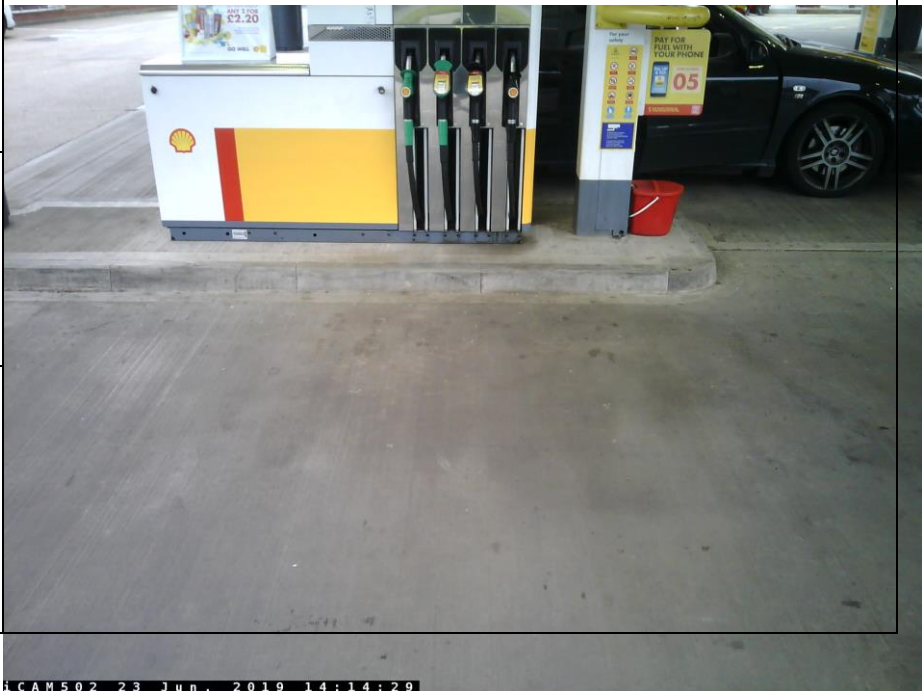
Photo No. 3	Date: 25/06/2019

Direction photo taken: North		
Description: View of a pump and the concrete ground that covers the majority of the site.

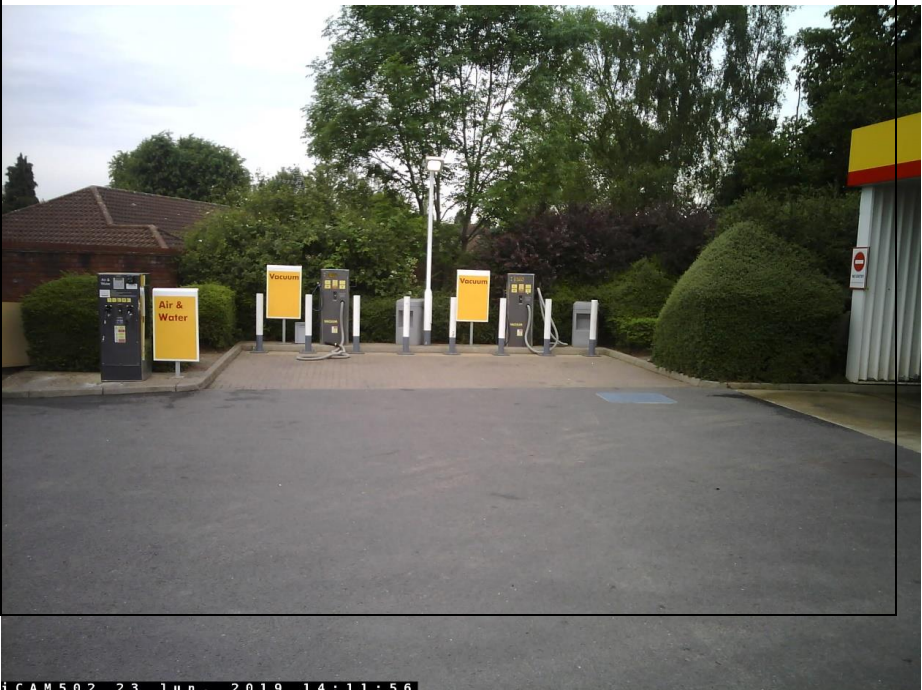
Photo no. 4	Date: 25/06/2019

Direction photo taken: North		
Description: View of the air and water and vacuum stations in front of the exit for the jet wash.
