Existing Site Plan 1:200

Location
58 Plough Hill
Cuffley EN6 4DS

Scale	Date
As shown	Nov 2017
Dwg No	
DB/JC/200

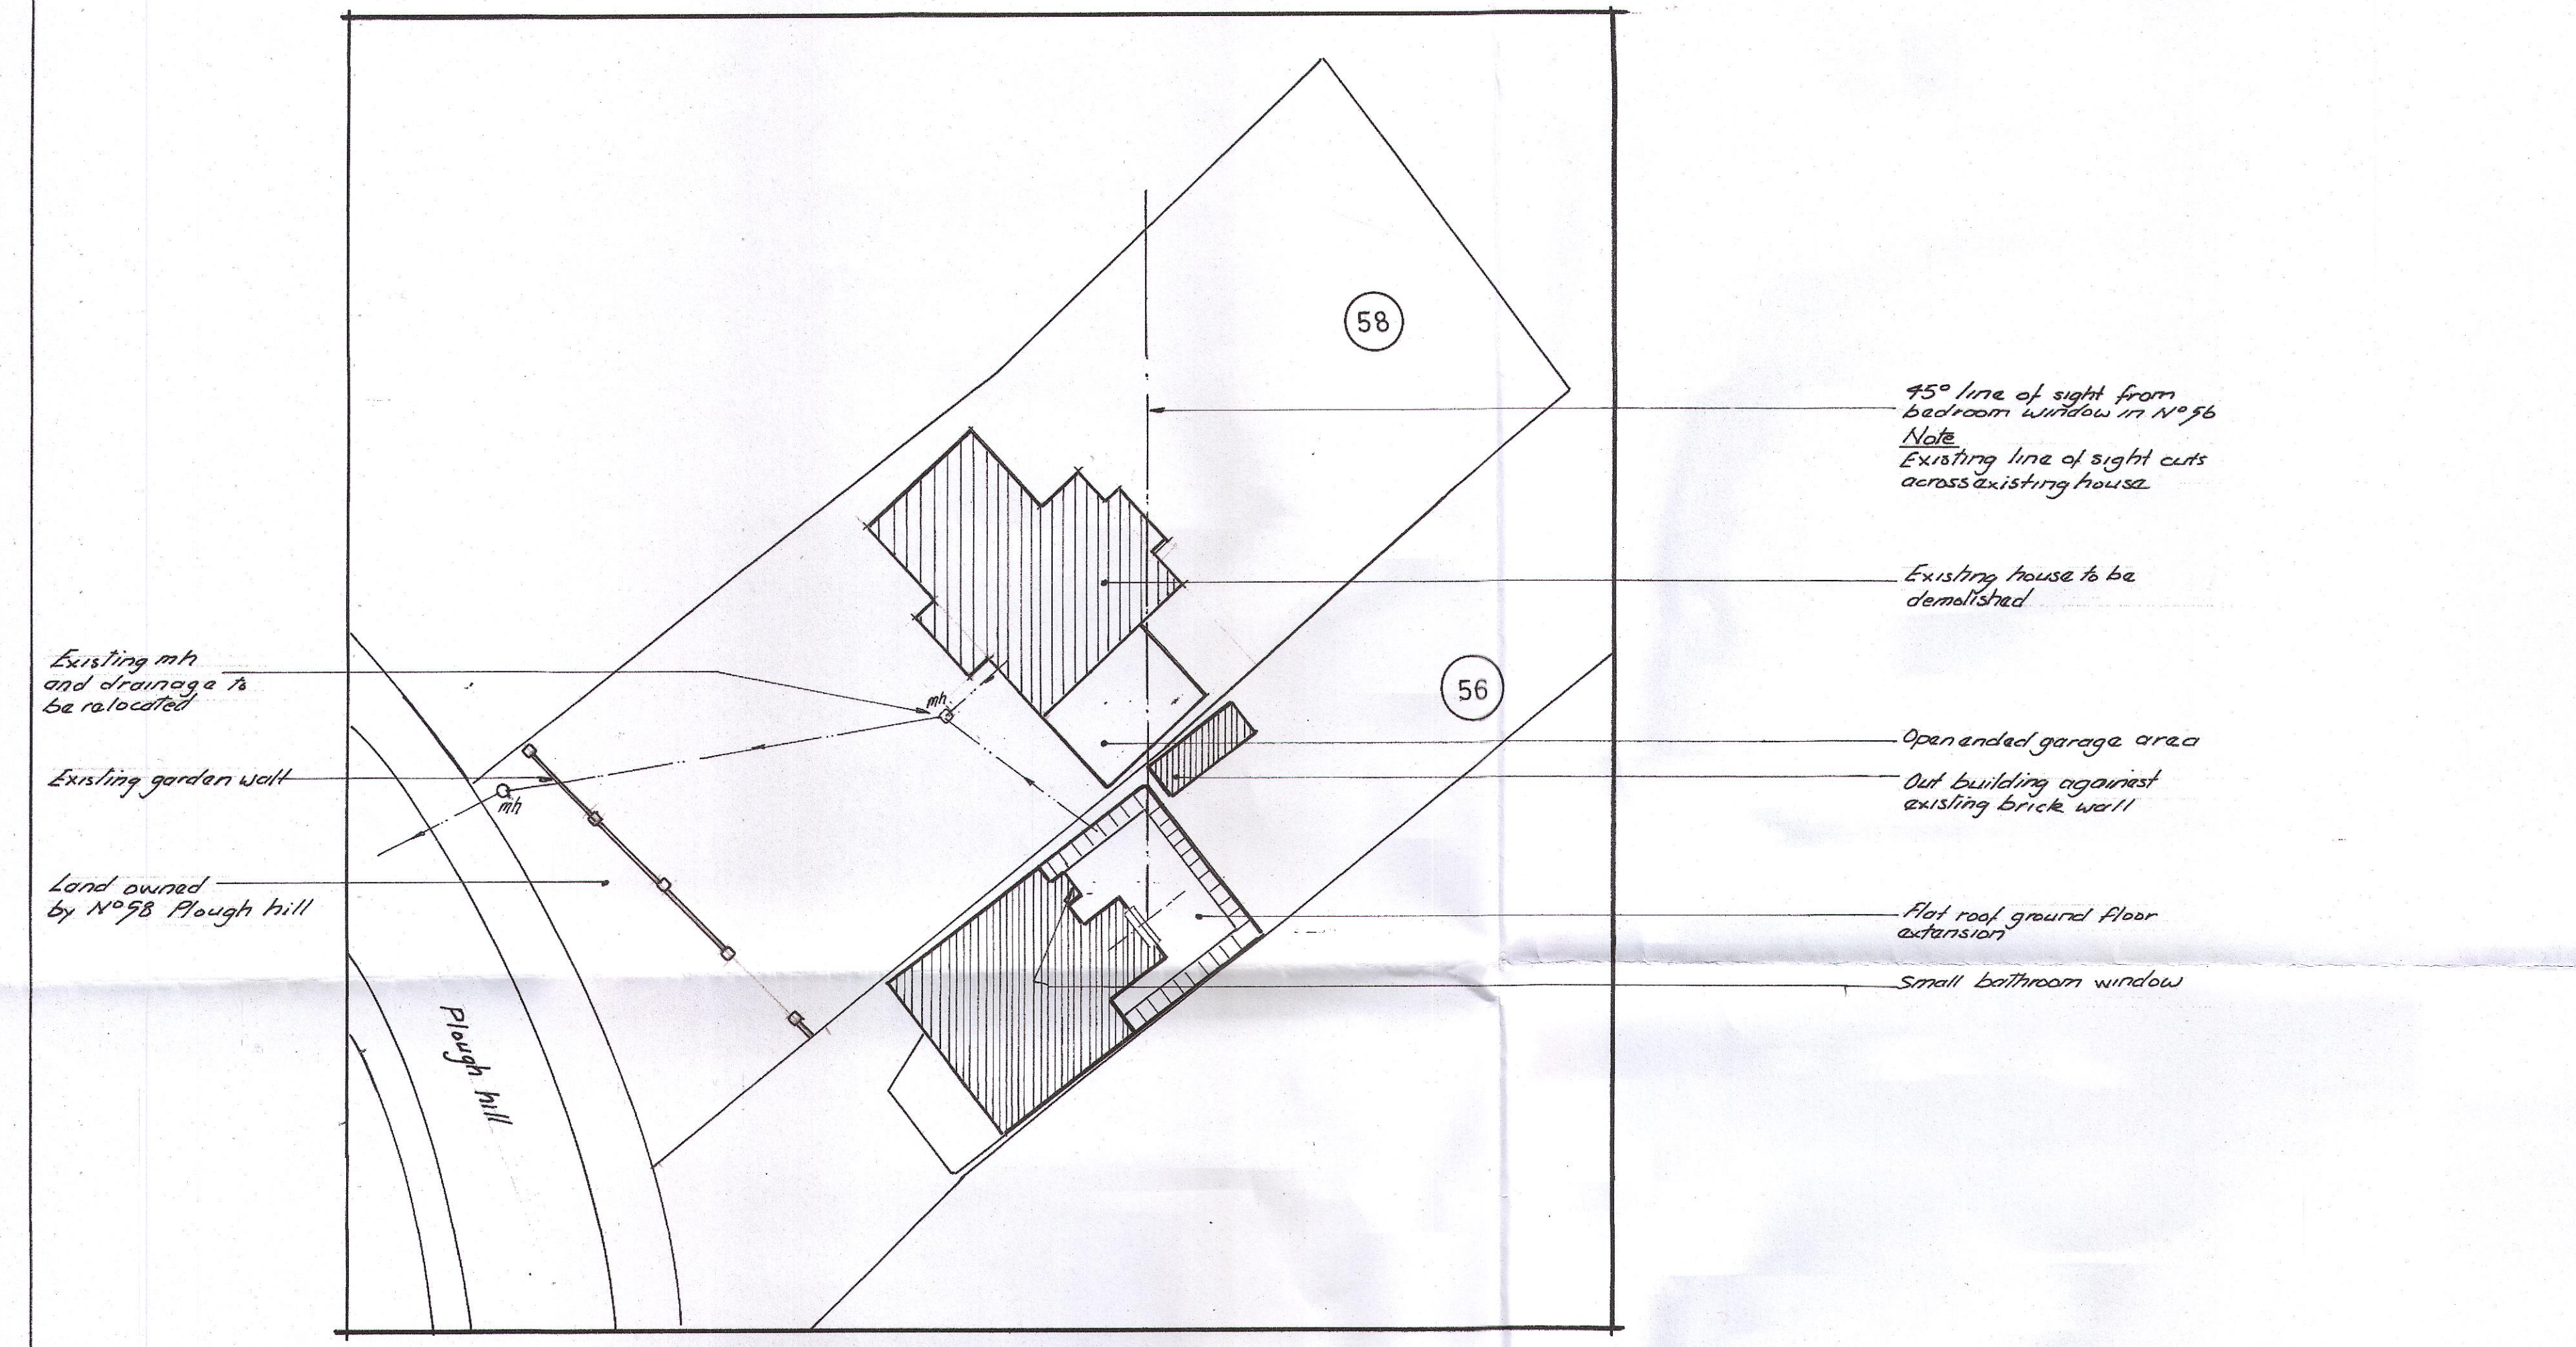
45° line of sight from bedroom window in No 56
 Note
 Existing line of sight cuts across existing house

Existing house to be demolished

Open ended garage area

Out building against existing brick wall

Flat roof ground floor extension

Small bathroom window

Existing mh and drainage to be relocated

Existing garden wall

Land owned by No 58 Plough Hill
