Preliminary Land Contamination Risk Assessment

**Warrenwood Manor
Hornbeam Lane
Essendon
AL9 6JF**

LBH4395 Ver. 1.0

March 2016

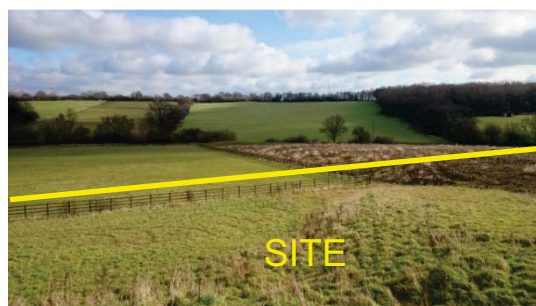
View across north-eastern site boundary towards brook

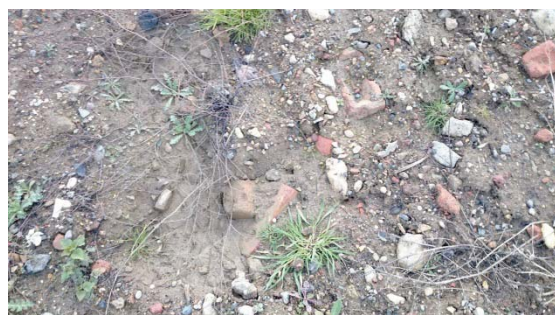
A visual inspection of the current site surface reveals a significant amount of scattered fragments of concrete, brick, glass, plastic and metal with limited vegetation growth.

Typical site surface detail

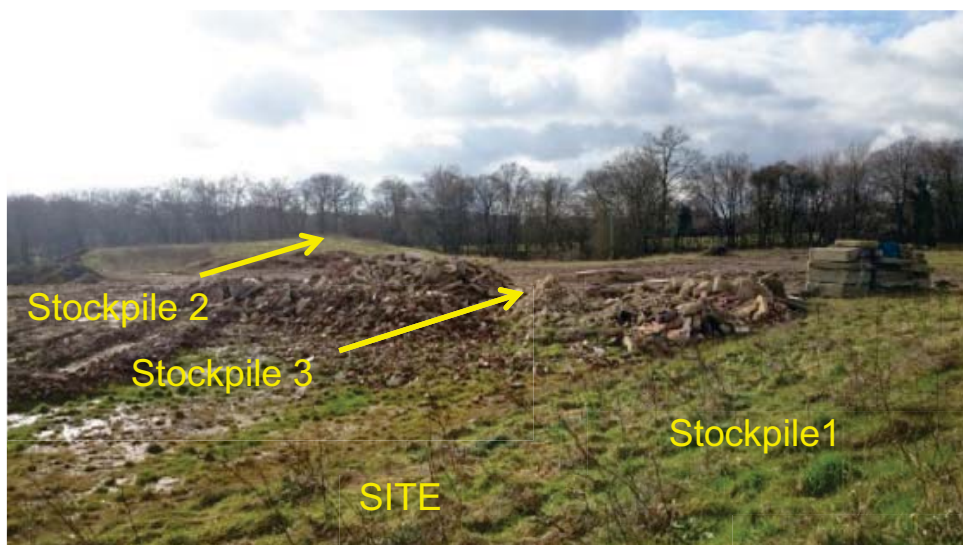
View south-westwards across the site, showing the three stockpiles.

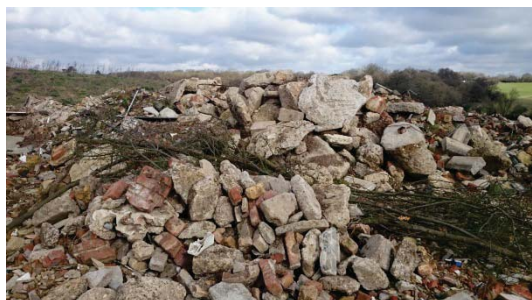
Top left, stockpile 3 containing demolition material

As described above, it is proposed to retain the made ground that is present on the site and to further remodel the slope through spreading the two topsoil stockpiles and removing the construction stockpile.

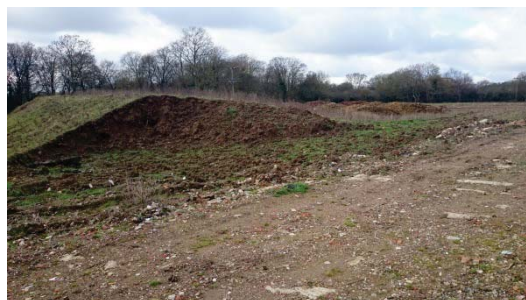
Top right, stockpile 2 containing topsoil

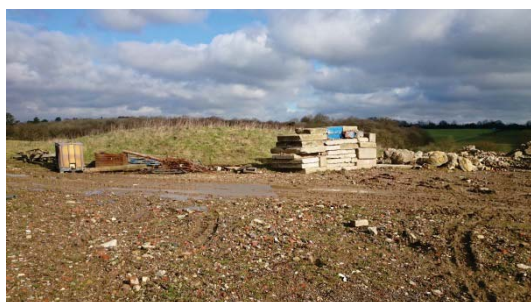
Bottom Left, stockpile 1 (in background) containing topsoil

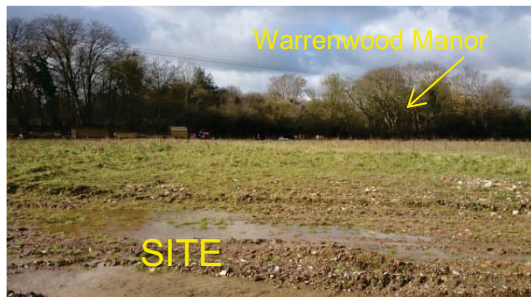
Warrenwood Manor is located on the opposite side of Hornbeam Lane, the surrounding area of which appears to have been cut into the hillside with variously levelled plateaus. There is also a large pond located to the north of the house.

View southwest across site towards recently constructed Warrenwood Manor (behind Trees)

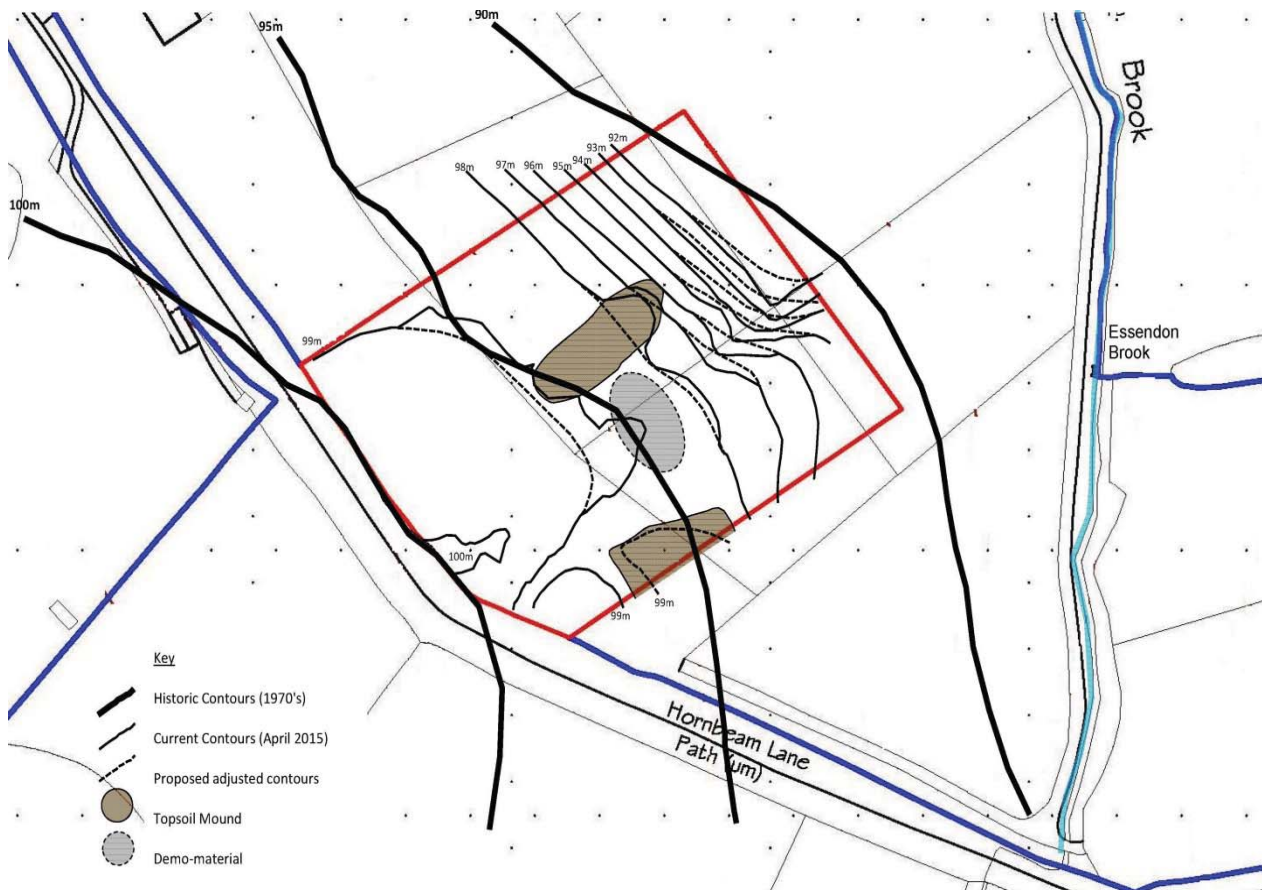
Plan showing previous, existing and proposed contours

The plan above demonstrates the current contours of the site (thin black lines), and the proposed modifications (dashed) by way of using the two topsoil stockpiles.

However, the heavier black lines derived from 1970s OS mapping indicate that at present, the thickness of recently-placed fill at the site increases from zero along the southwestern boundary to approximately 4m in the central area of the site. Along the northeastern boundary the thickness appears to vary from less than 1m in the north to approximately 3m in the easternmost section of the site.

While it is apparent that the made ground present on the site may be entirely composed of material cleared from the adjacent sites, given the deduced volume of made ground present it is also considered possible that there has been additional importation of material from external sources.
