# 4.0 LANDSCAPE AND VISUAL ASSESSMENT

## VIEW LOCATION PLAN

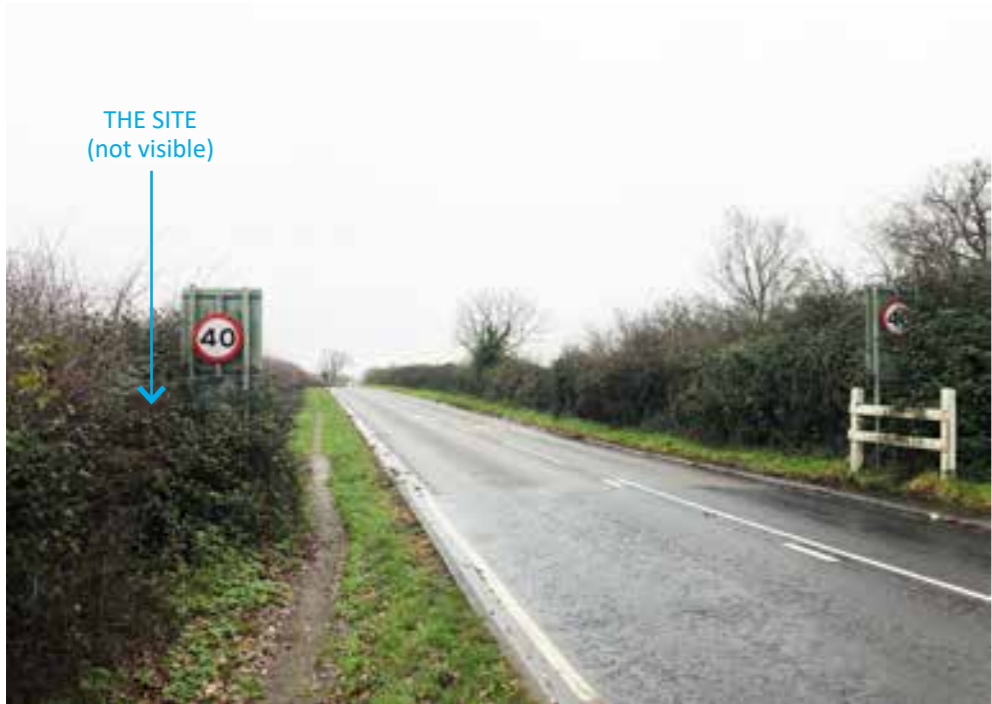
1. View looking east from Northaw Road West leaving Northaw to the brow of the hill. Site not visible.

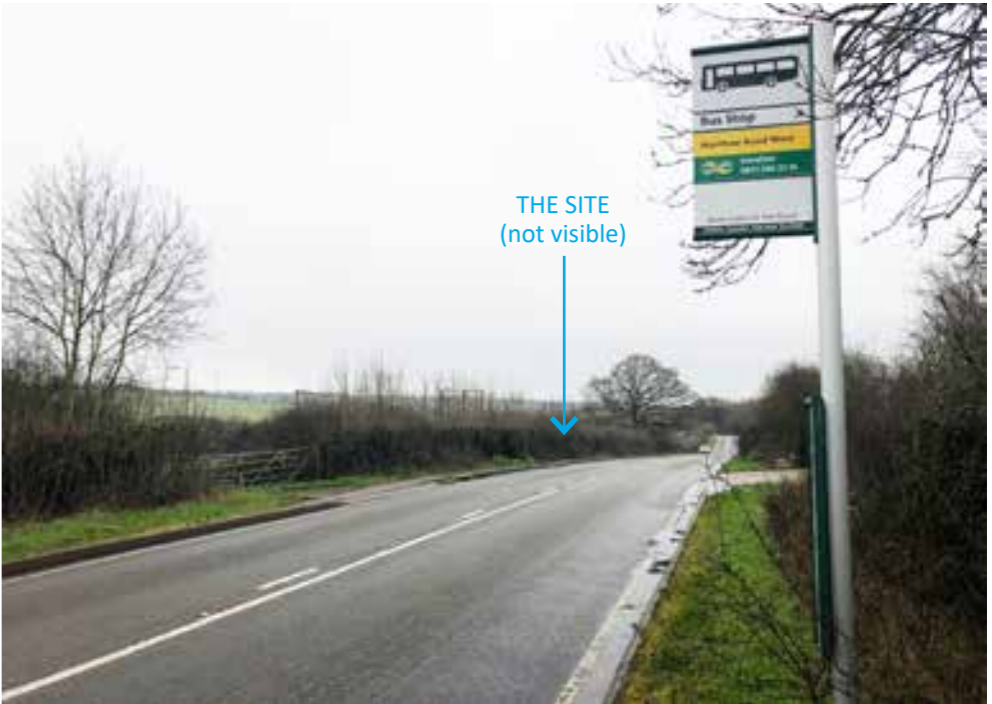
3. View from Northaw Road West bus stop adjacent to farm access. Site obscured by topography and hedges.

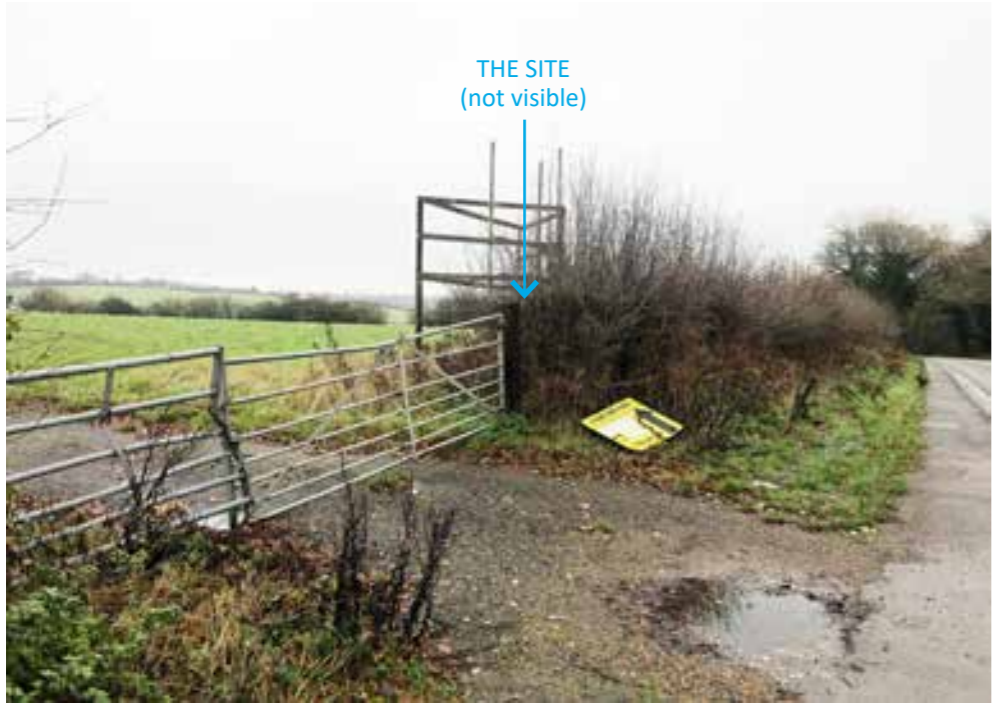
4. View looking east from field access opposite Northaw Road West bus stop looking towards Cuffley. The site is obscured by topography and hedgerows.

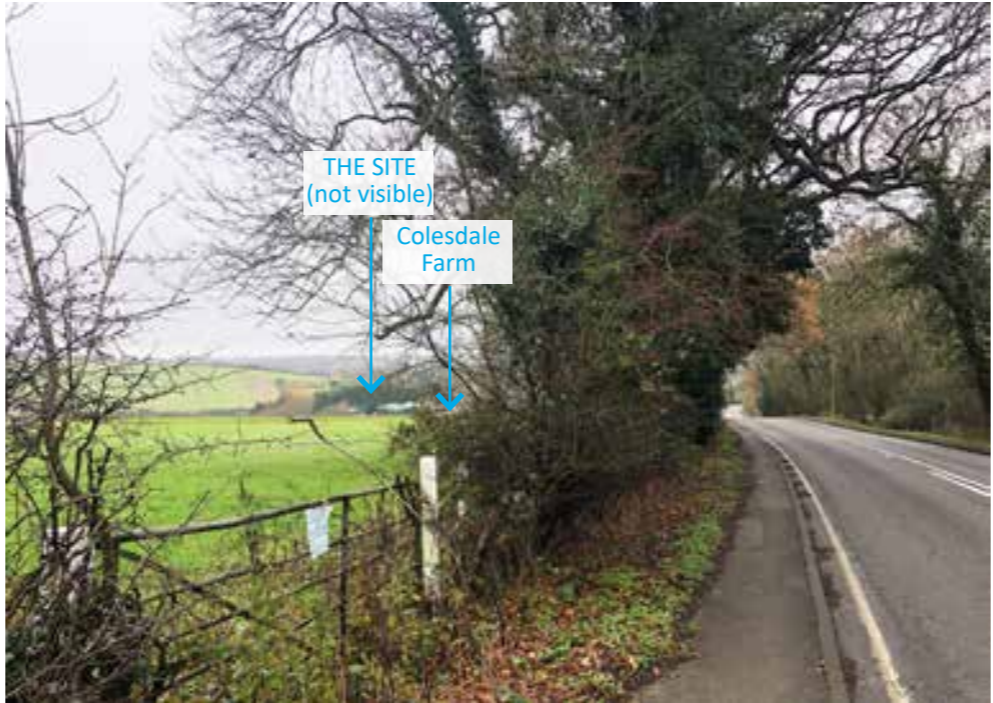
5. Glimpsed view through a field access towards Cuffley from Northaw Road West looking east. Colesdale Farm is partially visible. The site is obscured by landscaping.

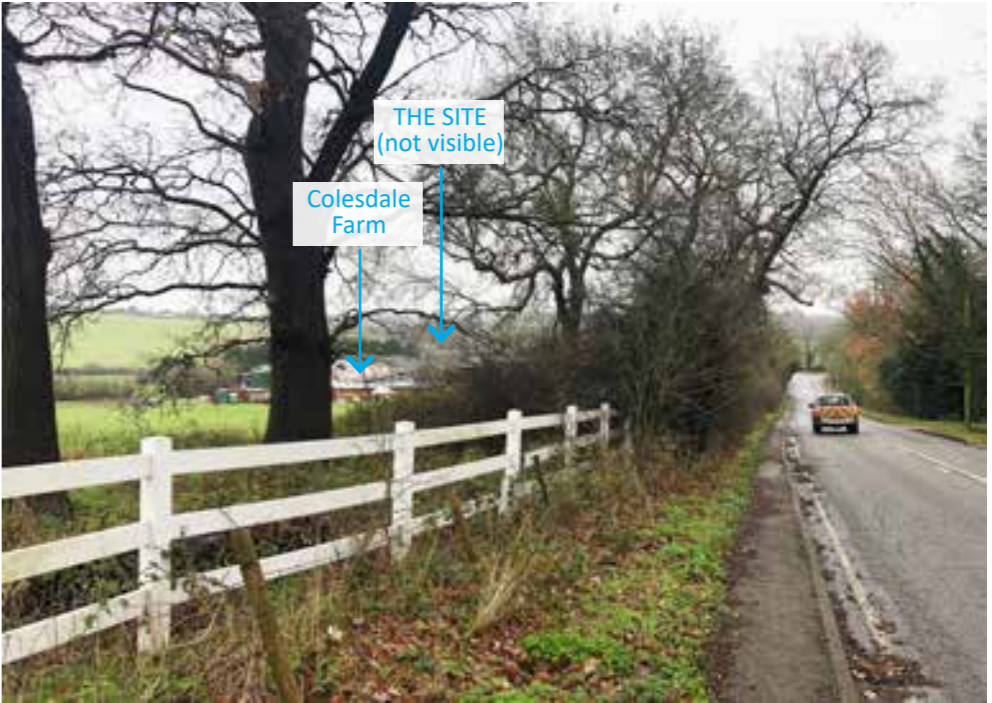
6. Glimpsed view through a gap in the hedge from Northaw Road West looking east. Colesdale Farm is partially visible. The site is obscured by landscaping.

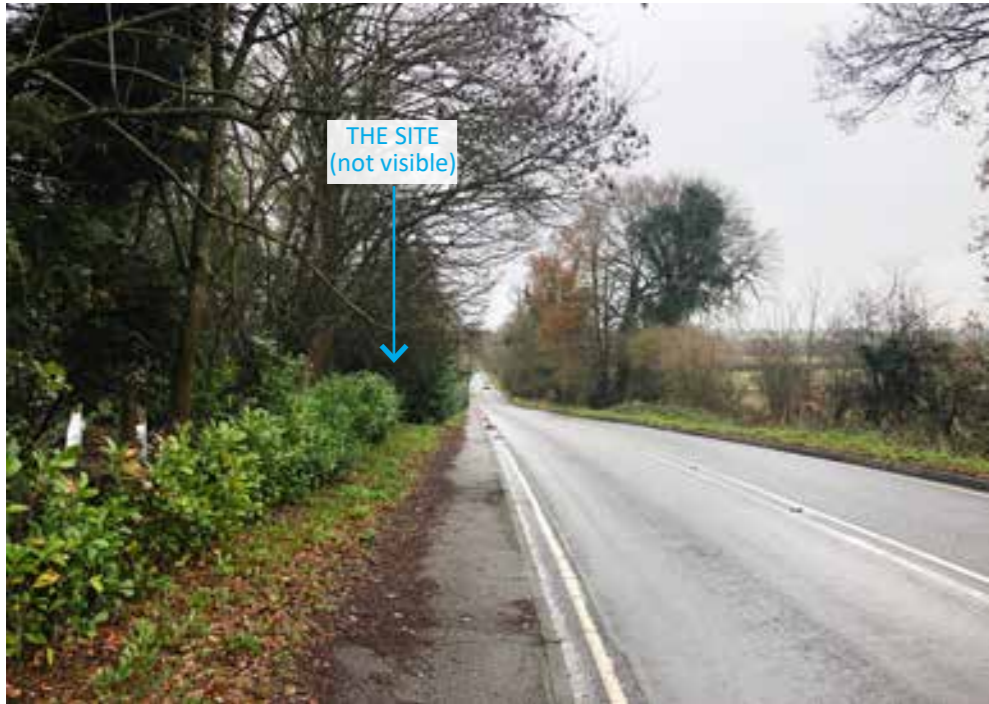
7. View looking east down Northhaw Road East leaving from Colesdale Farm. Site not visible.

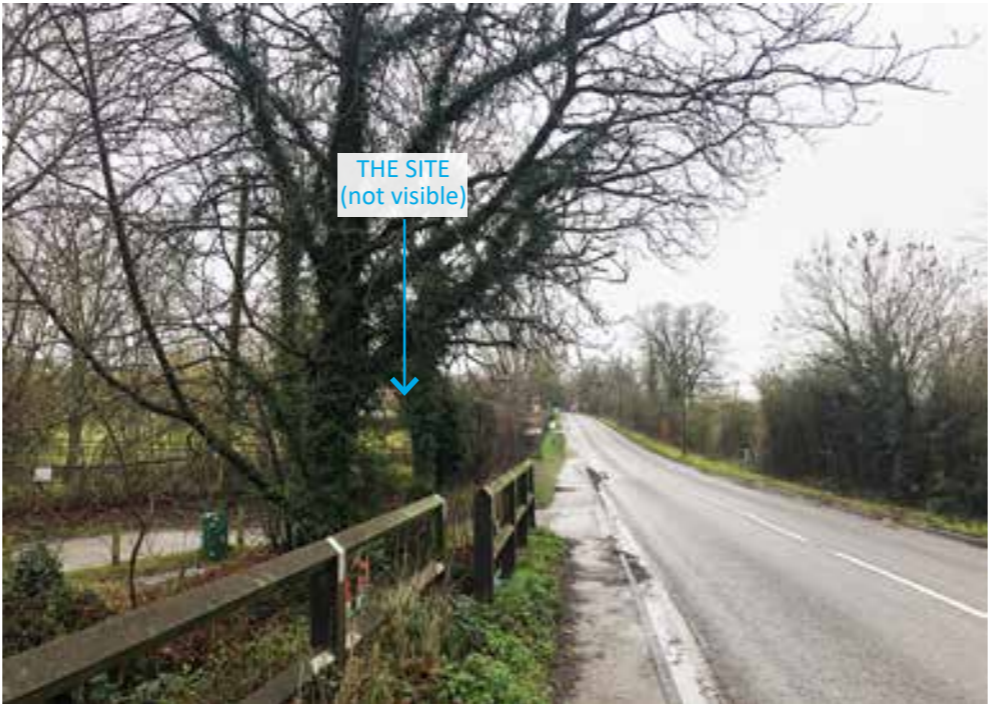
8. View looking east along Northhaw Road East from Hempshill Brook. Site obscured by trees and hedges.

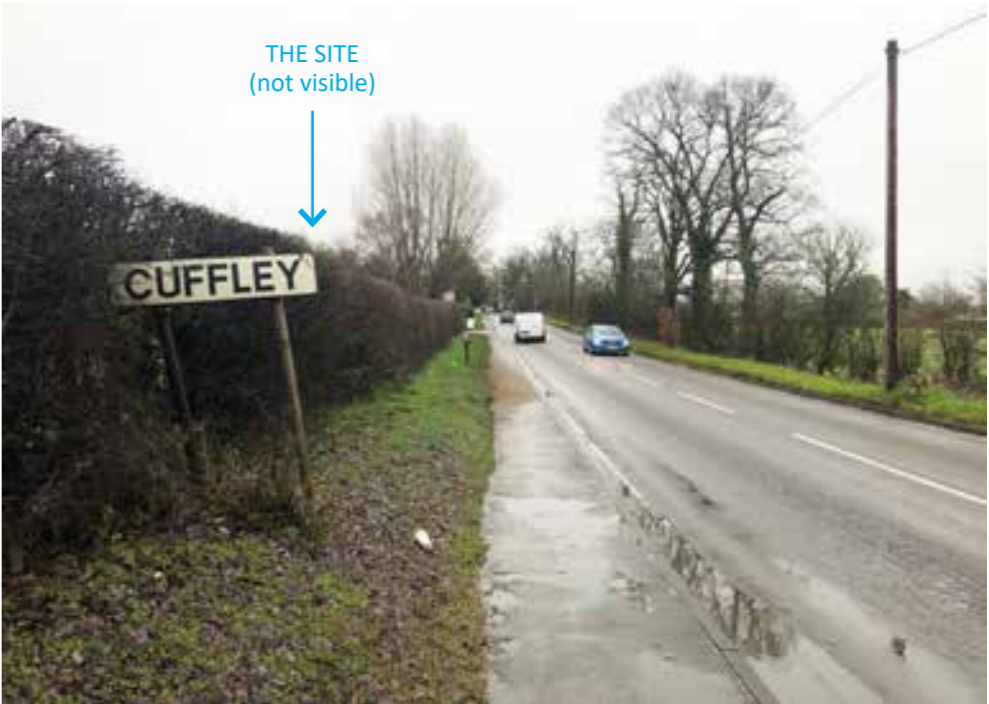
9. View looking east up Northhaw Road East. Site obscured by hedges.

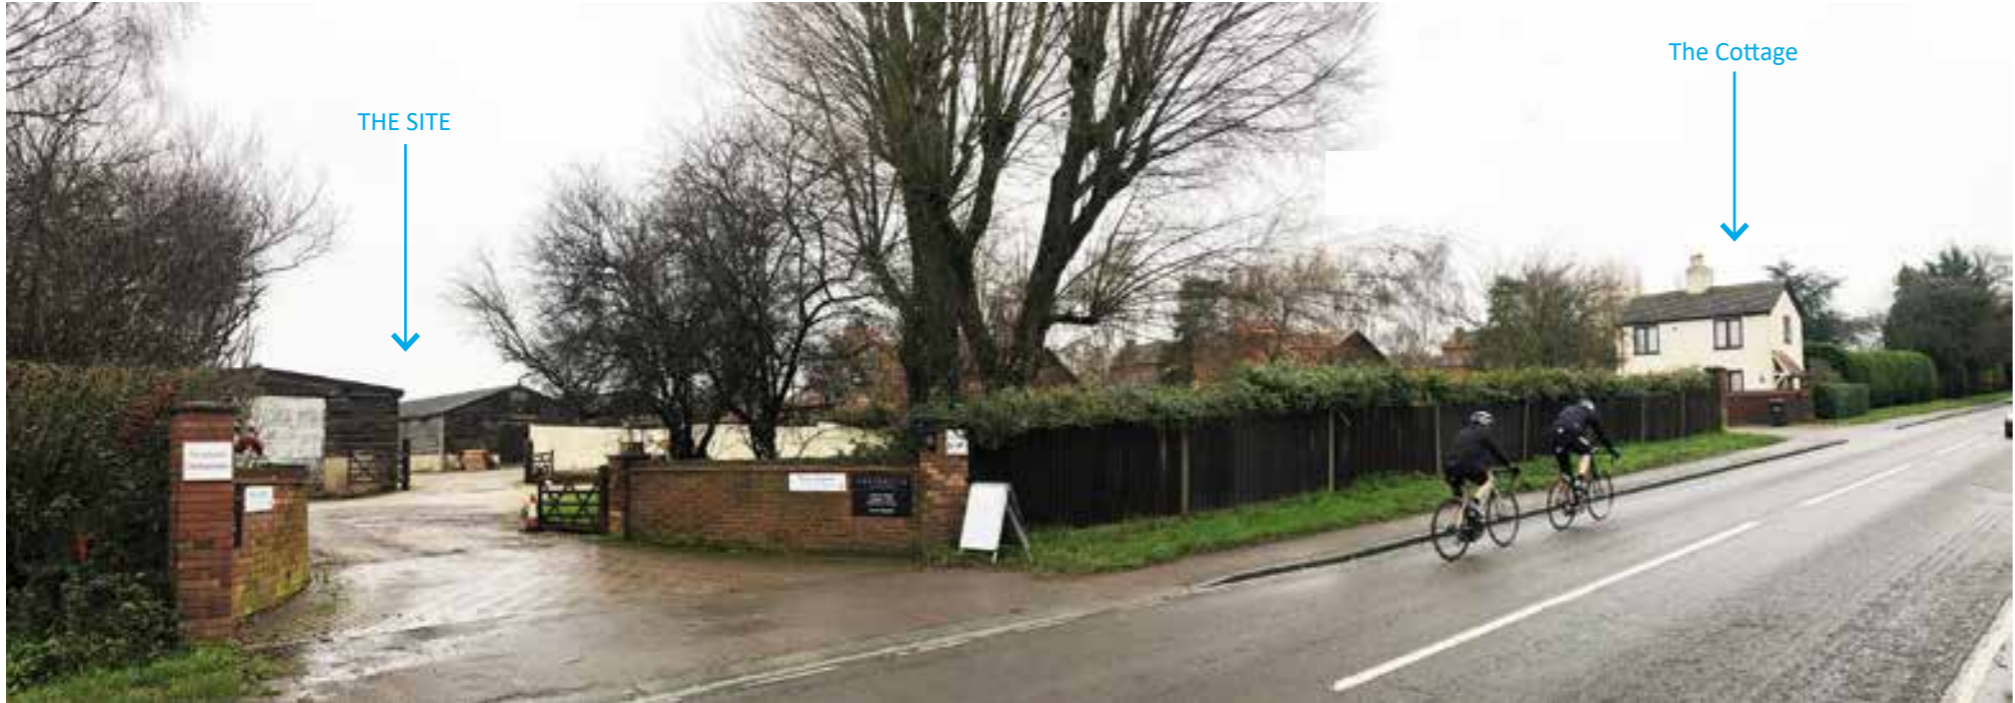
10. View looking northeast from Northhaw Road East at the site access with the site visible beyond. The second access to New Wells Farm is to the right next to Wells Farm Cottage (not part of the site)

View looking northeast from Northaw Road East at the site access with the site visible beyond. The second access to New Wells Farm is to the right next to Wells Farm Cottage (not part of the application site)

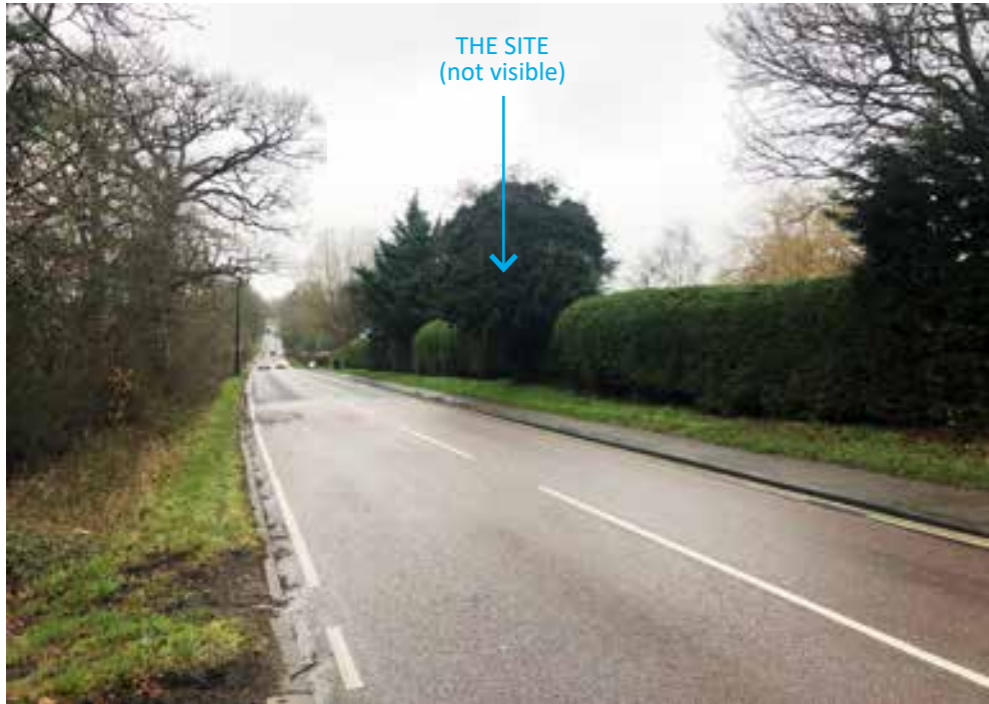
12. View looking west down Northaw Road East from the field access opposite the Football Club. Site not visible due to evergreen trees and hedges.

Existing view looking west down Northhaw Road East from the field access opposite the Football Club.

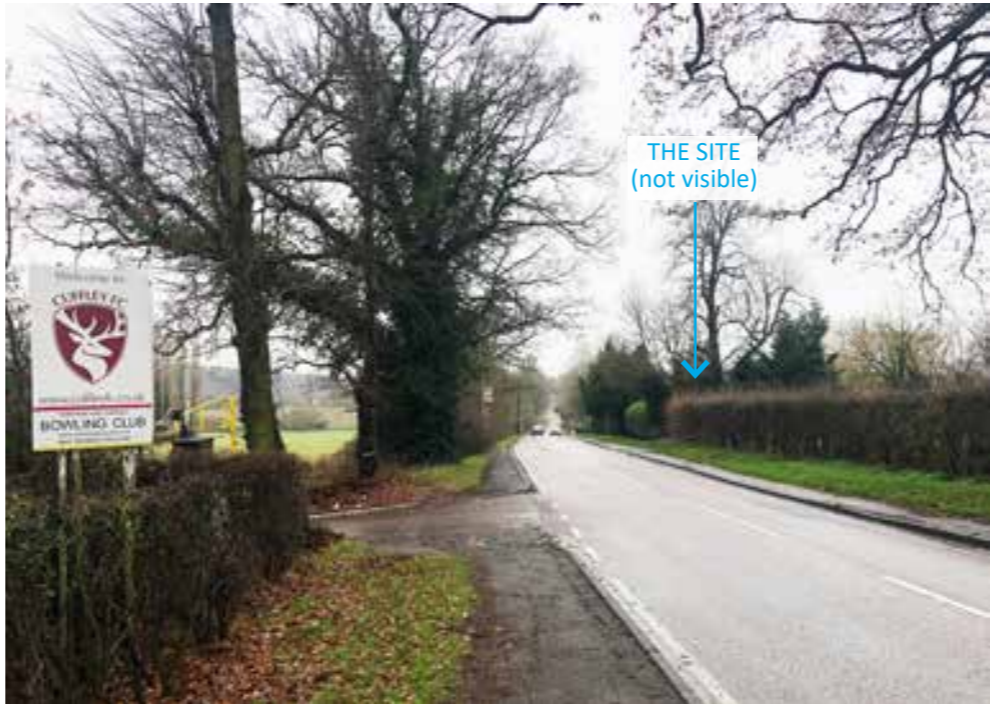
13. View looking west down Northaw Road East from Cuffley Football Club access. Site not visible due to evergreen trees and hedges.

Existing view looking west down Northhaw Road East, from Cuffley Football Club Access

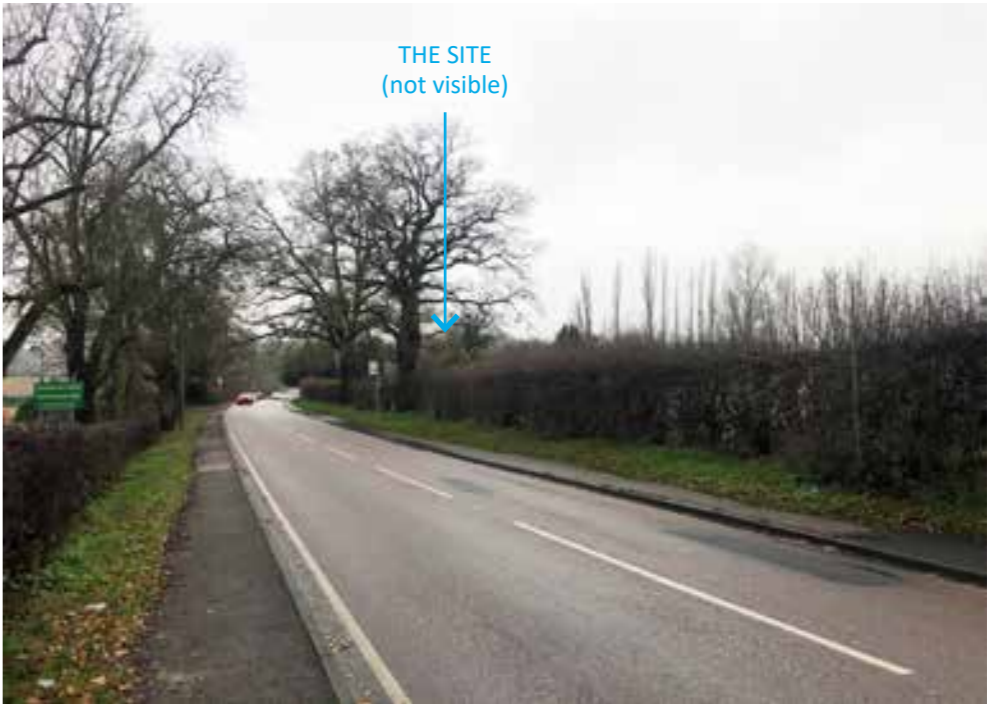
14. View looking west down Northaw Road East from Cuffley Tennis Club. Site not visible due to evergreen trees and hedges.

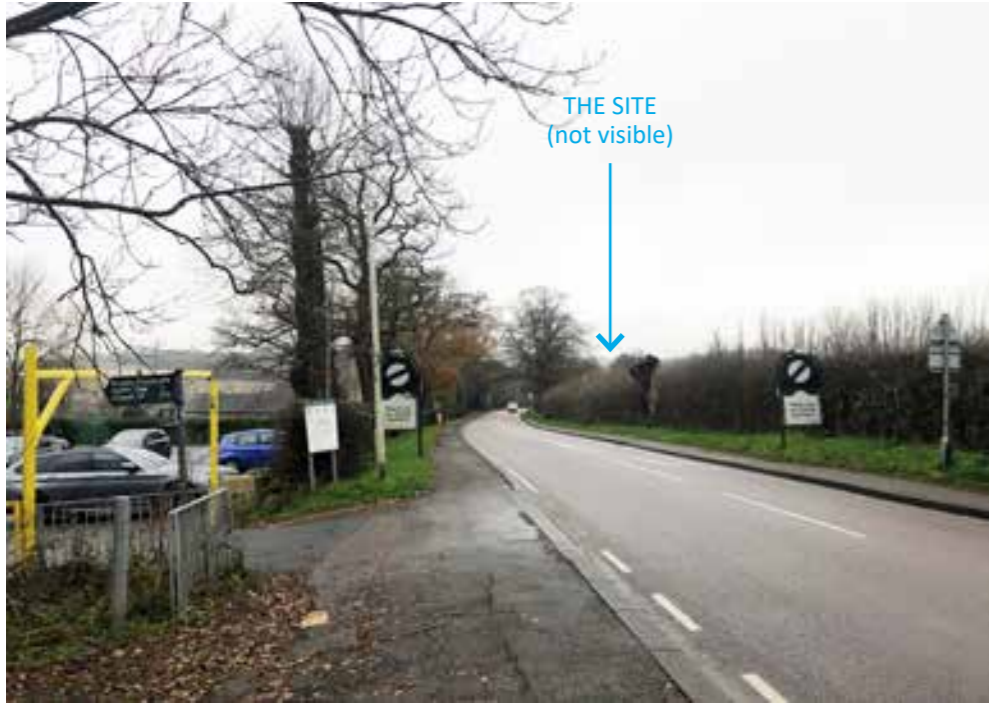
15. View looking west down Northaw Road East from Northaw Tennis Club access (next to the Hertfordshire Way). The site is obscured by hedgerows.

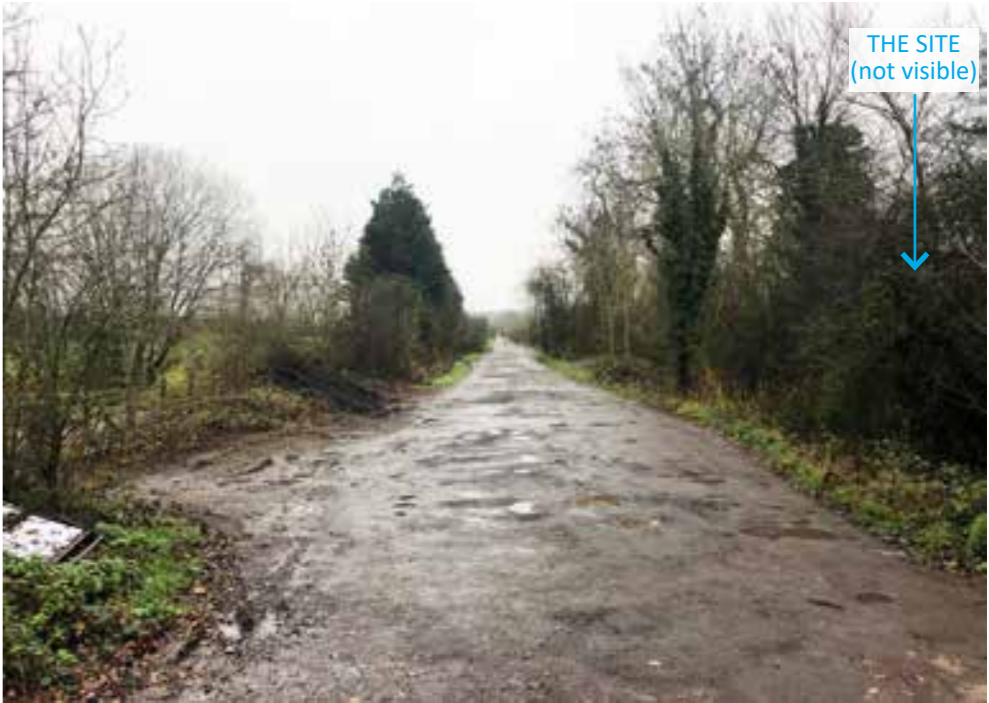
17. View northwest from Northaw Road East looking up the Hertfordshire Way. The site is obscured by the trees either side of the Hemshill Brook to the right.

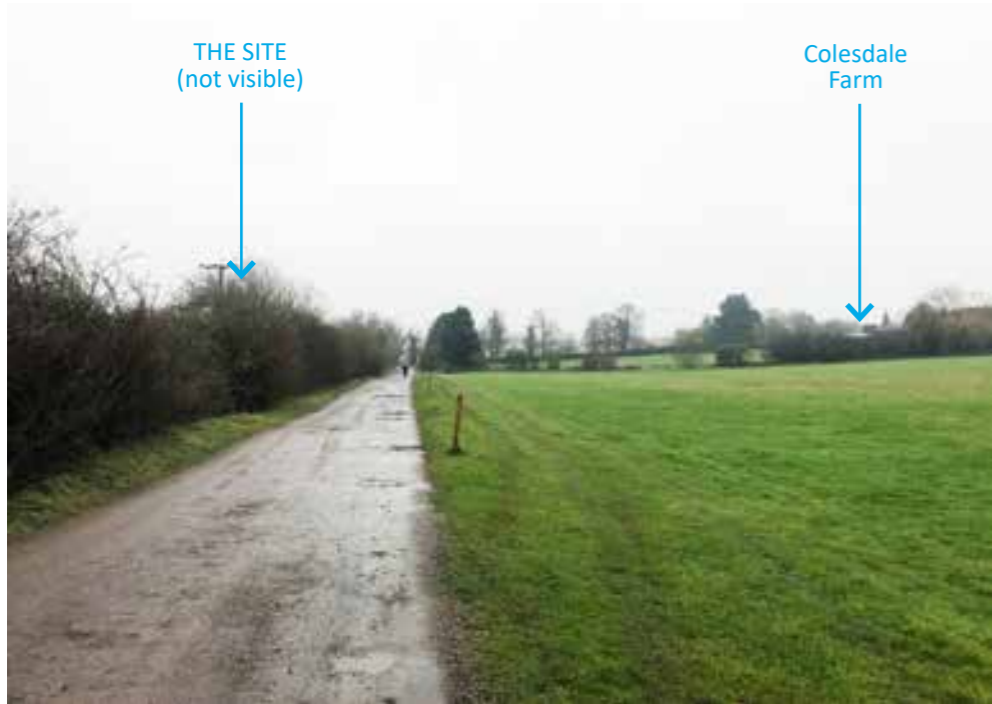
18. View looking south, down the Hertfordshire Way. The site is obscured by the hedge and trees to the left.

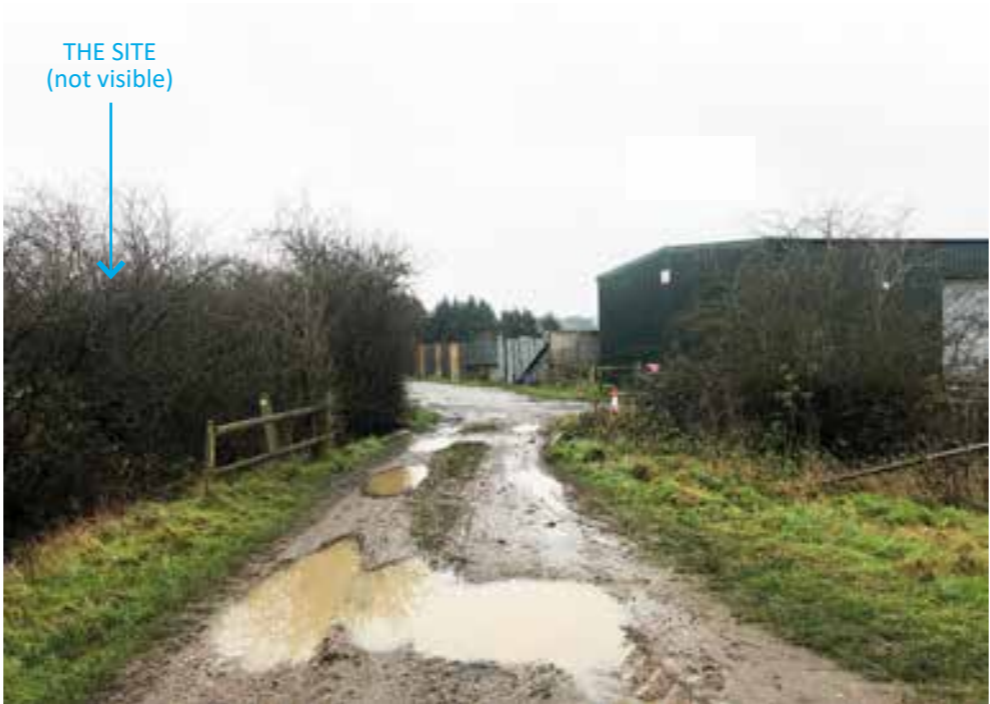
19. View looking south, down the Hertfordshire Way by the outlying barn building. The site is obscured by the hedge and trees to the left.

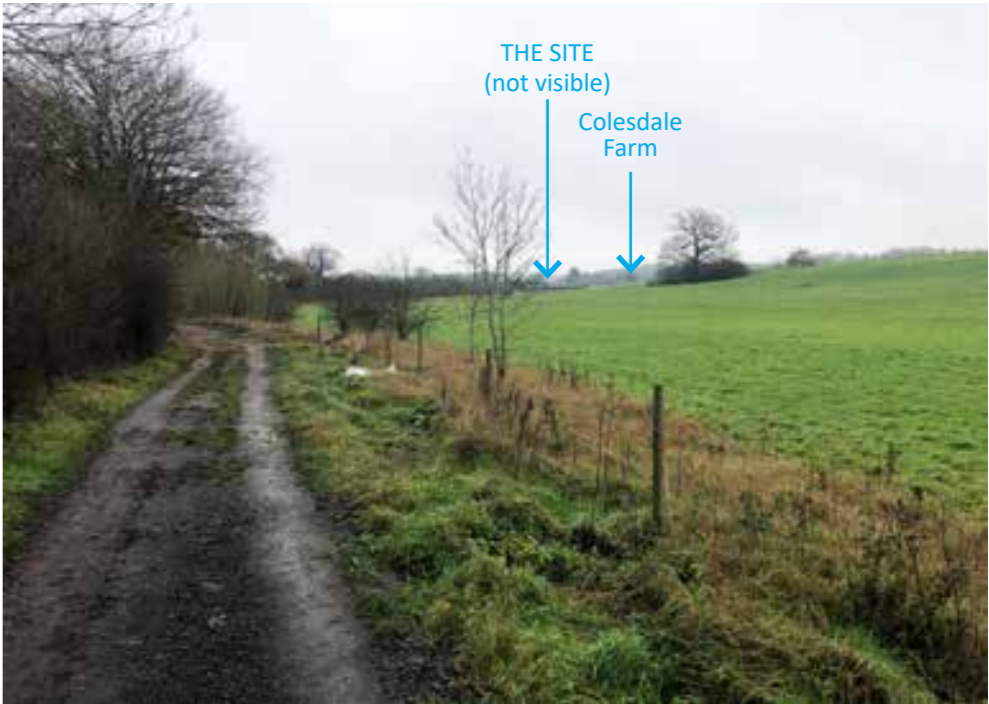
20. View looking south, down the Hertfordshire Way. The site is obscured by the topography, other agricultural buildings and landscaping.

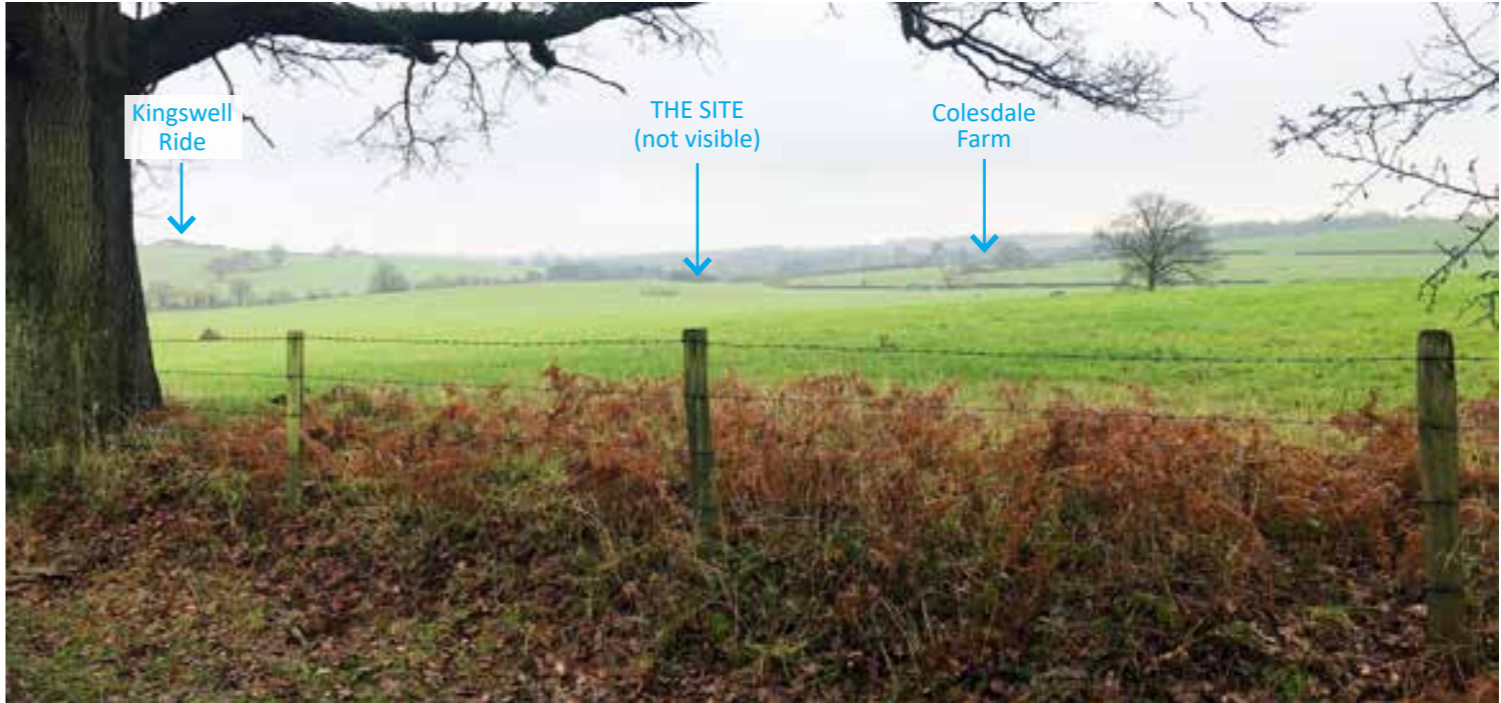
22. View looking southeast, from the Hertfordshire Way at the top of Hemps Hill. The site is obscured by the topography. From this point, the Hertfordshire Way falls down the North side of Hemps Hill towards Northaw and views back across to Cuffley are obscured.

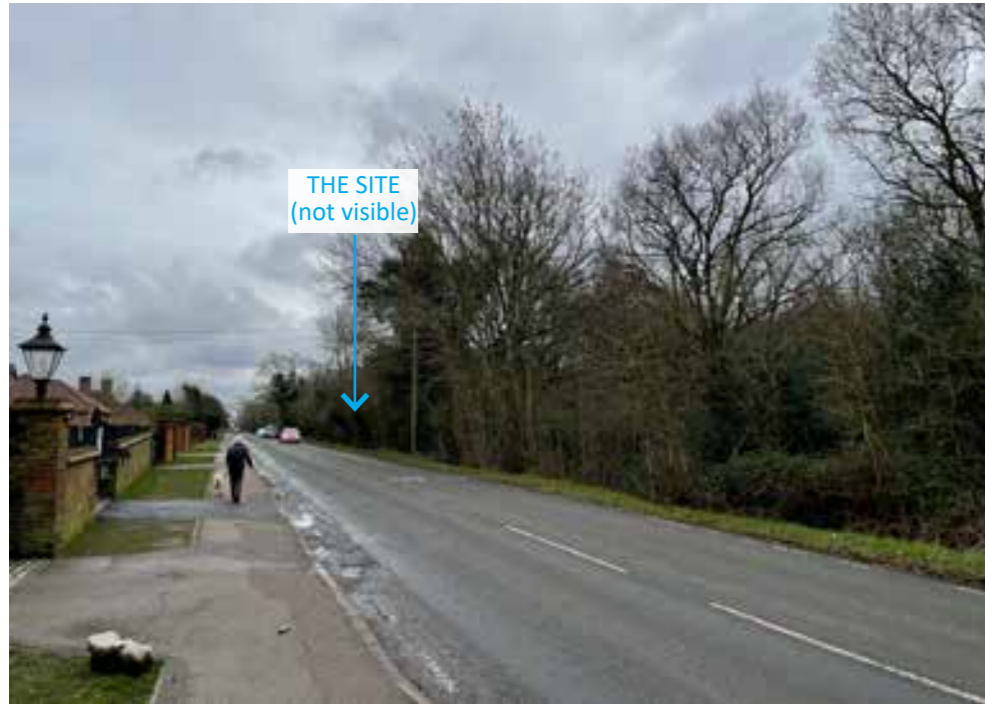
23. View looking south down The Ridgeway. The site is not visible due to topography and landscaping.

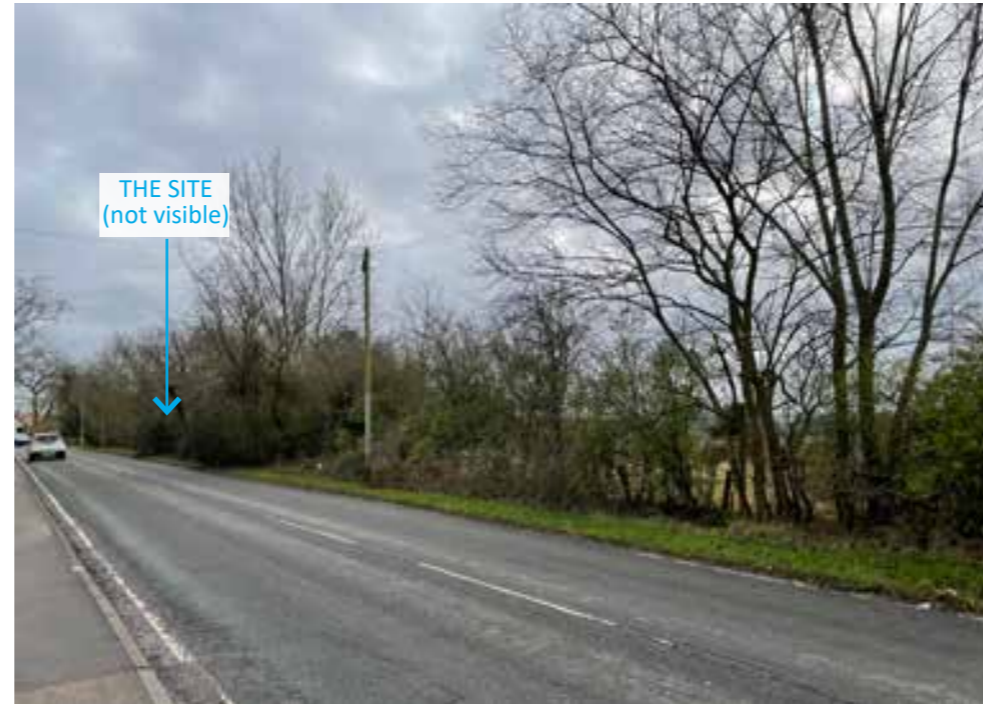
24. View looking south down The Ridgeway. The site is not visible due to topography and landscaping.

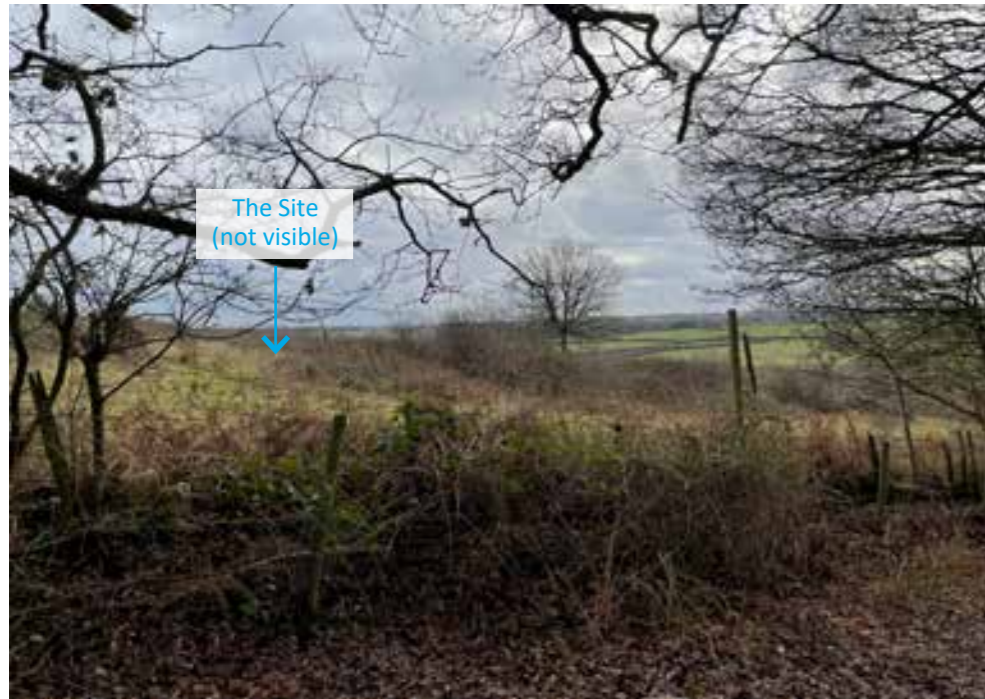
26. View looking south from the top of Footpath #1 towards the site. The site is obscured by topography.

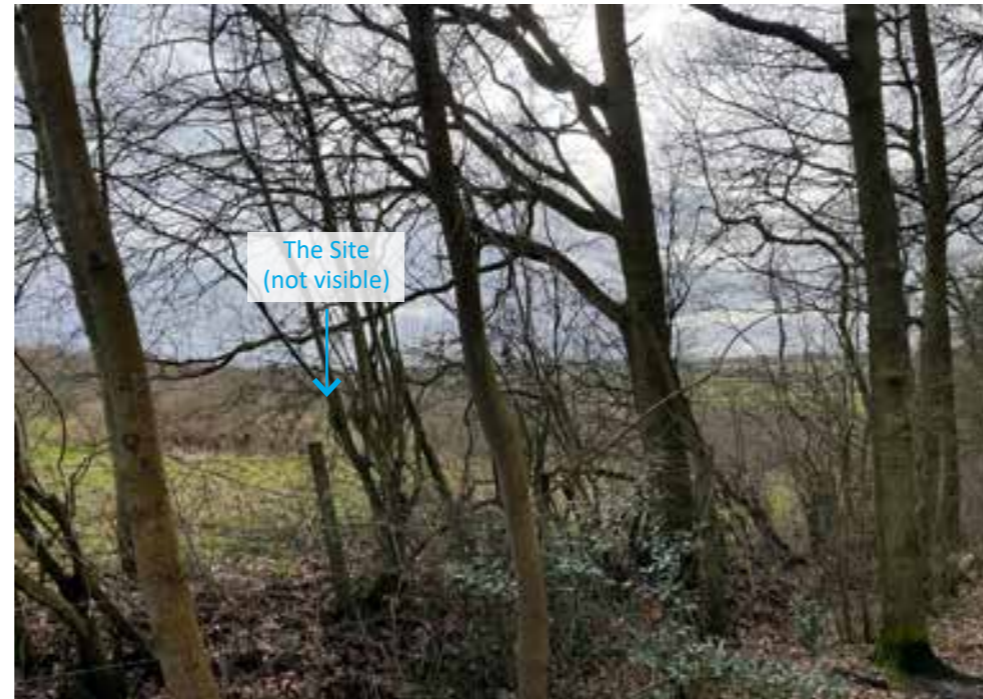
27. View looking south from the centre of Footpath #1 towards the site. The site is obscured by topography and landscaping.

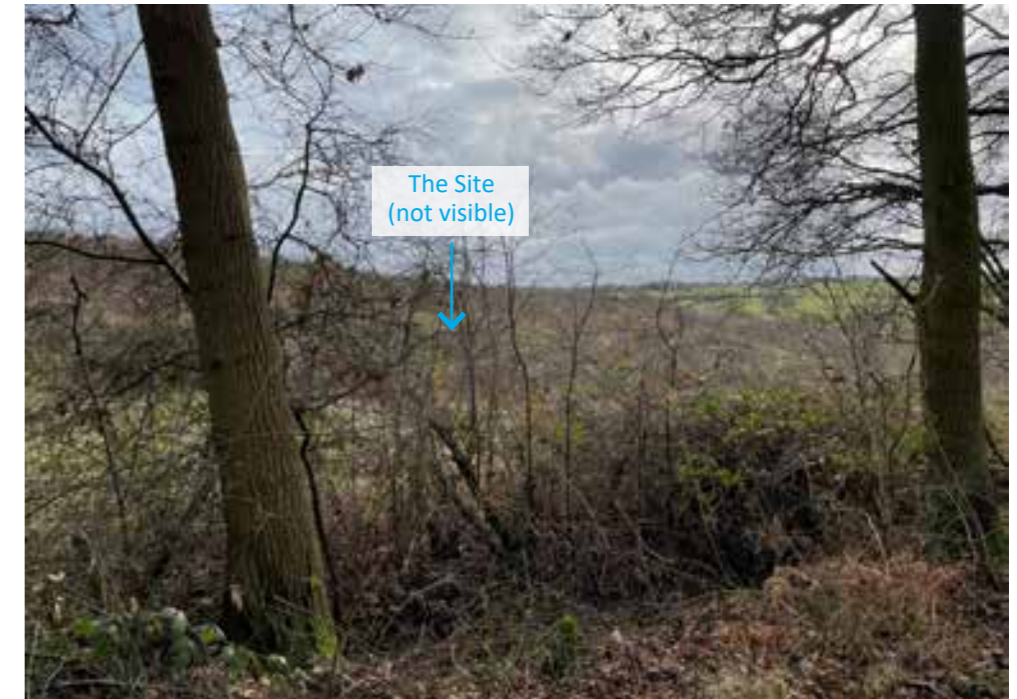
28. View looking south from the bottom of Footpath #1 towards the site. The site is obscured by topography.

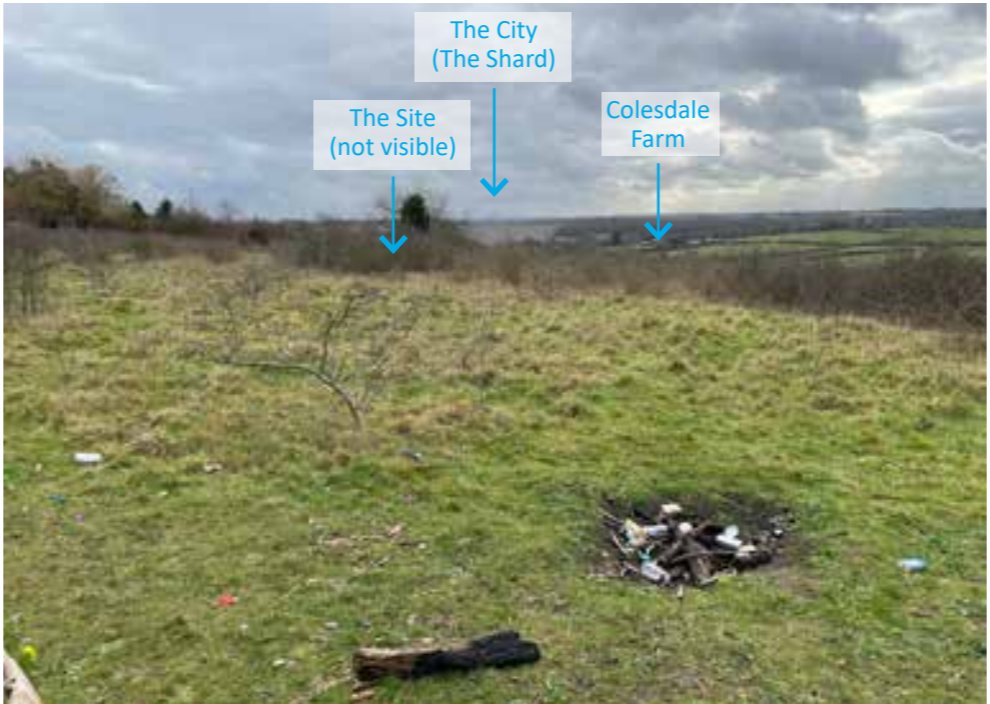
30. View looking south from an area with signs of informal use (litter and fire pits). The site is obscured by topography (although The City is visible on the skyline).

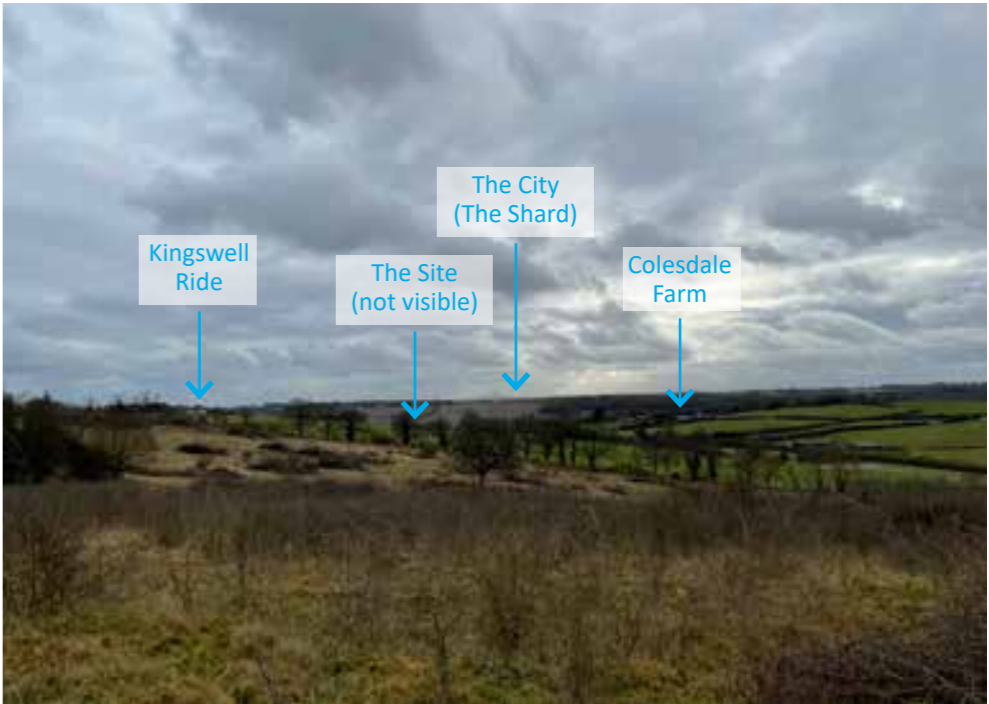
31. View looking south from the area used informally (no ongoing footway). The site is obscured by topography (although The City is visible on the skyline).

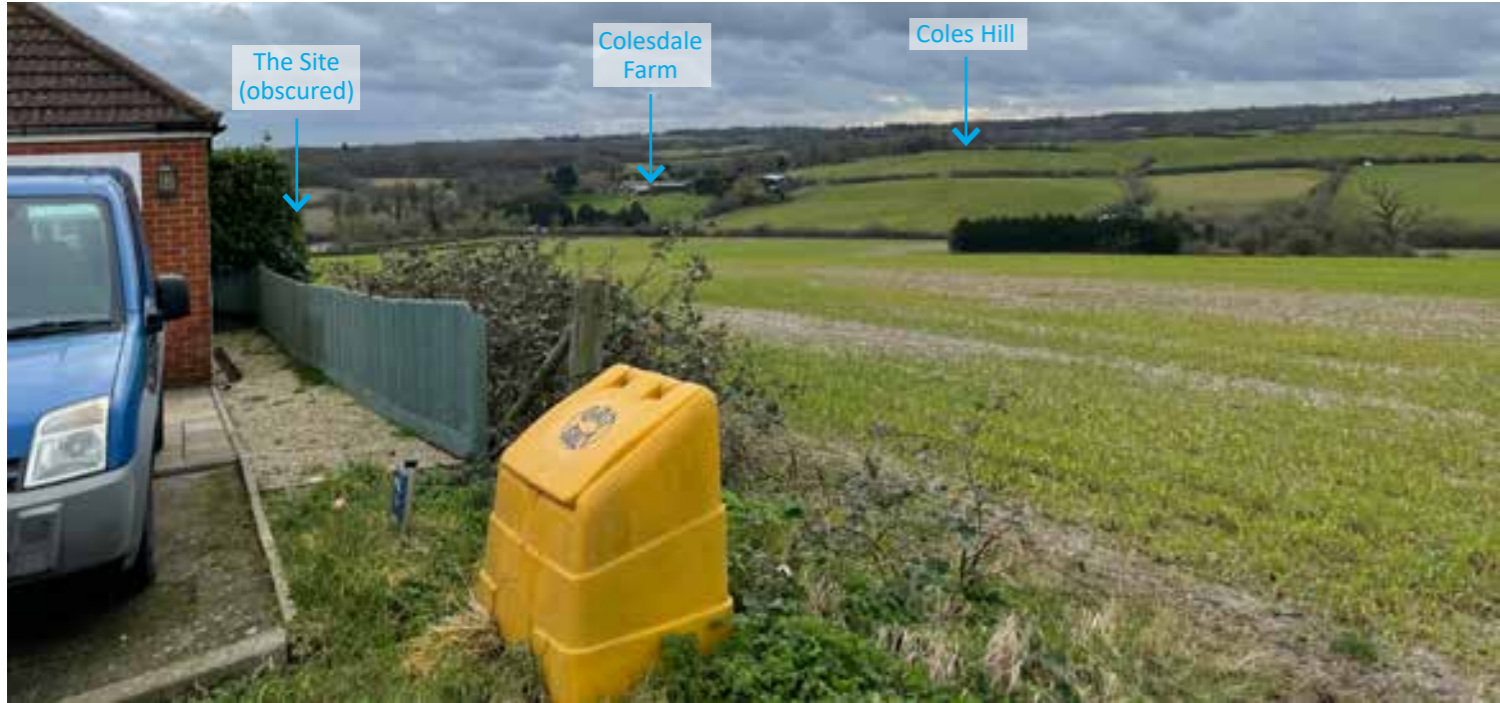
32. View looking south from the dead-end of Kingswell Ride. The corner of the site can be just seen to the left behind the houses if stood on the edge of the highway boundary.

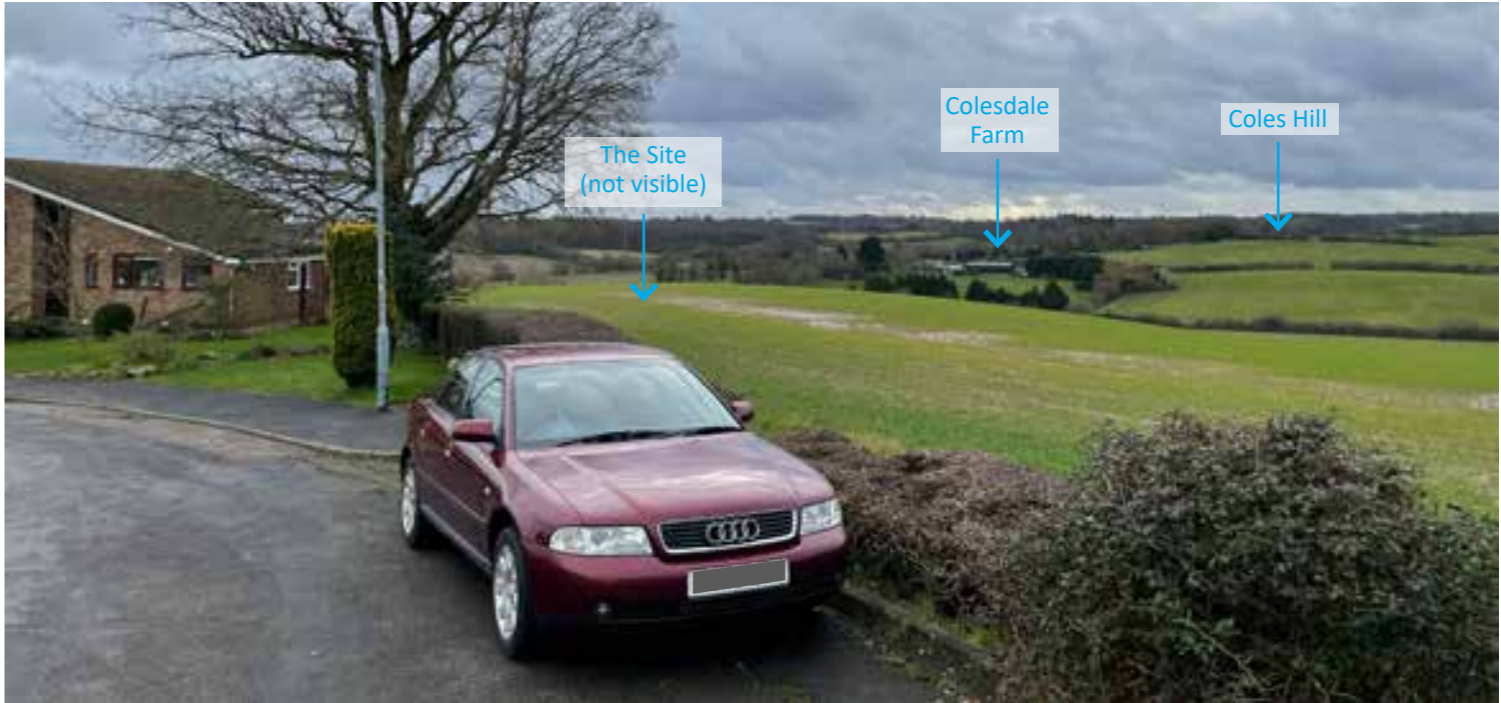
33. View looking south from the dead-end of Colesdale. The site is not visible due to the topography.
