# 4.0 LANDSCAPE AND VISUAL ASSESSMENT

## VIEW LOCATION PLAN

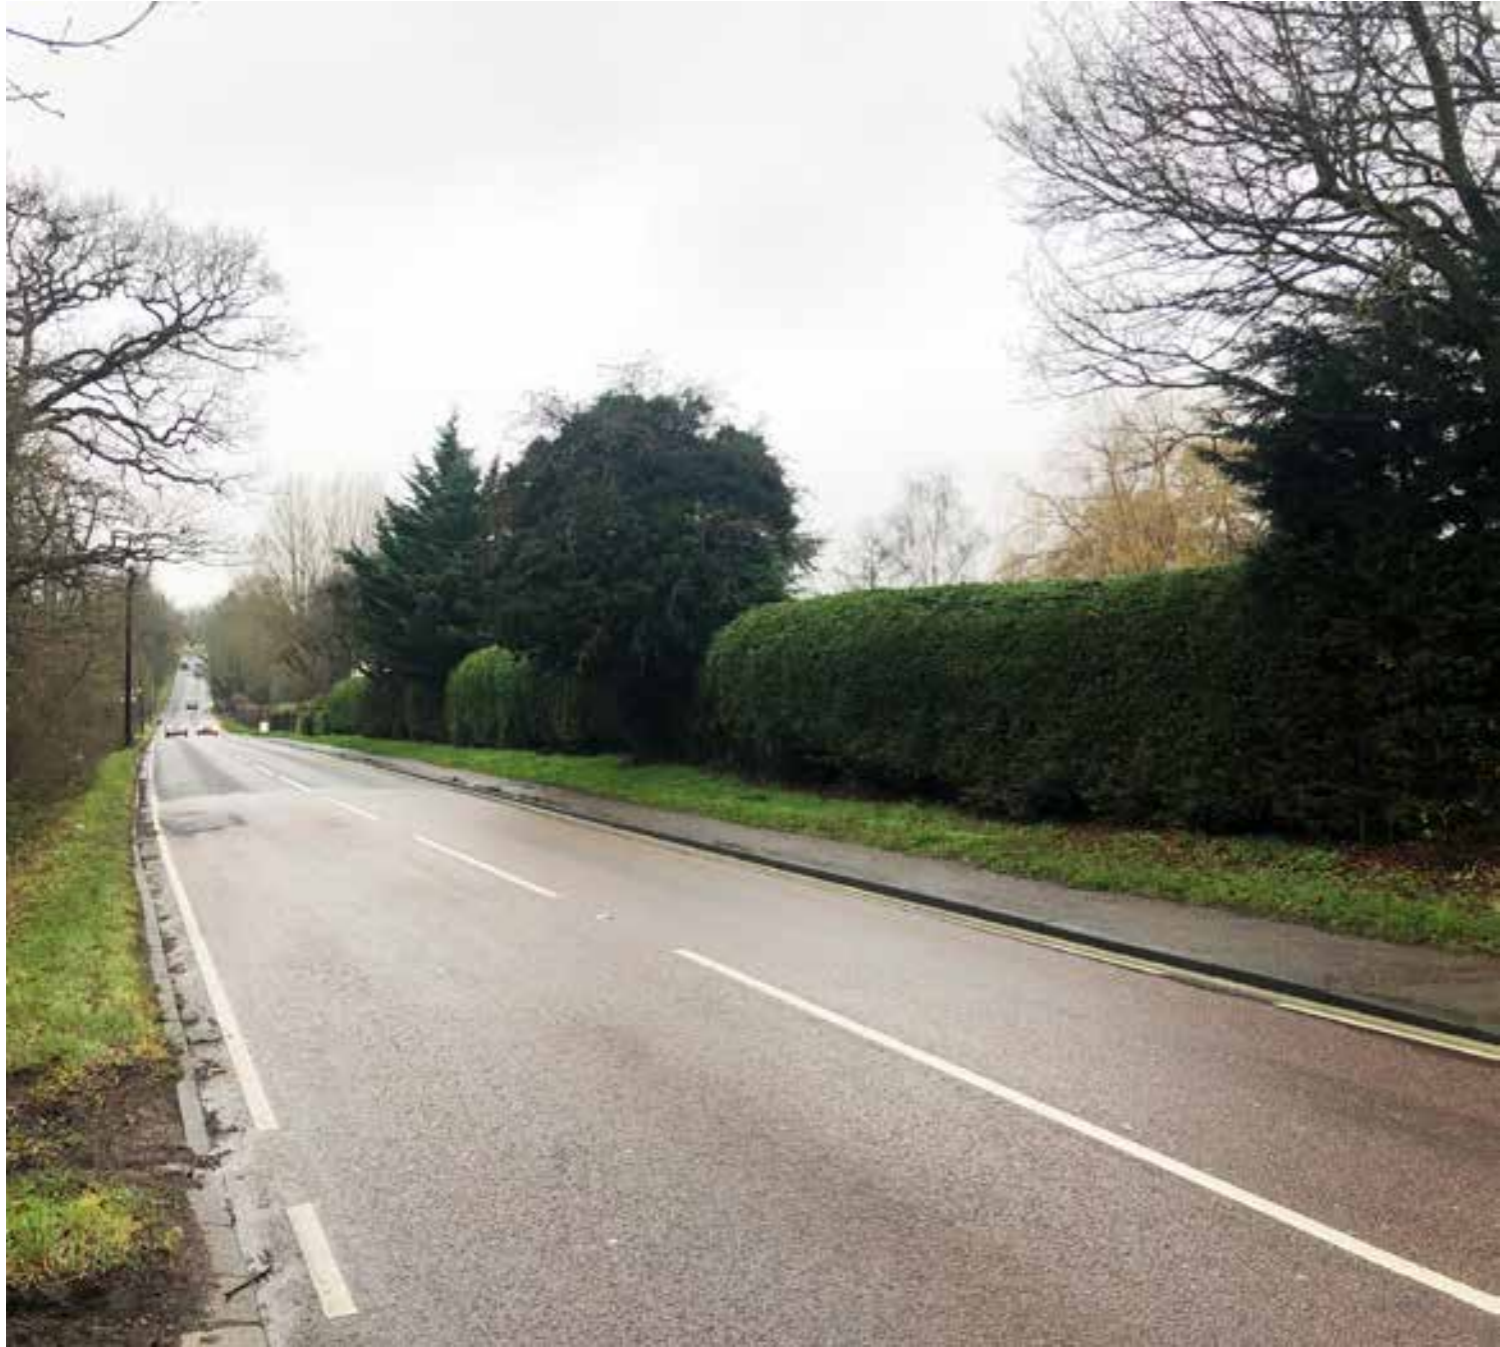
## VIEW 12 - EXISTING AND PROPOSED

Existing view looking west down Northhaw Road East from the field access opposite the Football Club.

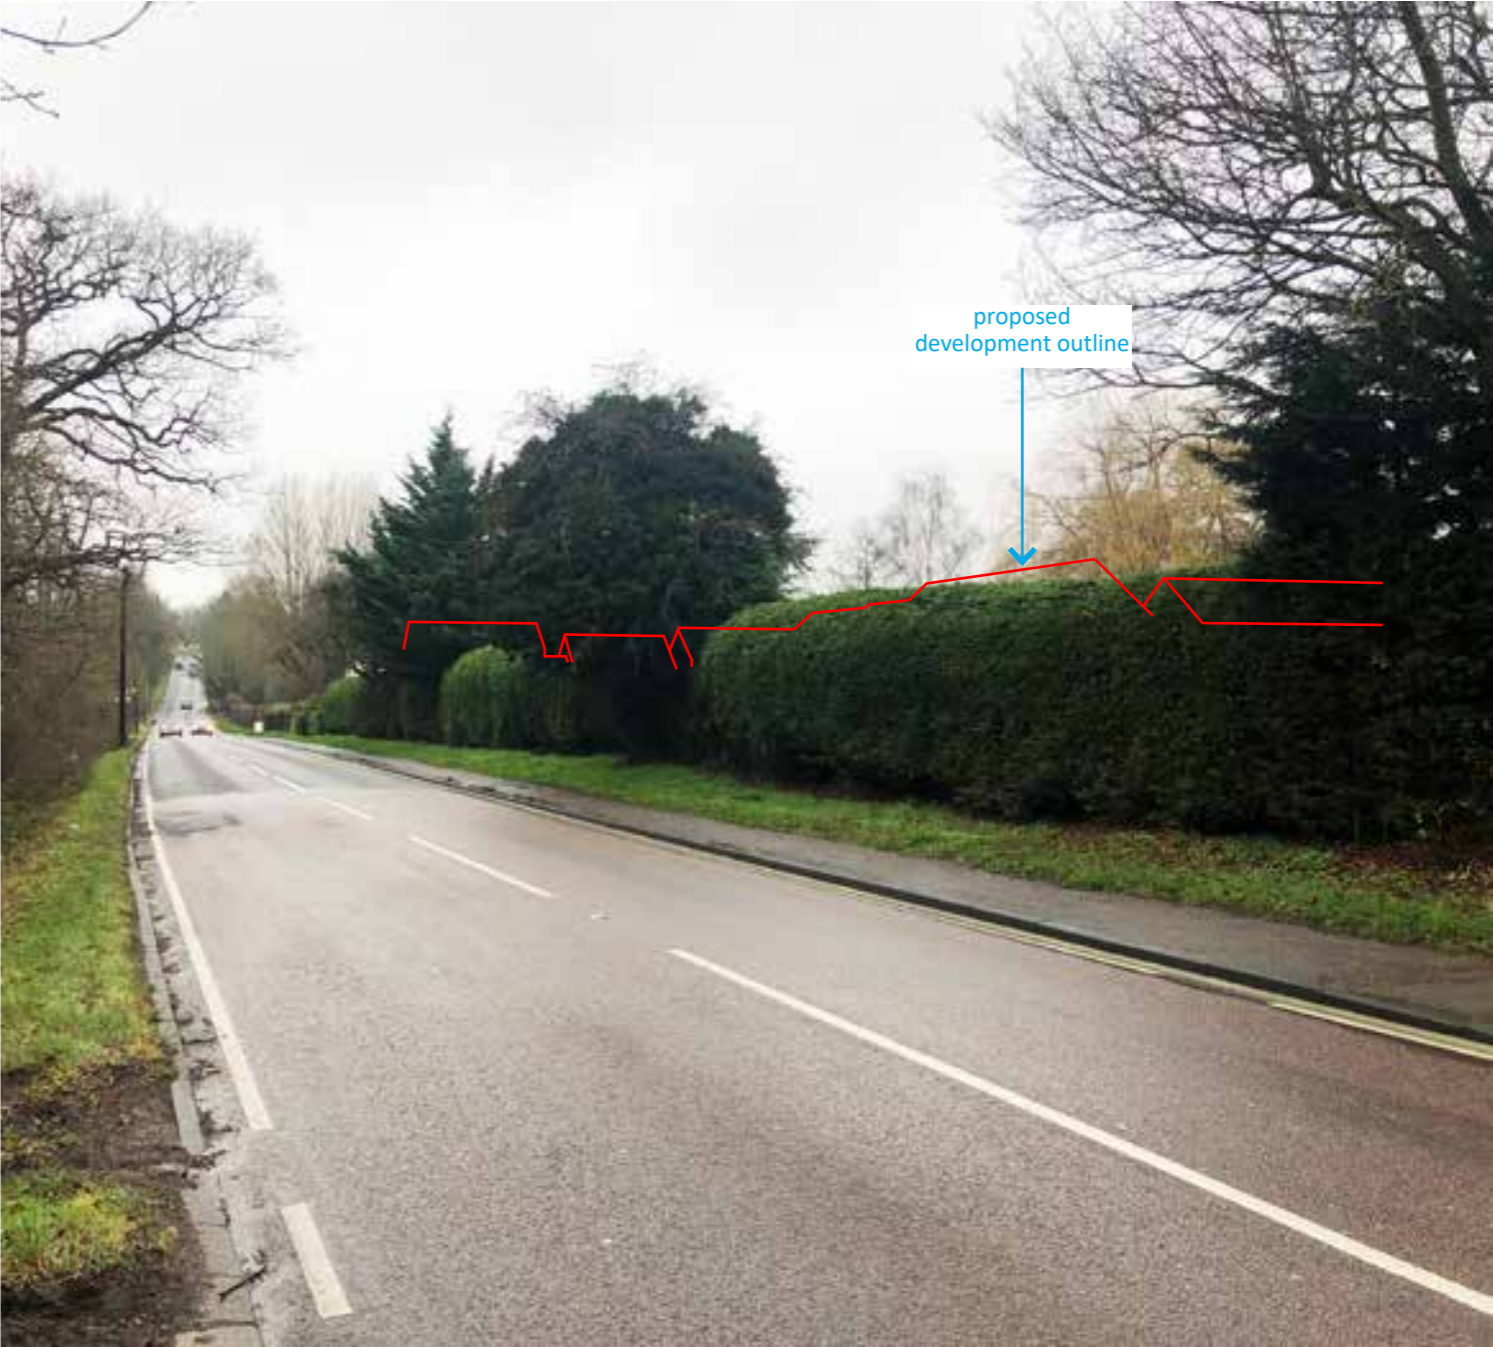
Comparative view with proposed building outline

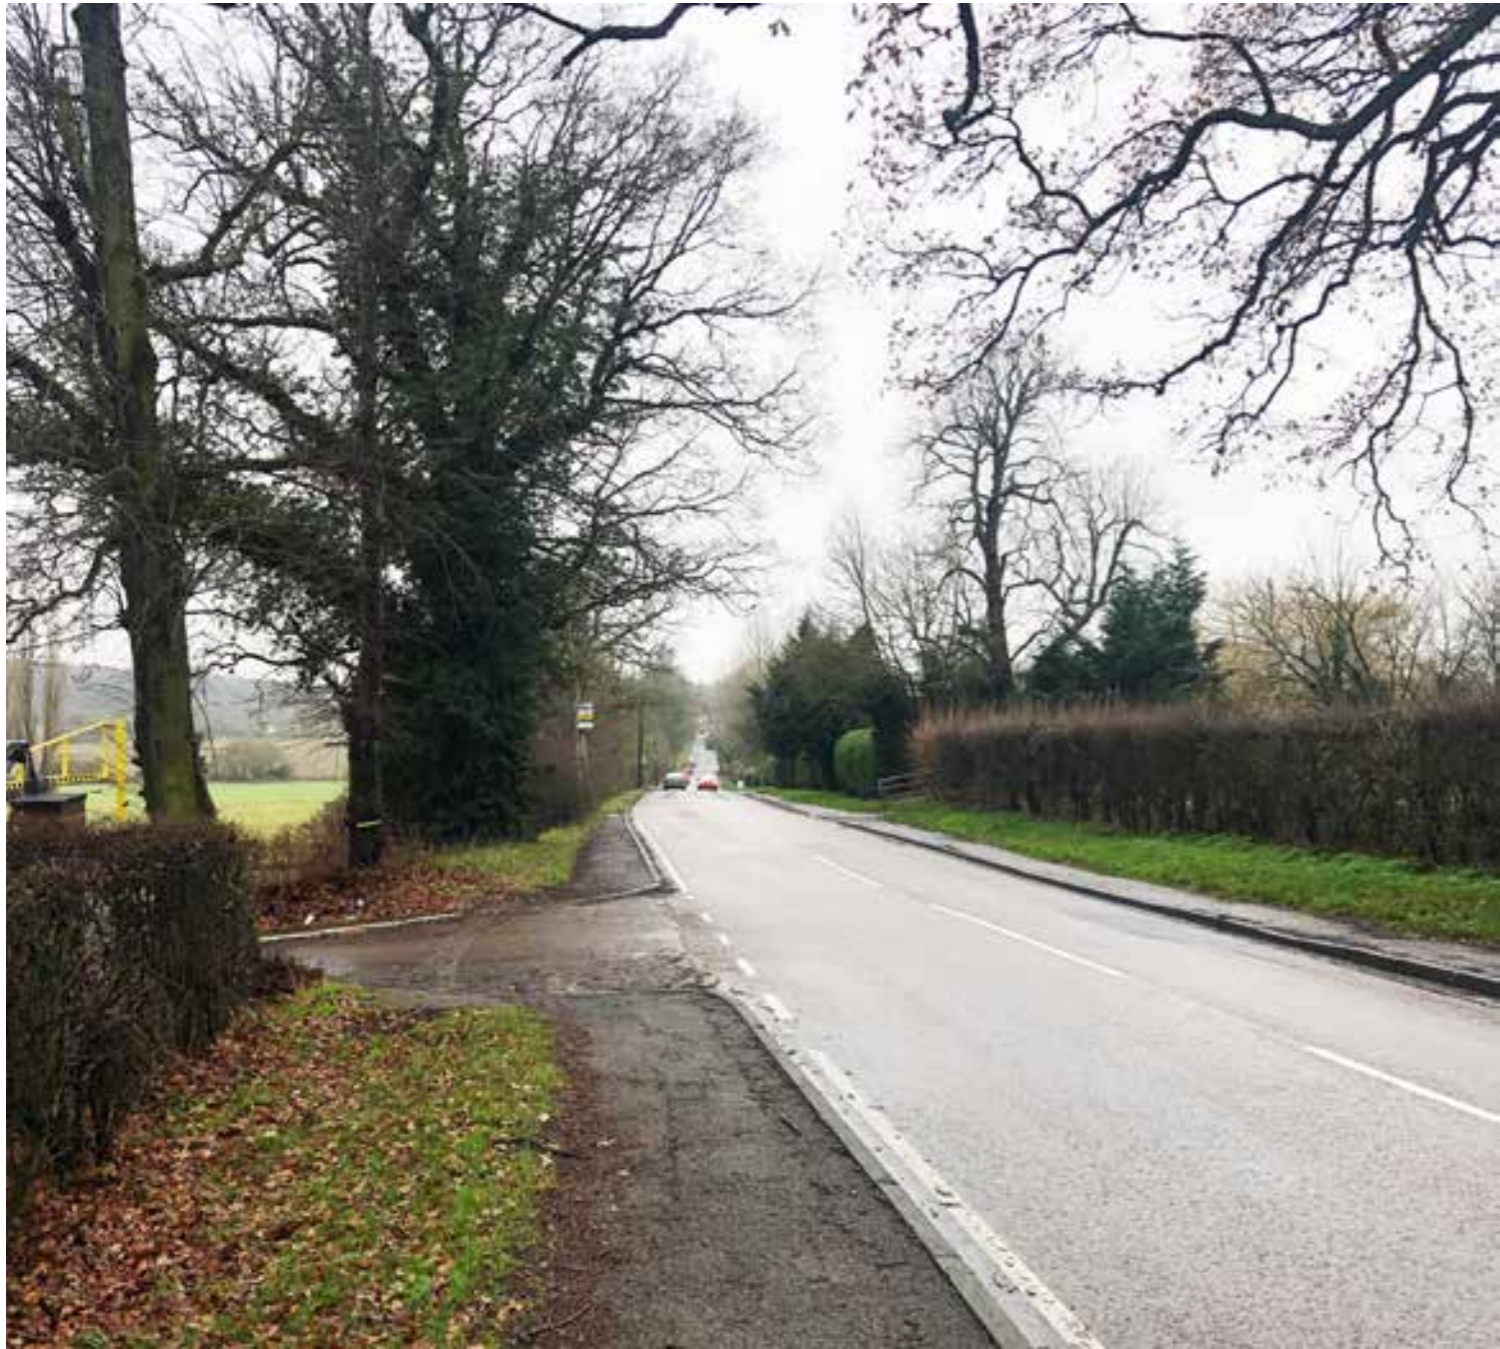
## VIEW 13 - EXISTING AND PROPOSED

Existing view looking west down Northhaw Road East, from Cuffley Football Club Access

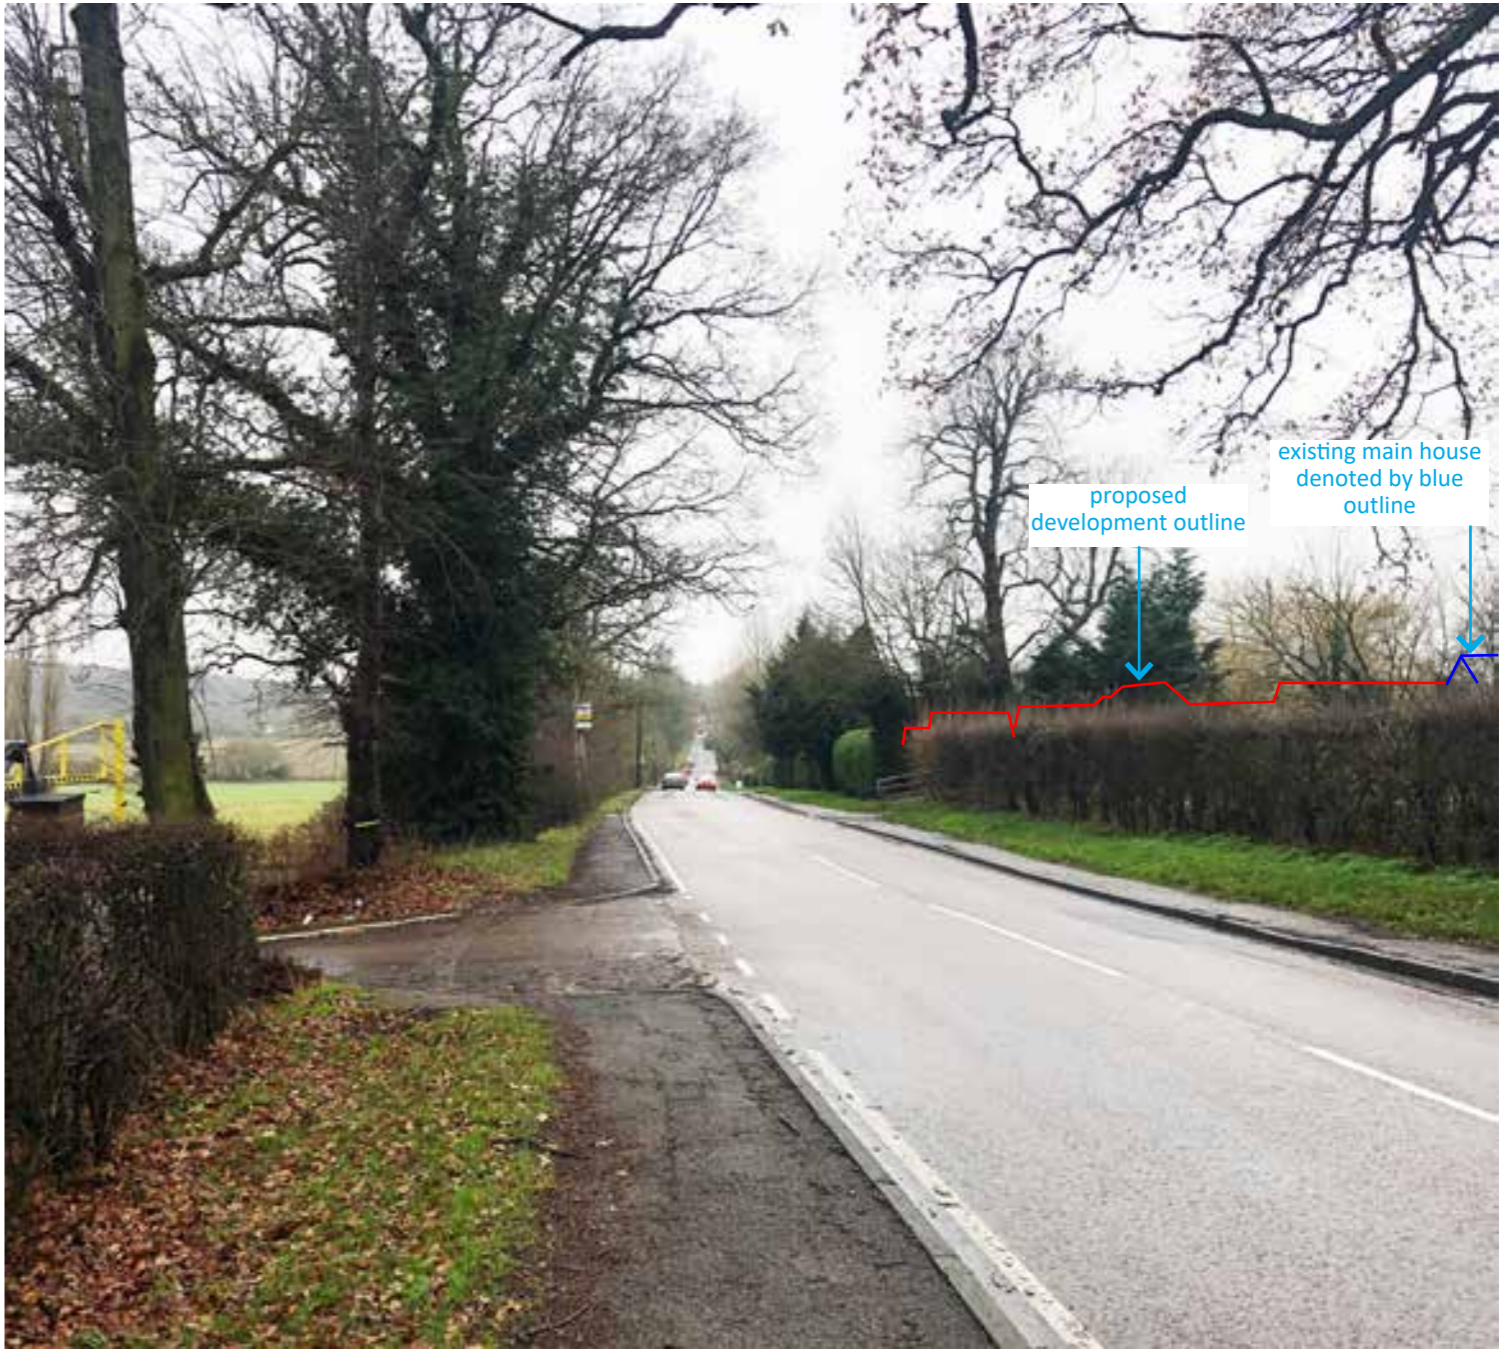
Comparative view with proposed building outline (red) and existing main house (blue)

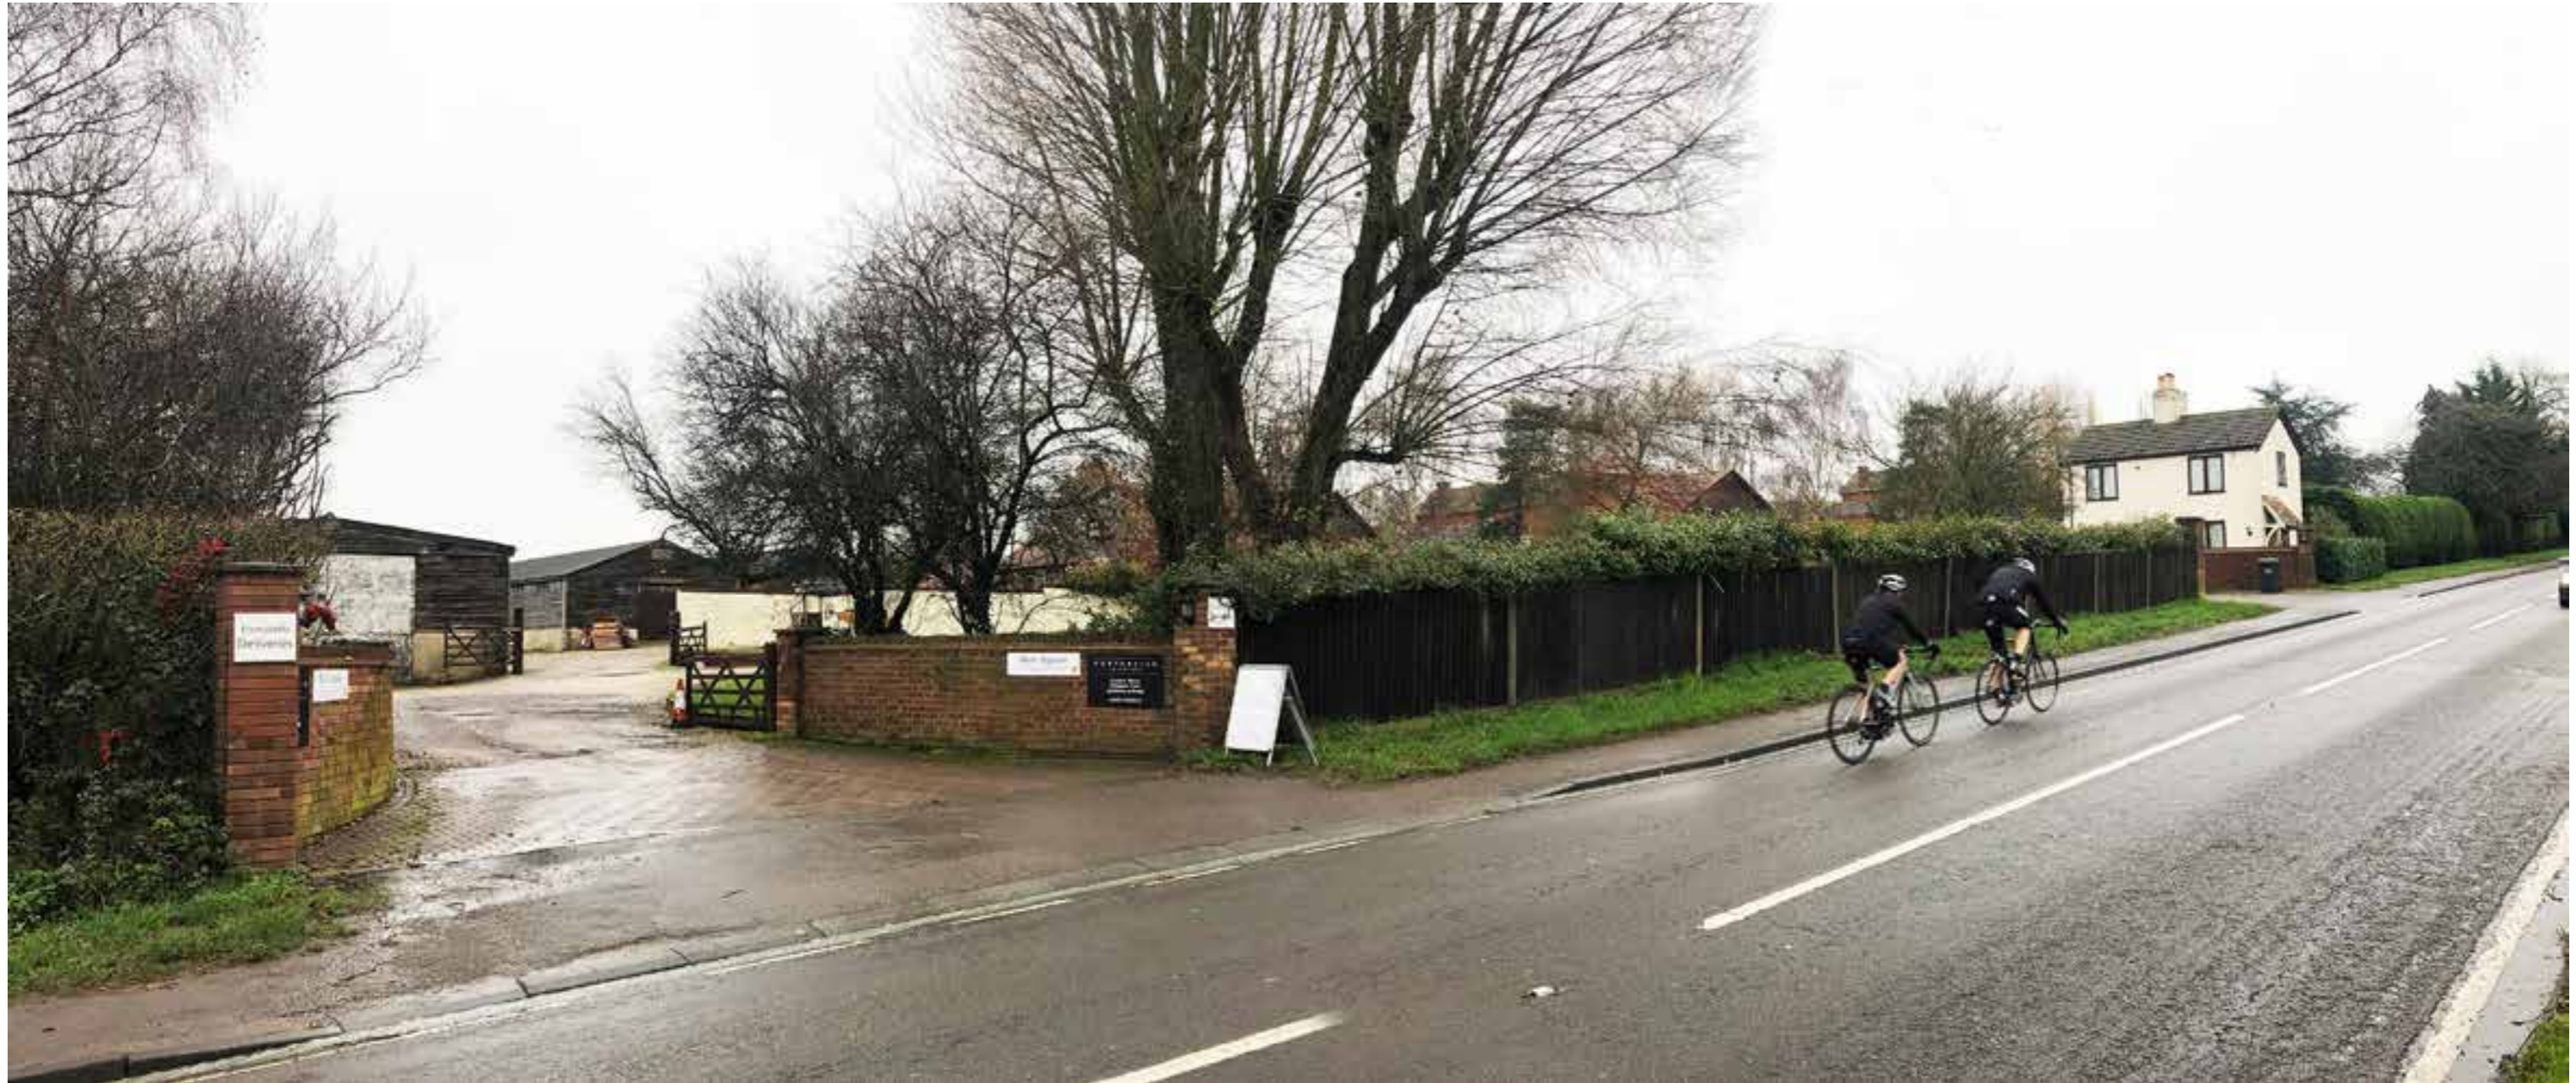
### VIEW 10 - EXISTING

View looking northeast from Northaw Road East at the site access with the site visible beyond. The second access to New Wells Farm is to the right next to Wells Farm Cottage (not part of the application site)

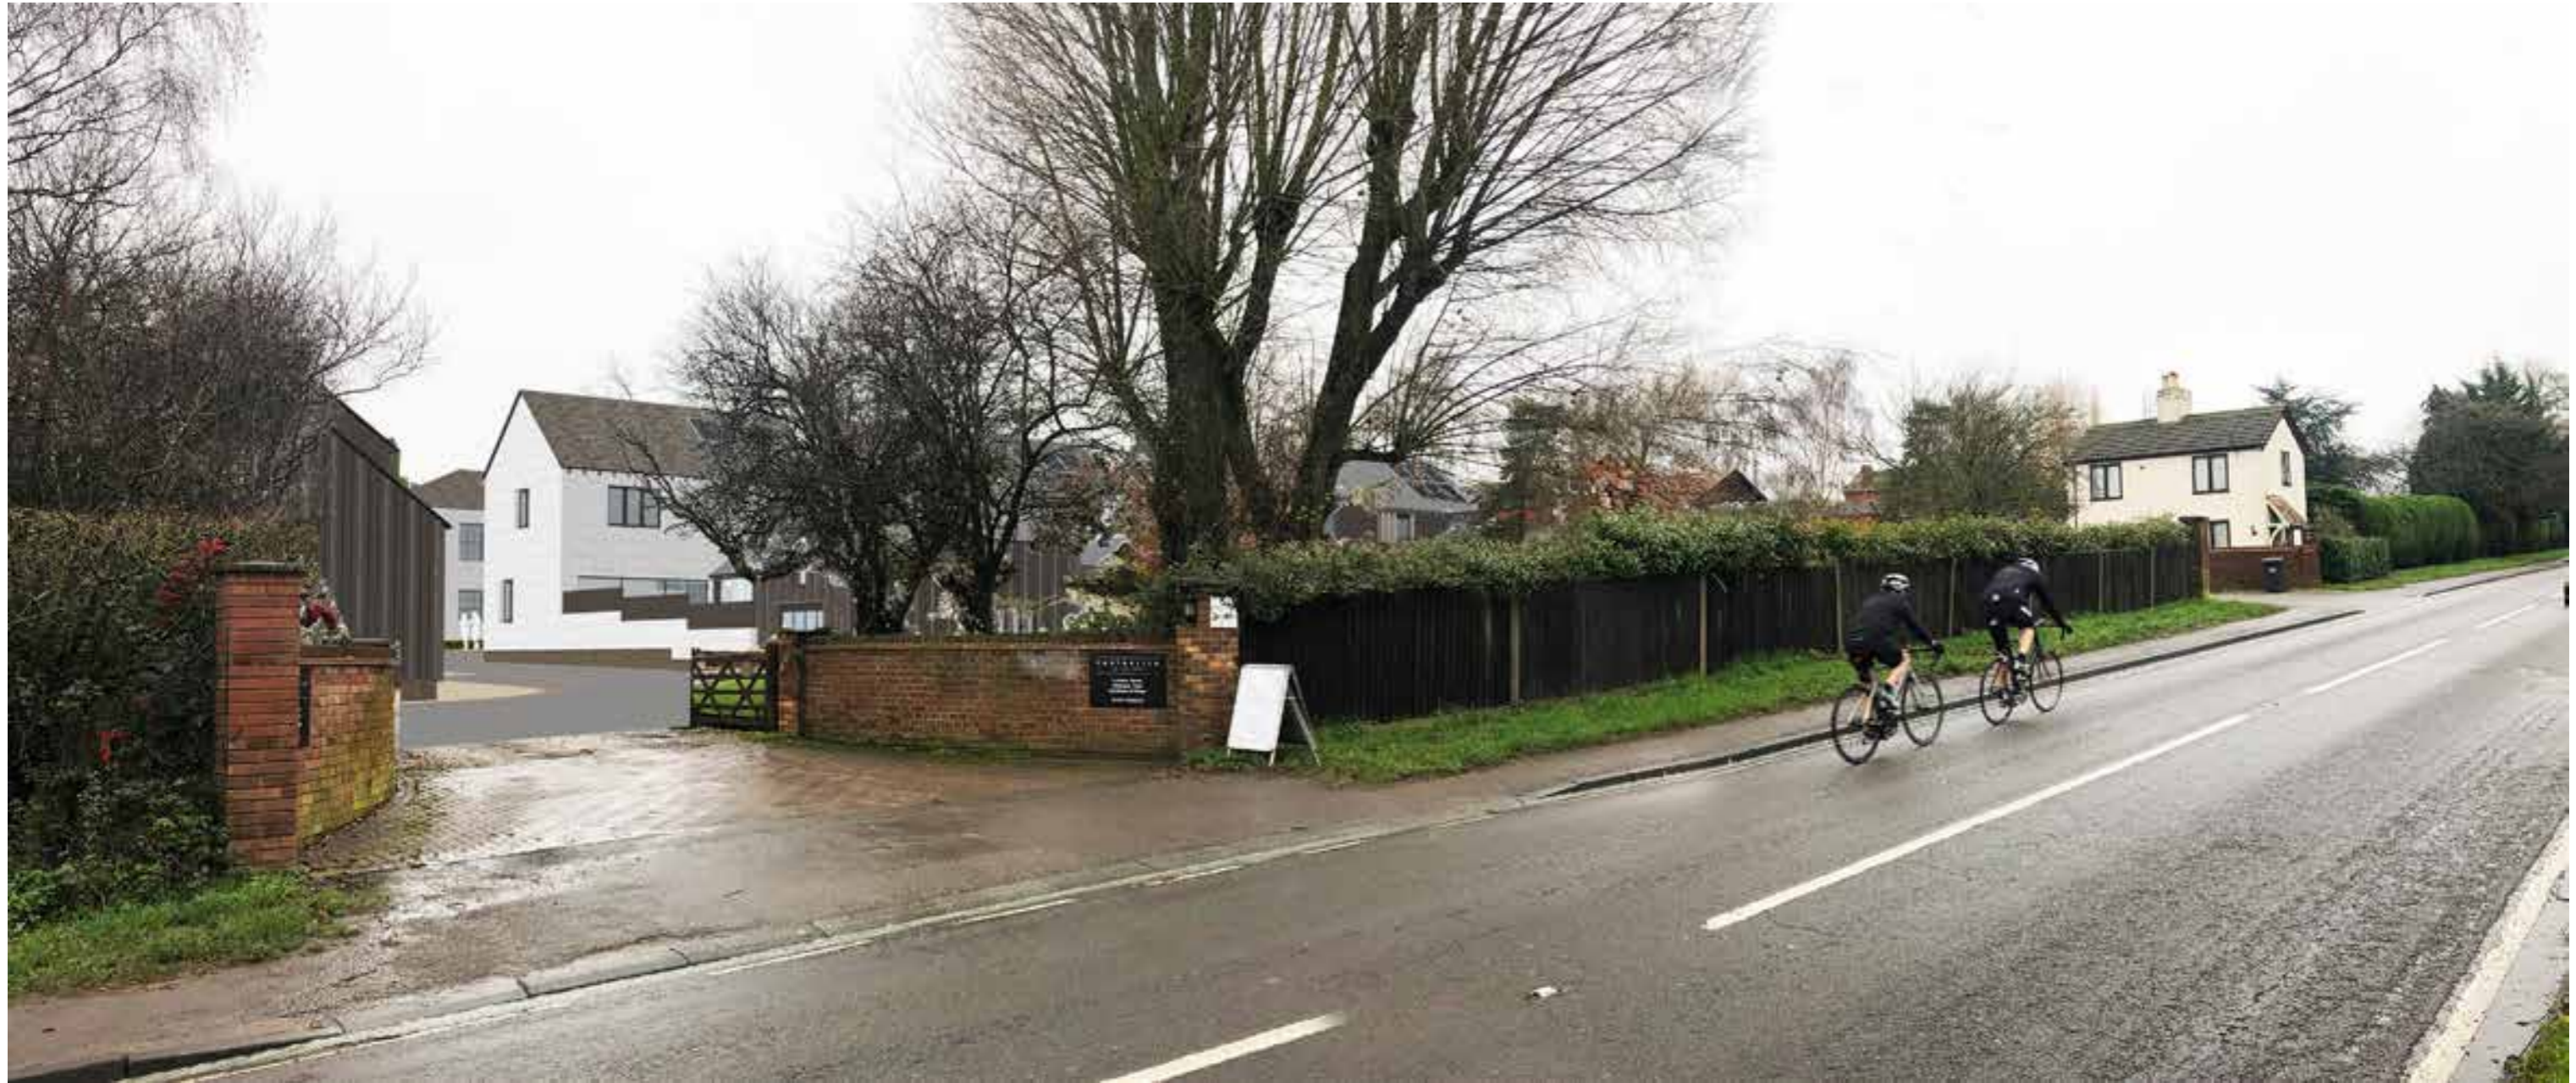
### VIEW 10 - PROPOSED

Comparative photomontage showing the proposed scheme
