**Wells Farm Outbuildings
Northaw Road East
Cuffley
Hertfordshire EN6 4RD**

Bat Report

Report Date: 24th August 2021

Client: King & Co (Wells) Ltd

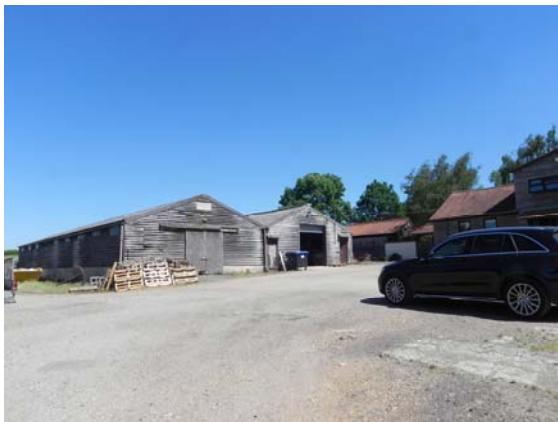
Photograph 1: courtyard view northeast

The outbuildings are located around a central courtyard of hardstanding.

To the south of the courtyard is the driveway from the road with recreational and arable fields beyond.

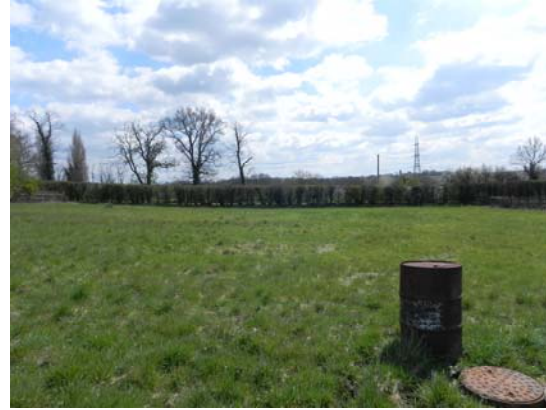
Photograph 5: roadside hedgerow

To the west is a field of semi-improved grassland with bordering hedgerows and trees. The roadside hedgerow and field hedgerow provides flight connectivity from the outbuildings to a tree lined brook (Hempshill brook) that provides further linking bat flight habitat from Wells Farm to the wider countryside. In the southwest corner of the field near the road is a large pond with an island of scrub and tall ruderal habitats around its margins.

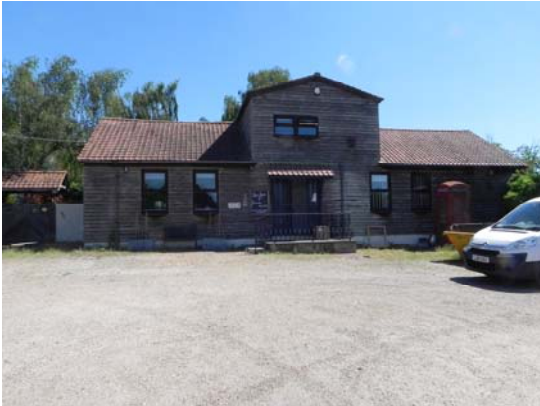
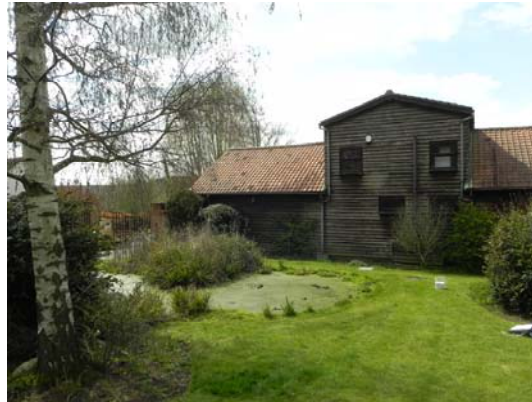
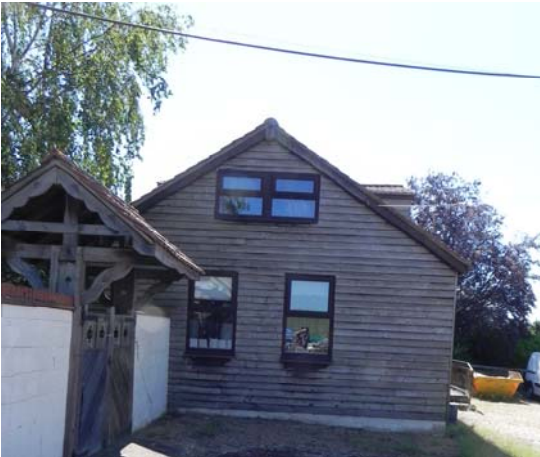
Photograph 8: office southwest elevation

The building has brick/block walls clad with weatherboarded and supports a pitched roof clad with interlocking red clay tiles. Gables project to the southeast and northwest with a taller central section supporting a shallow pitched roof with gables projecting to the northeast and southwest.

The building is in good condition but a few potential bat access points to suitable roosting sites were identified.

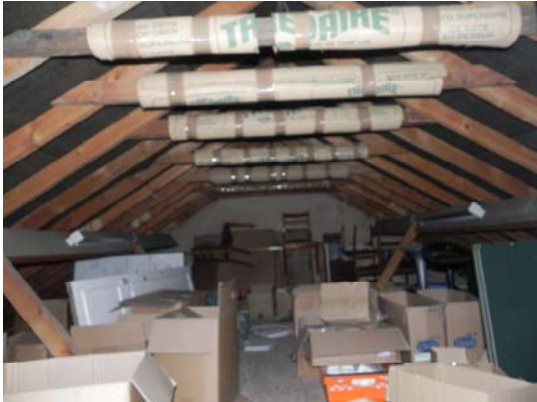
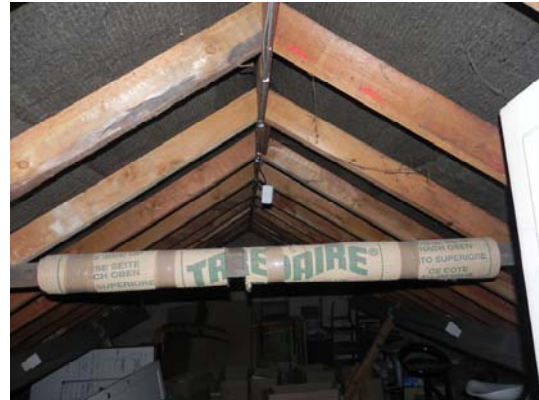
Photograph 11-12: office southeast loft structure

Internally there are three timber-framed roof voids with the roof tiles lined internally by traditional 1F bitumastic felt. Pipistrelle bats will typically roost within the crevices between the tiles and roof linings.

The two side lofts have a height from the loft floor to the ridge of 2.18 metres. The southeast loft provides suitable conditions for roosting bats but the northwest loft is less favourable mainly due to the presence of a window. The window would create light internal conditions during the daytime less suitable for void dwelling bats. In such conditions bats would need to seek warm dark crevices in which to roost such as the crevices between the roof and felt lining.

Mice droppings were identified during the search of the lofts but no bats or any signs of bat use (such as bat droppings or feeding remains) were identified. However, in the event of bats roosting in the exterior crevices between the tiles and roof lining there may be no bat droppings found on the loft floor.

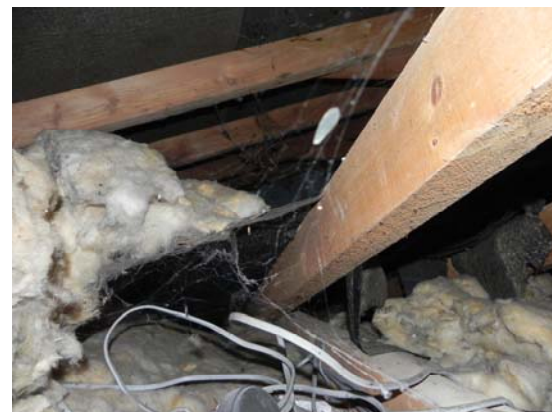
Photograph 14: central void

The central loft has a height of just 0.56 metres to the ridge and there is a beam across the hatchway preventing access. The inspection from the ladder found the loft to be of limited suitability for roosting bats due to the sealed roof and cluttered nature of the void.

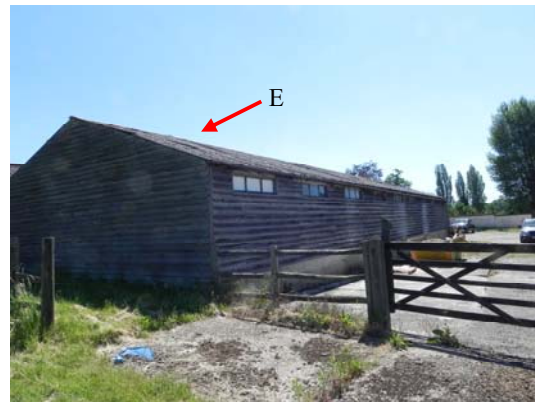
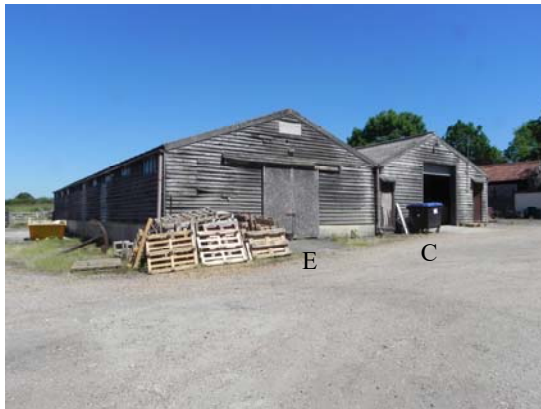
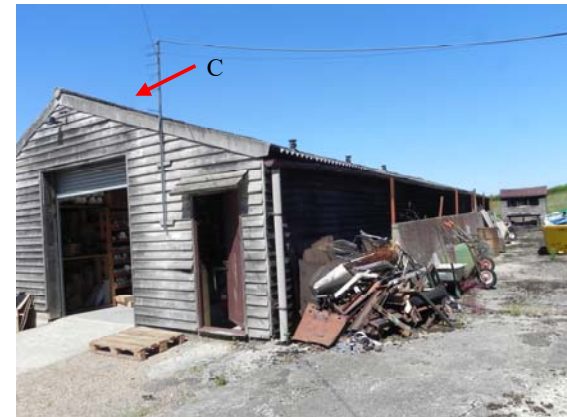
The building has a timber frame construction with weatherboarded walls on a brick/breezeblock rendered base and supports a shallow pitched roof clad with corrugated asbestos with gables to the southeast (front) and northwest (rear). There are doors along the front elevation and small windows along the sides.

The weatherboarding is deteriorating and there are several areas with raised timbers providing opportunities for bats to roost behind the weatherboarding. The previous survey in March by babec confirmed the weatherboarding on the west elevation as a pipistrelle bat roosting site (bat observed behind the cladding). There are also gaps suitable for roosting bats behind the fascia boards at the gable ends.

During the internal inspection a single old long-eared bat dropping was identified at the north end of section E. Pipistrelle bat droppings were also identified externally below the weatherboarding of the west elevation. The Warehouse is a confirmed bat roost

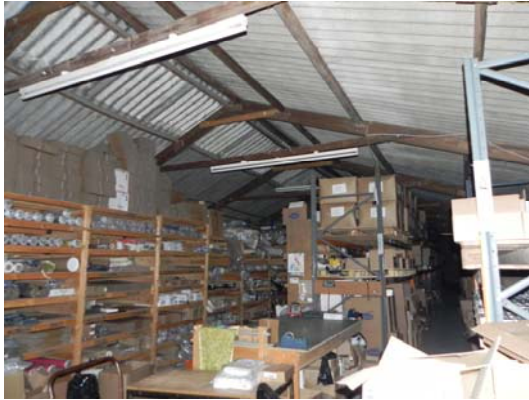
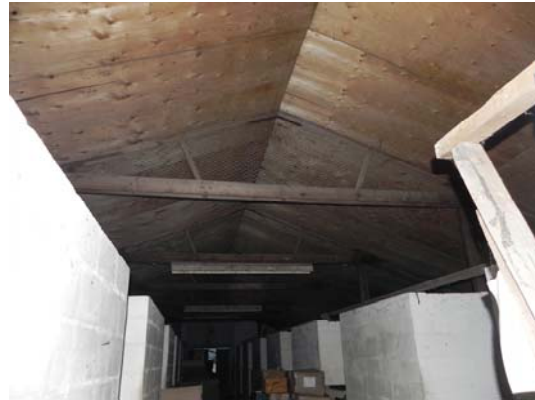
Photograph 19: warehouse (C) interior Photograph 20: warehouse (E) interior

The asbestos roof of section C is unlined but the asbestos roof covering section E is lined with plywood. The walls are either lined with plywood or white Tyvek.

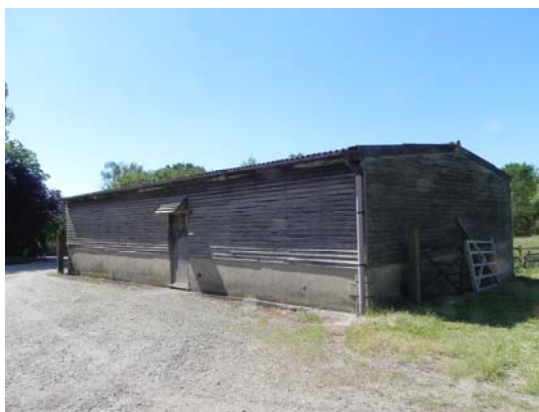
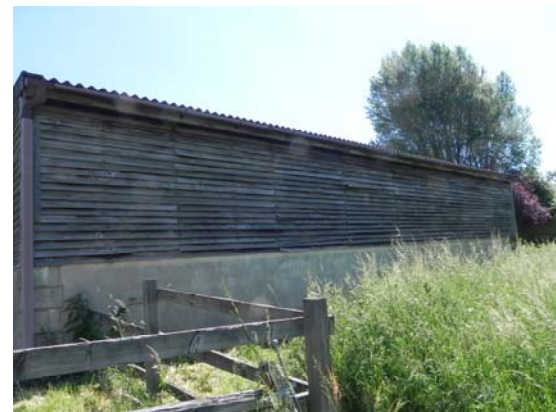
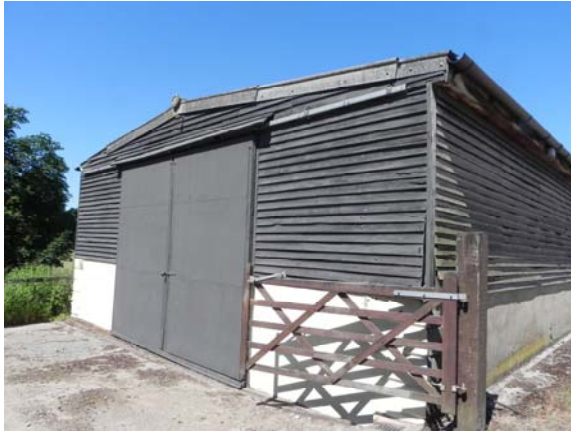
The shed has breezeblock rendered walls with timber weatherboarding above and a very shallow pitched roof clad with corrugated asbestos with gables to the southeast (front) and northwest (rear).

Externally, there are gaps beneath the weatherboarding, fascia and corrugated asbestos. The weatherboarding is deteriorating and there are several areas with raised timbers providing opportunities for bats to roost behind the weatherboarding.

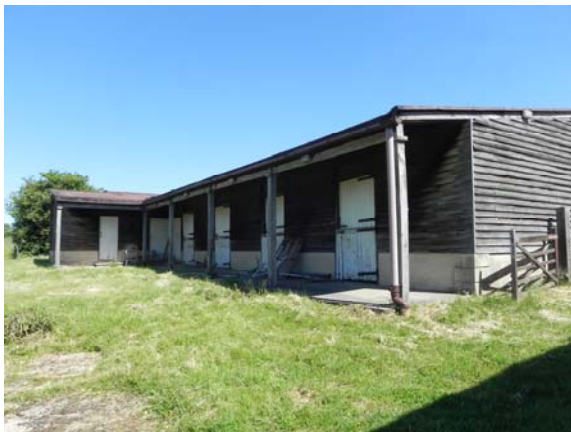
Photograph 24: stable block SW/SE elevation

The building includes 4 connected stables units at the south end with a middle storage section divided into three units and extending to the west and an end storage unit with windows.

The stable block has breezeblock and brick walls with exterior timber weatherboarding.

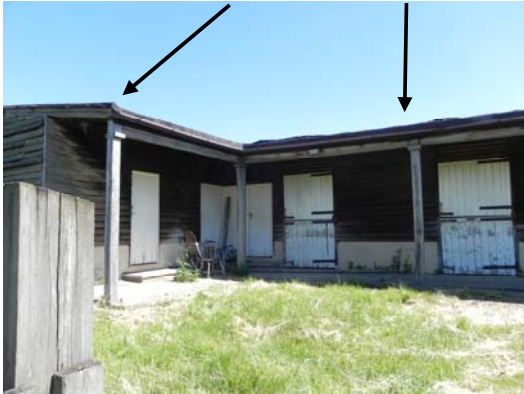
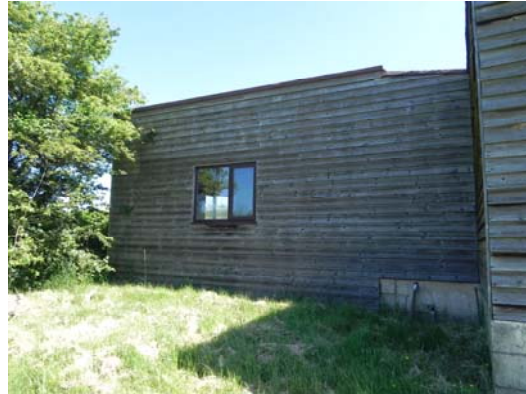
The roofs of the storage areas are flat. The middle section supports dark internal conditions but the north storage section has windows creating relatively light internal conditions less suitable for bats. The timber walls in the north storage area are lined internally with breathable Tyvek membrane.

Gaps are present behind the weatherboarding providing potential for bats to roost in the exterior crevices.

Openings into the stables/storage units enabling bats to enter are present along the eaves and there are also horizontal louvre openings above the stable doors

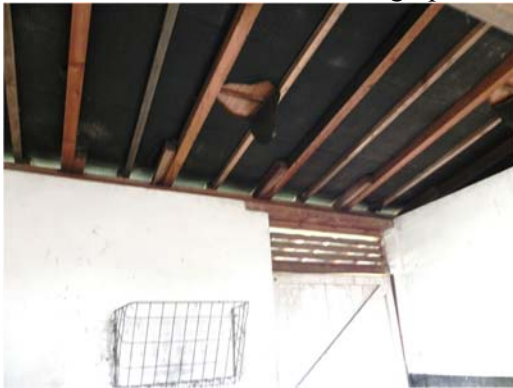
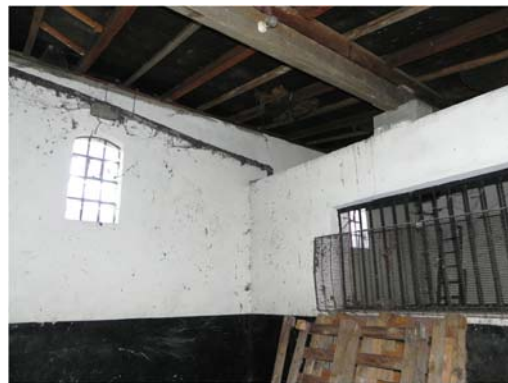
Photograph 27-28: stables interior

The windows in the stables render light internal conditions less suitable for roosting bats but there are solid timber beams and potential crevices within the roof structure. Holes in the bitumastic felt enable bats to retreat to the crevices between the timbers and felt.

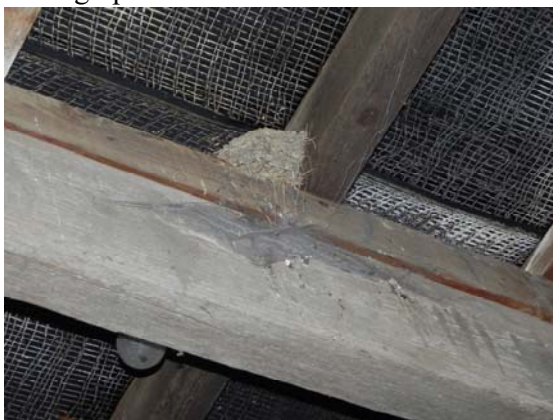
Photograph 29: disused swallow nest

Disused swallow nests were observed during the inspection

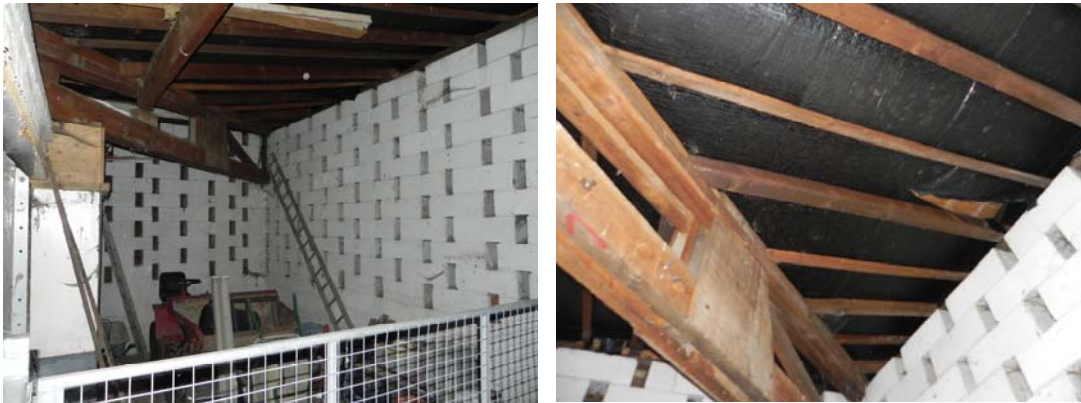
Photograph 30-31: brown long-eared bat roosting area

During the original inspection, storage items by the door prevented full access to the middle section but for the survey on the 19th July 2021, the blockage was removed and long-eared bat droppings (estimate 100-200 droppings) were identified inside. Two clusters of approximately 50 droppings each were observed below a large timber beam in the northeast corner and near a hole in the bitumastic felt suggesting that a brown long-eared bat is roosting below the beam and also in the crevices between the roof timber boards and bitumastic felt lining.

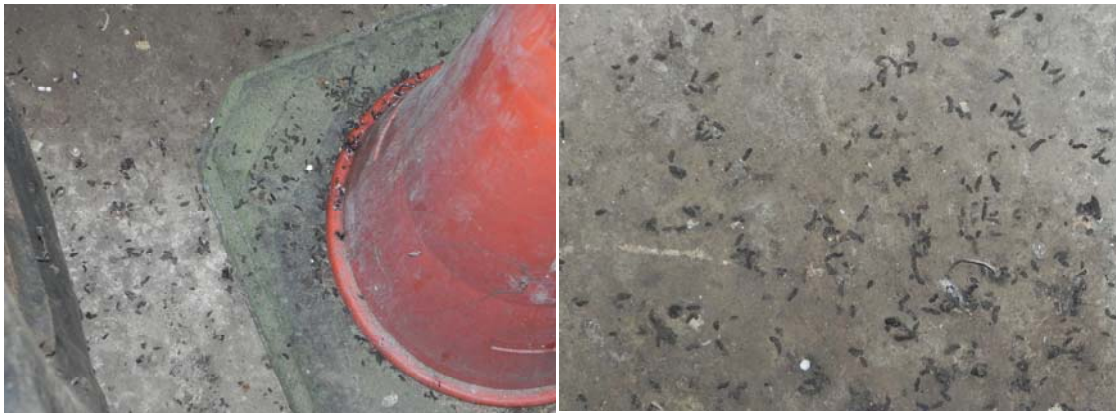
Photograph 32-33: long-eared bat droppings below roosting areas

A line of long-eared bat droppings was also observed where the open area links to the west roof void.

No significant accumulations of bat droppings were observed to suggest any past presence of a nursery colony.

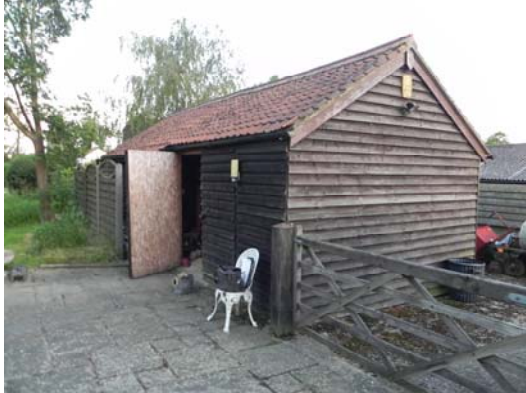
Photograph 34: garden barn

The building has timber walls on a concrete base with weatherboarding and a pitched roof clad with interlocking red clay tiles. Gable ends project to the southeast and northwest. Internally the building has a height from the floor to the ridge of 3.4 metres and provides dark warm conditions suitable for bats. The timbers are modern with no suitable joints for roosting bats. The roof and walls are lined by traditional bitumastic

The building is in good condition and the inspection found the exterior to be well sealed. The ridge cap is closely cemented with no gaps and the pitch tiles fit tightly together. There are some potential gaps behind the fascias at the gables but the weatherboarding is tight. The building therefore offers limited opportunities for bats to access the inside.

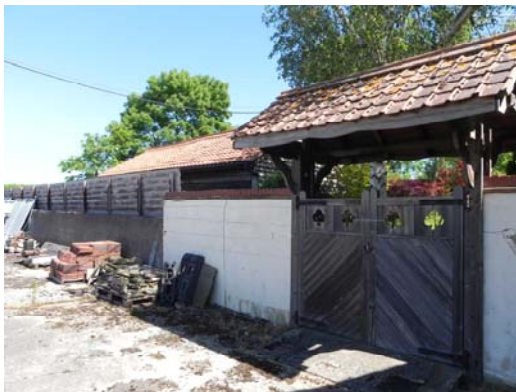
Photograph 35: Lychgate south of garden barn

A small Lychgate is situated on the east side of the site between the garden barn and office at Ordnance Survey Grid Reference TL30020202.

The open nature of the structure is of negligible suitability for roosting bats but it does support a pitched tiled roof with tiles lined by timber boards.

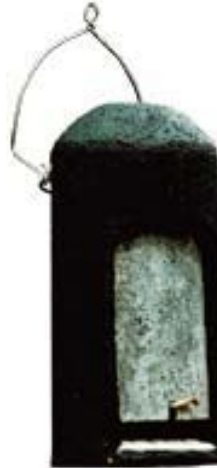
Type 2FN- round domed roofed box with front and rear entrance and increased height that allows bats to form clusters,

Height 360mm
Diameter 160mm
Weight 4.3kg

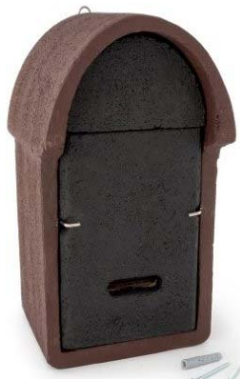
Large Multi Chamber Woodstone Bat Box

Dimensions
13cm x 27.5cm x 16cm

Weight 4kg

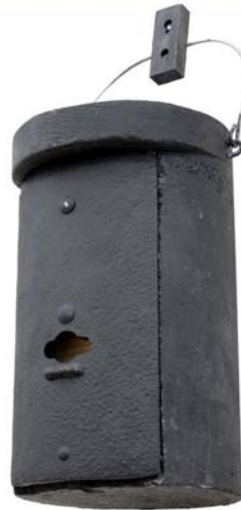
Schwegler Type 1WI

Designed for all year occupation
Can be set into wall flush with the surface
with entrance visible

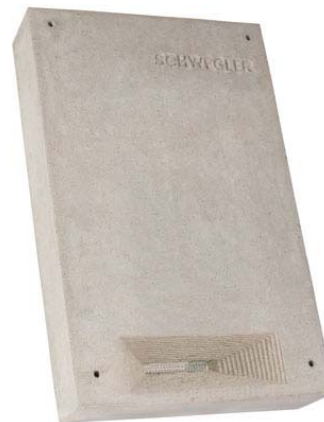
Height 545 mm
Width 345 mm
Depth 95 mm
Weight 15 kg

Since a pipistrelle bat also roosts behind the weatherboarding of the warehouse during the cooler months, a box suitable for hibernating bats is required. It is therefore also recommended that a Schwegler bat box (Type 1WI) be erected just below the west apex of property H04 enabling bats to fly. This box is designed for all year round occupation and can be incorporated within the wall of the house flush with the surface.

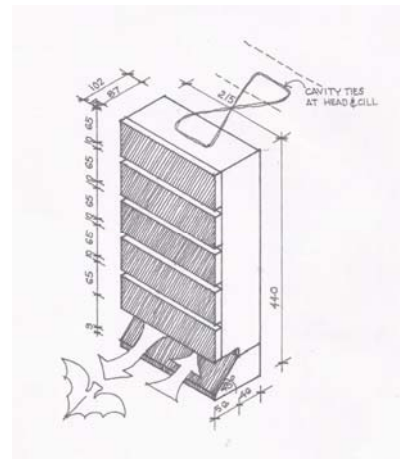
Habibat Bat Box

Box made from concrete plus brick facing that can be incorporated in walls

Height 440 mm
Width 215mm
Depth 102 mm
Weight 9 kg
