## Replacement Section - Post/Stud

## Vertical Face Repair - Post/Stud

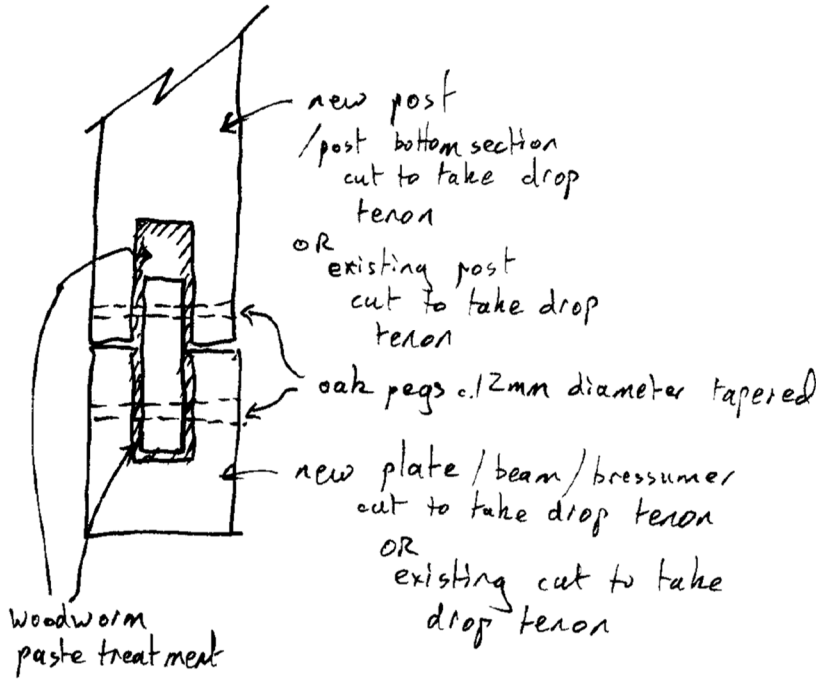
C

# New Post – Sole Plate – Alternatives

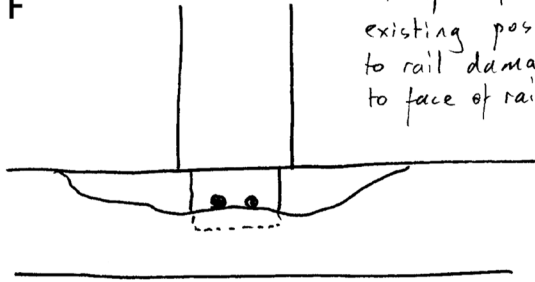
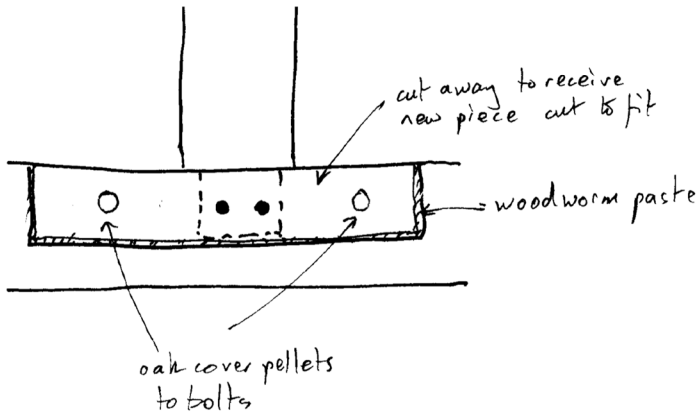
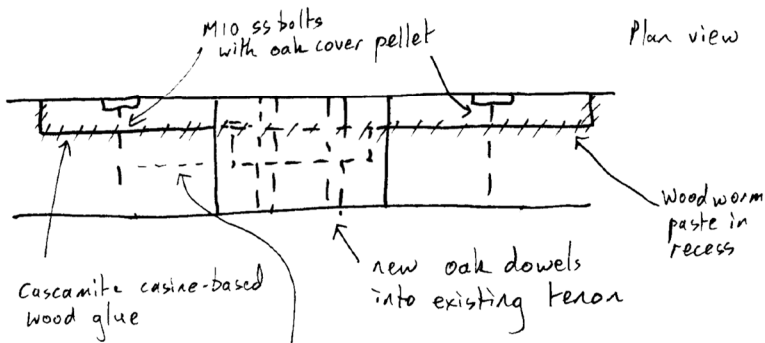
F

# Face Repair - Post - Beam

Example of existing post to rail damage to face of rail.

Depth of cut out determined by depth of decay and ease of reforming joint.

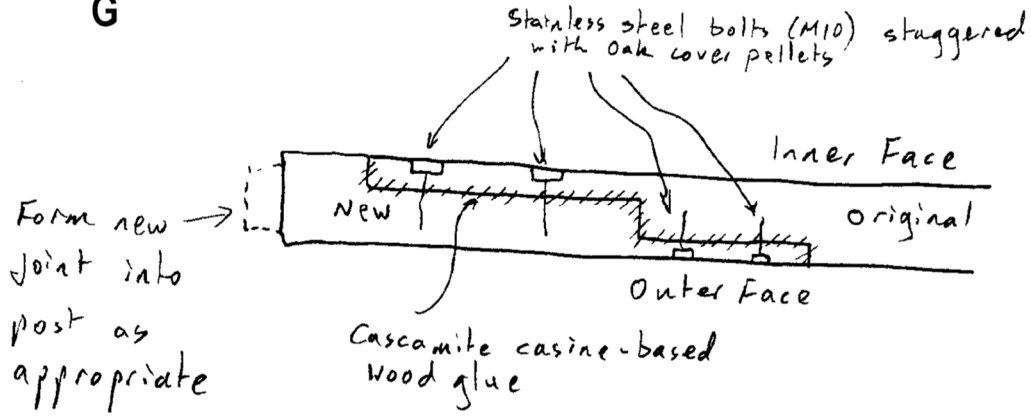
G

# Beam Repair - Example

Plan view

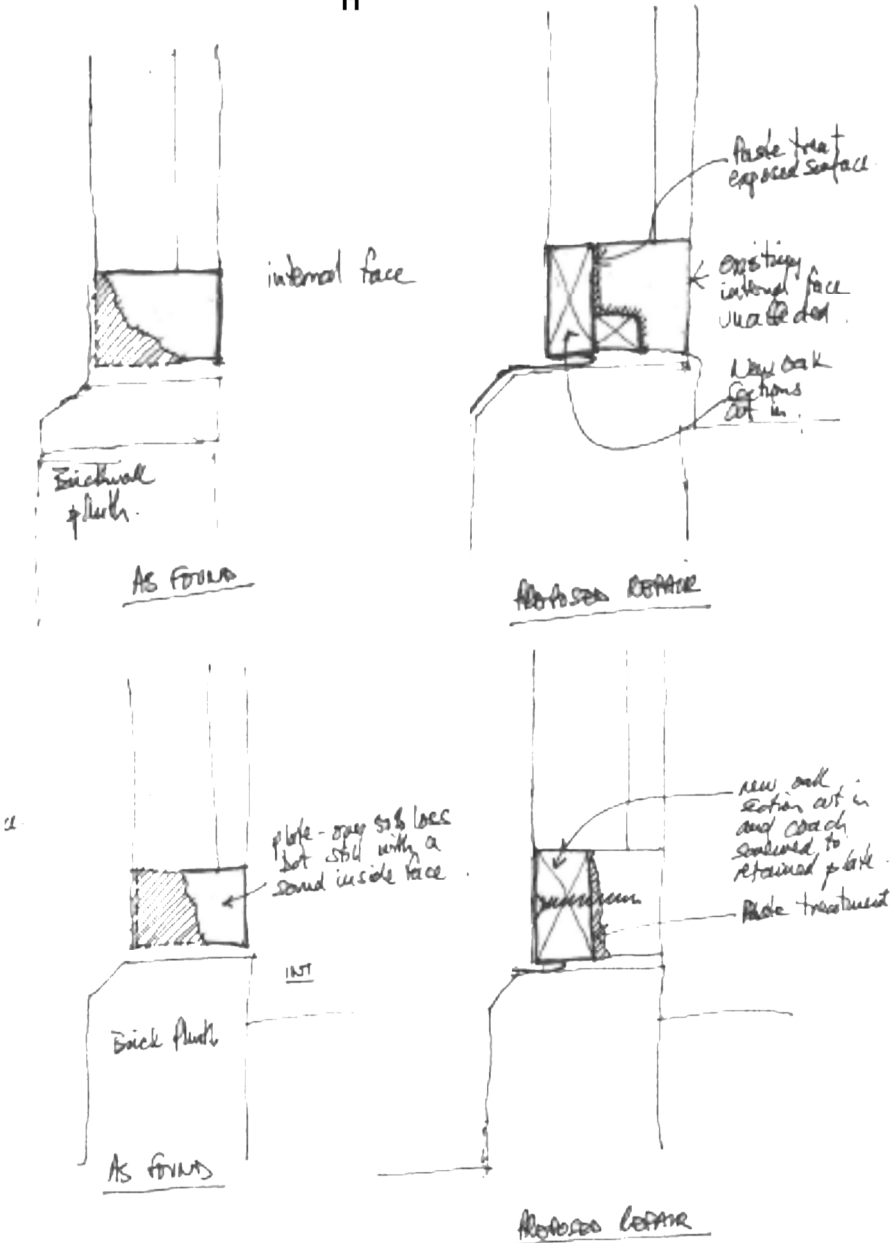
H

# Face Repair - Sole Plate & Beam - Alternatives

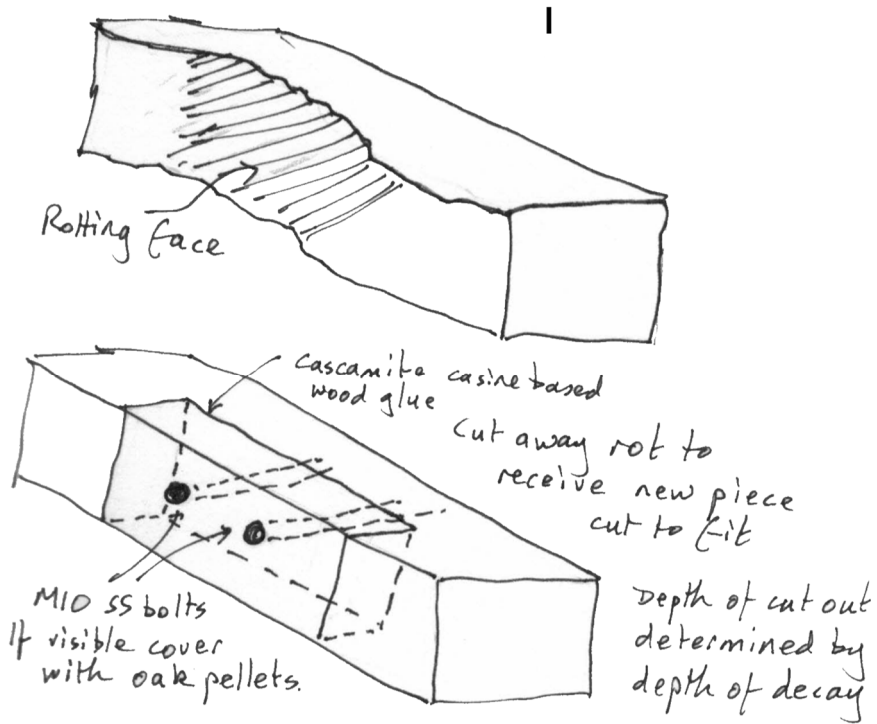
## Small Area Face Repair

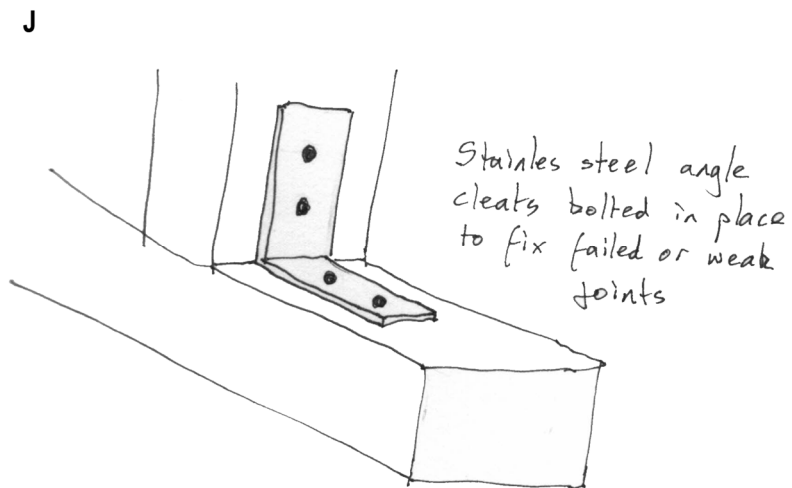
## Angle Repair to Joint
