# Windows - Assessment

## Northaw House, Northaw

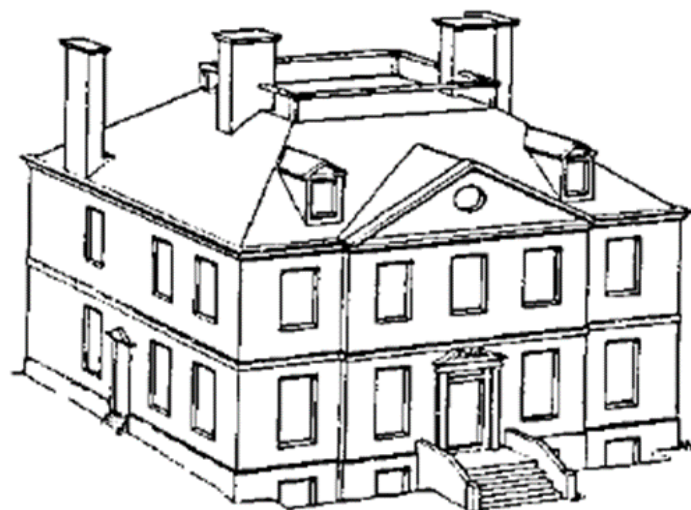
1. Following a site visit with Place Services on Monday 7th November, this note pulls together information regarding the front ground floor windows at Northaw House in order to provide justification for their replacement with sash windows.

*Figure 1: Phase 1 of Northaw House c. 1698*

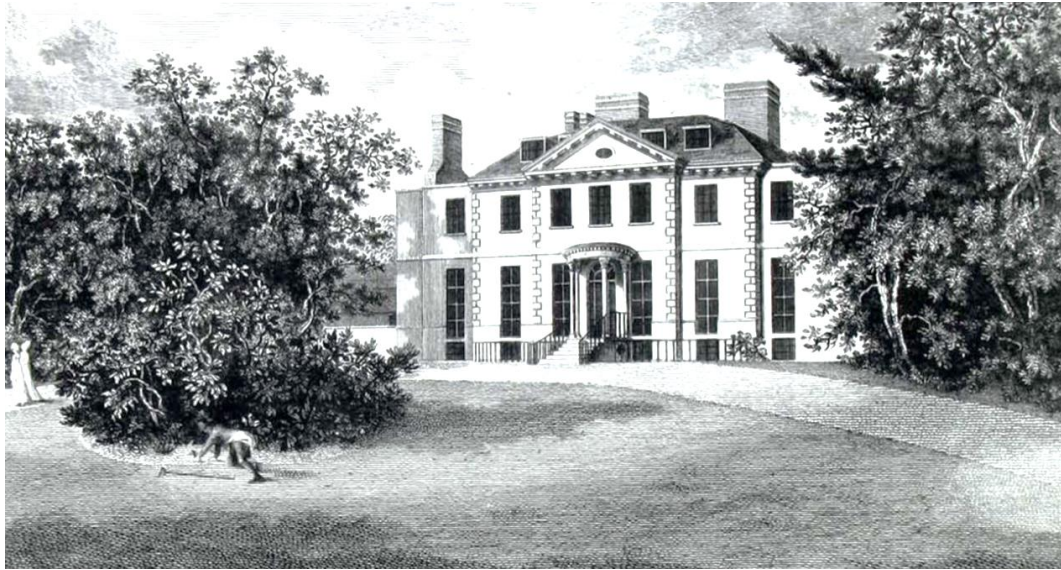
7. The first image to clearly show the front elevation of Northaw House is an 1805 engraving by James Peller Malcolm (**Figure 3**) who was an American/English topographer and engraver who lived between 1767 and 1815.

*Figure 3: 1805 Engraving of Northaw House by J P Malcolm*

8. The engraving shows the lengthened windows and the extended building. The style windows themselves are difficult to make out but appear to show each window comprising 8 panes of large glass. While it would be more typical to find sash windows in a building of this nature, it could be that larger French doors, which were gaining in popularity in the late 18<sup>th</sup> and early 19<sup>th</sup> century, were introduced due to the scale of the openings (though it is important to note that in this case the windows were never actively used as doors given that they are suspended far above the ground and there is no known evidence of balconies etc.).

13. The current windows, while broadly matching those shown in the 1805 sketch, are of no special interest in their own right being late 19<sup>th</sup> or early 20<sup>th</sup> century in date and of fairly standardised form and construction. Similarly, they do not contribute, in any meaningful way, to the significance of the grade II listed building.

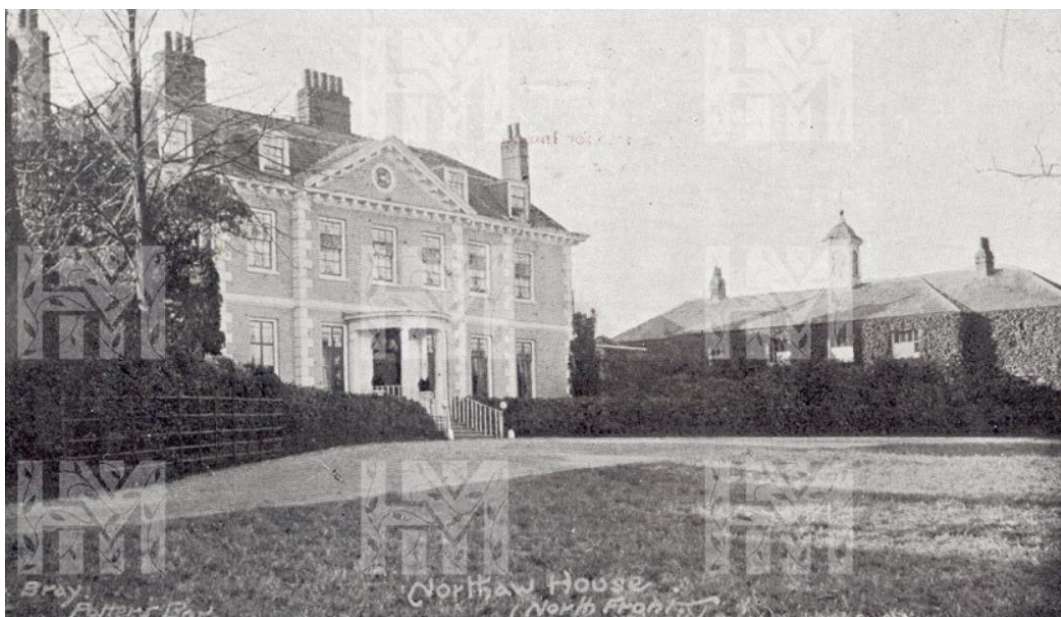
11. By c.1900-1905 the current 8 panel windows appear to have been introduced. Based on photographic and stylistic evidence, these appear to have been introduced in the late 19<sup>th</sup> or early 20<sup>th</sup> century. These windows, while relating to those shown in the 1805 engraving, are not sensitive in their own right (being relating late in date) and do not, aesthetically, relate positively to the building where upper floors feature multipaned sash windows characteristic of the 18<sup>th</sup> and 19<sup>th</sup> centuries.

*Figure 5: Photograph of c.1900-1905 © Hertford Museum*
