## Bat Roost & Breeding Bird Survey

**Northaw House, Coopers Lane, Northaw,  
Herts, EN6 4NJ  
(Grid Ref: TL 274 024)**

Client: LW Developments Ltd

ISSUE DATE: 1<sup>st</sup> July 2017

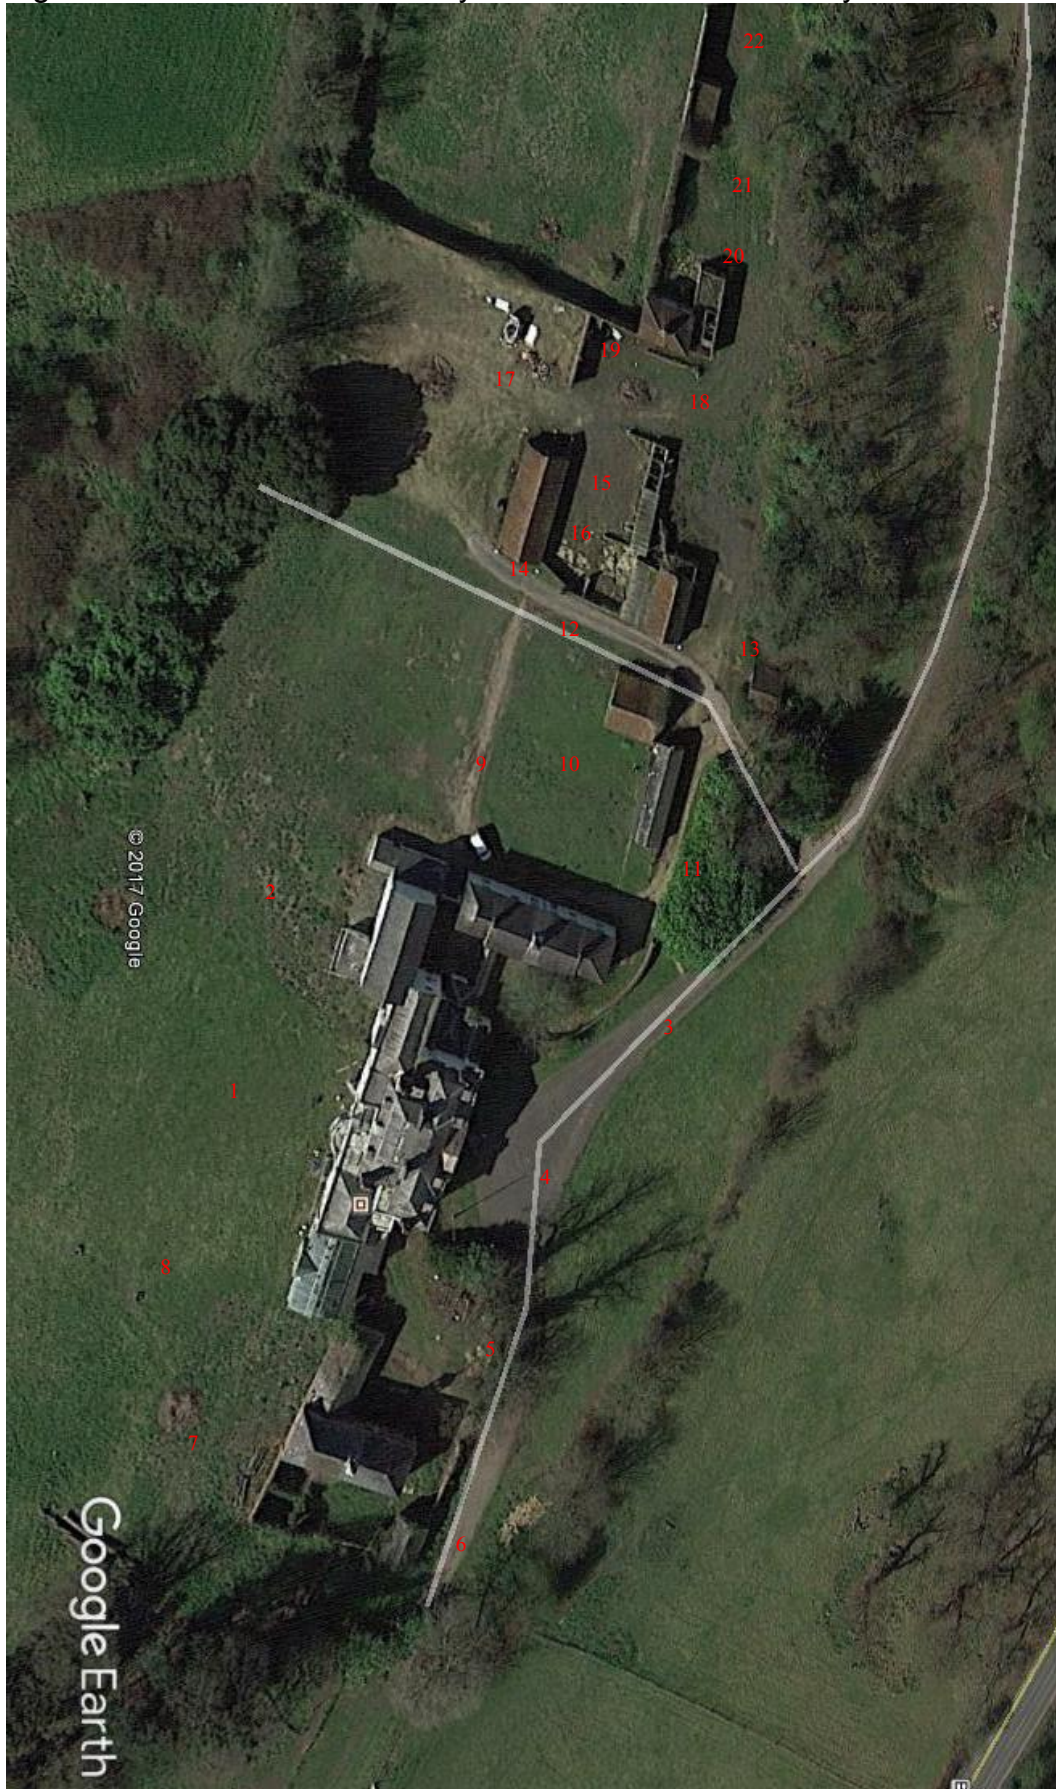
Fig 4. Position number of surveyors for Dawn / Dusk surveys

- 2.5.5 Area surveyed. Outside of buildings, see Fig 4 for positions of surveyors
- 2.5.6 Method. As per; Bat Conservation Trust (2016). *Bat Surveys – Good Practice Guidelines 3<sup>rd</sup> Edition*. **Bat Conservation Trust, London**. ISBN 13 978-1-872745-96-1.

- 2.6.5 Area surveyed. Outside of buildings, see Fig 4 for positions of surveyors
- 2.6.6 Method. As per; Bat Conservation Trust (2016). *Bat Surveys – Good Practice Guidelines 3<sup>rd</sup> Edition*. **Bat Conservation Trust, London**. ISBN 13 978-1-872745-96-1.

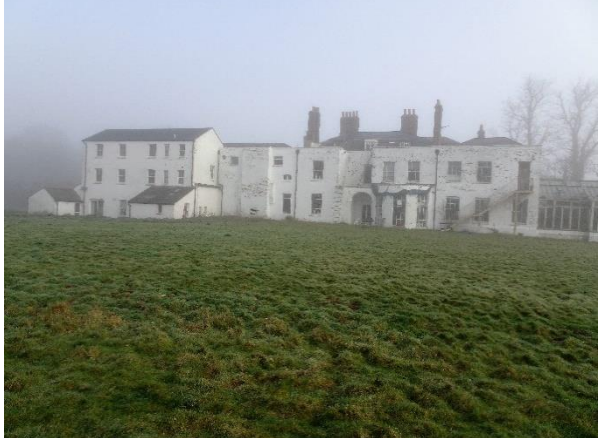
Building No	Building Description	Photo	Suitability for Bat Roosts
1a	<p>Northaw House is a Grade 11 Listed building originally constructed in 1698. 3 storey, slate roof, attics and basement. In the whole in good condition with well maintained brickwork and roof. Some missing slates and damage in parts to brickwork are evident. Also some damage to window sills and boardings. Currently vacant.</p>

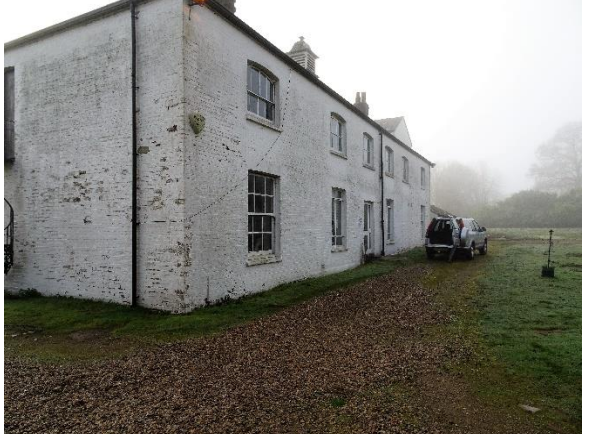
High
1b	<p>Extension of above building (1a) – The Ballroom Wing. 2 storey slate roof, with attics. In the whole in good condition with well maintained brickwork and roof. Some missing slates and damage in parts to brickwork are evident. Currently used for office space.</p>

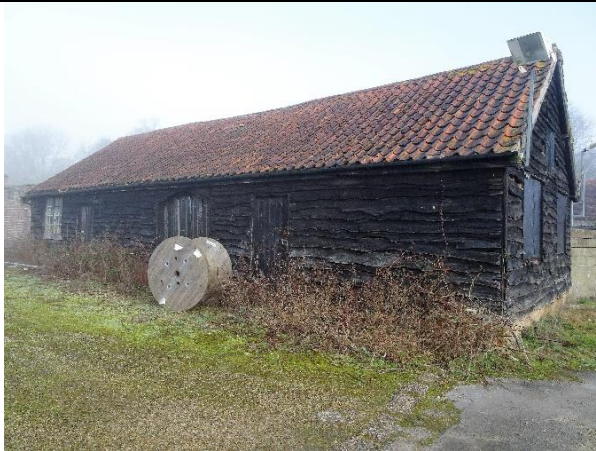
4	Wooden storage building / barn with tiled apex roof. Loose tiles, broken boards.

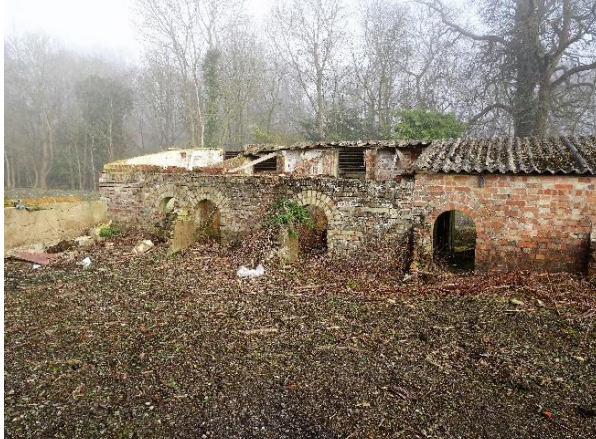
High
5	Brick piggery with corrugated asbestos roof. Damaged brickwork, multi crevices.

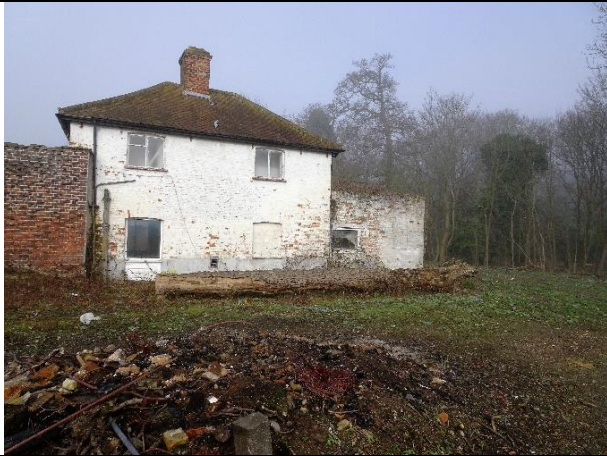
6	<p>2 storey detached house built in 1970's. Brick built with sloping tiled roof. Damaged brick work and roof spacings. Open windows damaged boarding</p>

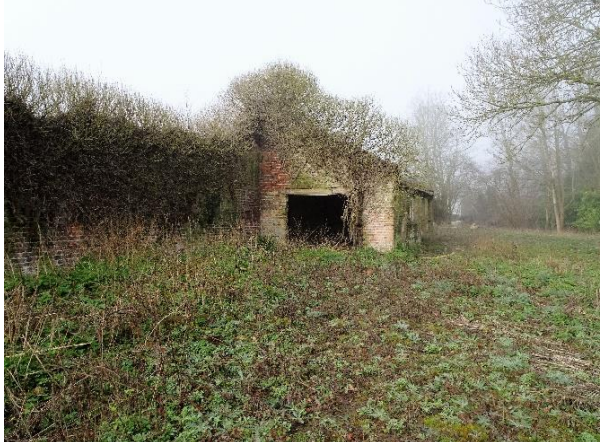
High
7	<p>Single storey brick/stone built storage building. Damaged brick, open access, damaged roof.</p>

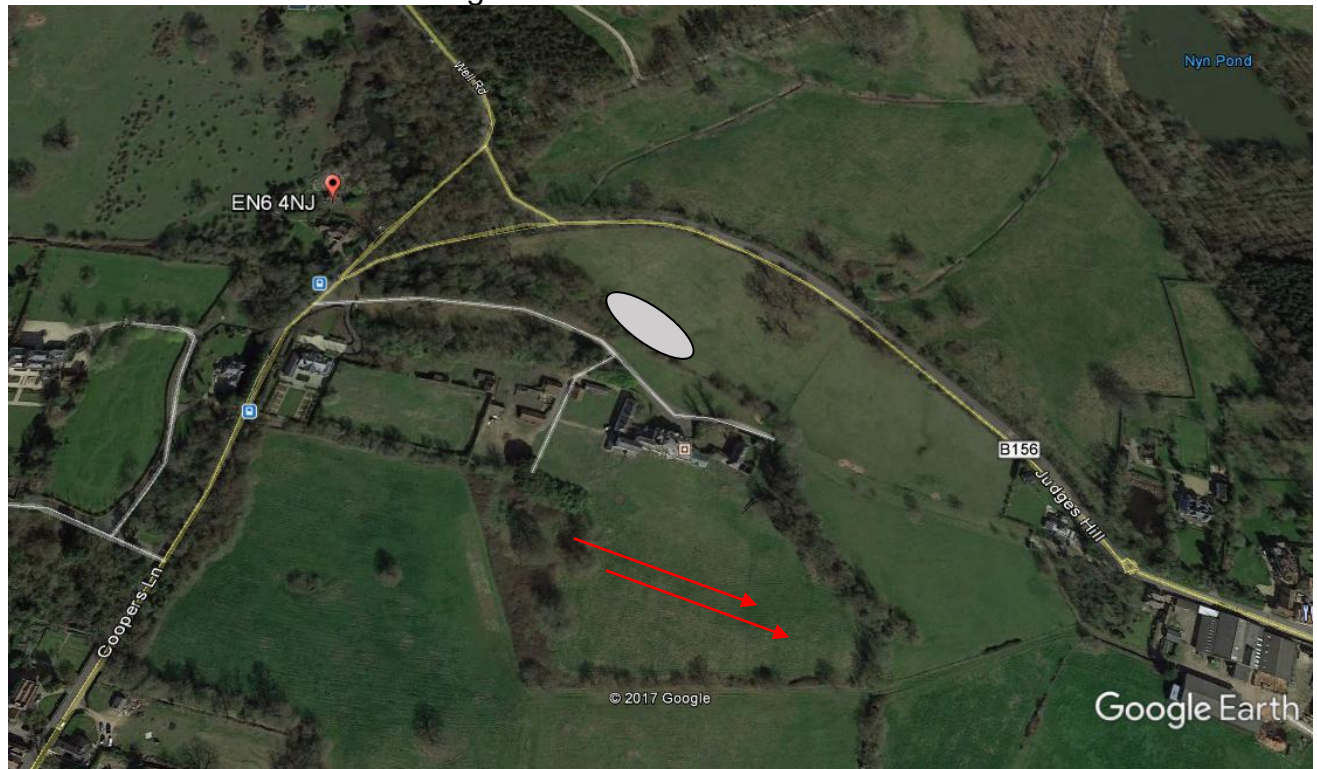
Fig 5. Area of bat activity.

3.4.3 Pipistrelle bats were noted foraging immediately north of the main house and Pipistrelle bats, Natterer's and Brown Long-eared bats were noted transecting the southern fields.

Pipistrelle bat foraging

Natterer's and Brown Long-eared bats transects
