**LANDSCAPE AND ECOLOGICAL MANAGEMENT PLAN
One YMCA, Welwyn Garden City**

BMD.23.0005.RPE.MP.801.LEMP

B. STRUCTURE ASSESSMENT JANUARY 2023

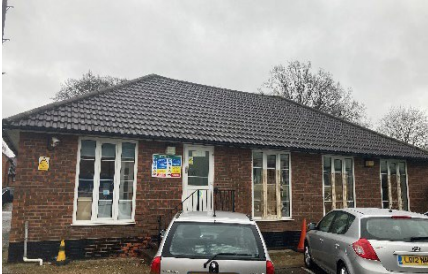
Building Ref	Building/ structure style	Notes 2019	Notes 2023	Category	Photograph
B1	<p>Single storey, brick-built structure with tiled pitch roof. In active use as a workshop.</p> <p>Three separate internal roof voids (i–iii).</p>	<p>Brickwork and tiles generally in good order, tiles sealed at ends and soffit boards in good condition.</p> <p>Internal space light and in regular use.</p> <p>Void i; Small void, internally boarded, heavily cobwebbed.</p> <p>Void ii; No access but well-sealed and considered similar to void i.</p> <p>Void iii; Open up to apex used as games room, boarded against tiles.</p> <p>No evidence of bats. Potential roost features on external soffits examined with endoscope and no bats present and no signs of access/use and very dirty.</p>	<p>Visual inspections same as in 2019.</p> <p>Brickwork and tiles in generally good condition, small gaps under soffits but dirty and examined with endoscope and no bats present.</p> <p>Roof voids dirty and well-sealed.</p> <p>No evidence of bats. Although potential roost features present on exterior.</p> <p>Precautionary approach advised with soft strip of tiles and soffit boards with Ecologist present.</p>	Negligible

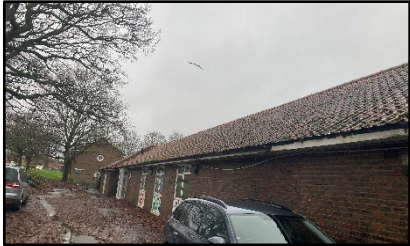
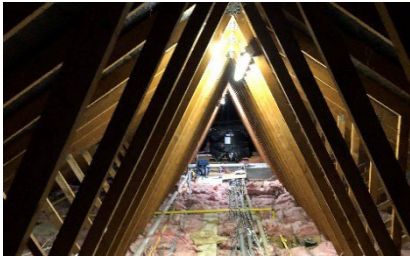
B2	<p>Single storey, brick-built structure with tiled pitch roof. In active use as communal facilities.</p> <p>One long internal roof void.</p>	<p>Brickwork and tiles generally in reasonable condition and soffit boards generally tight.</p> <p>Void lined and in good condition with internal light system. Potential access points via slipped tiles, gaps around air vent stacks and holes in soffit boards.</p> <p>Internal void cob-webbed with small skylight in northern end. No evidence of bats or use by bats.</p> <p>External potential roost features included occasional gaps and puck holes, examined with endoscope and no bats present.</p>	<p>Visual inspections same as in 2019.</p> <p>Roof void lined in very good condition, cobwebs present. Access points from exterior slipped tiles, however no added changes or potential access points than previously surveyed.</p> <p>External potential roost features included occasional gaps and puck holes, examined with endoscope and no bats present.</p>	Low

- 4.1.5 A precautionary approach is recommended during the demolition of the buildings with low bat roosting potential (B2, B3ii and B4, see plan at Appendix):

- **Immediately prior to works commencing:**
 - Erection of three bat boxes, suitable for pipistrelle species, within or in close proximity to the Site, e.g. on the mature trees away from the main building. These should be attached to a single tree at approximately 120° so providing a range of potential roosts with different micro-conditions. (Purpose: to ensure a safe place for bats should they be found during the works)

- Tool box talk to on-site workers on bats. (Purpose: to ensure on-site workers are aware of the possibility (albeit low) of individual bats and what to do should they find one during the works. To ensure the works and workers do not breach current legislation)

- Inspection of potential roost features where possible to identified any bats, if present, utilising the features
 - Soft strip of the potential roost features prior to demolition

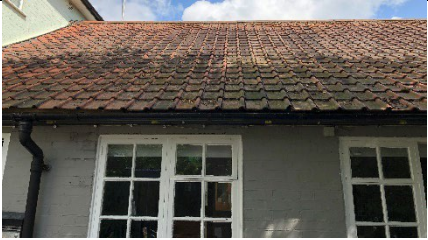
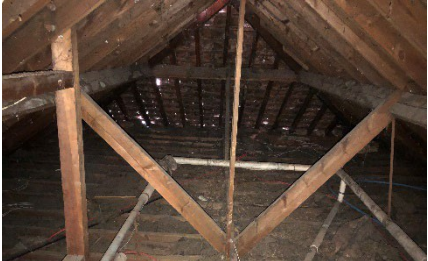
Building Ref	Building/ structure style	Notes 2019	Notes 2023	Category	Photograph
B3	<p>Modern, single storey, brick-built structure, with tiled pitch roof and small flat roofed annex to north.</p> <p>In active use as recreational area, toilets block and office space.</p> <p>Two separate roof voids present.</p>	<p>Brickwork and tiles generally in reasonable condition and soffit boards generally tight.</p> <p>Access via small holes in brickwork, gaps in brick vents, and puck holes.</p> <p>Void i; No internal void, open up to high suspended ceiling with small apex void above. Wooden and steel beams above and old lighting fixtures above the suspended ceiling.</p> <p>Void ii; Small void above suspended ceiling at northern end of the building. No internal membrane, draughty, light and heavily cobwebbed.</p> <p>No evidence of bats, potential roost features examined with endoscope and no bats present.</p>	<p>Visual inspections same as in 2019.</p> <p>Access via small holes in brickwork, gaps in brick vents, and puck holes.</p> <p>VOIDS same as previously recorded.</p> <p>No evidence of bats, potential roost features examined with endoscope and no bats present.</p>	<p>Low (B3ii) Negligible (B3i)</p>

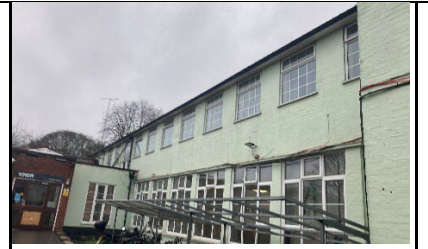
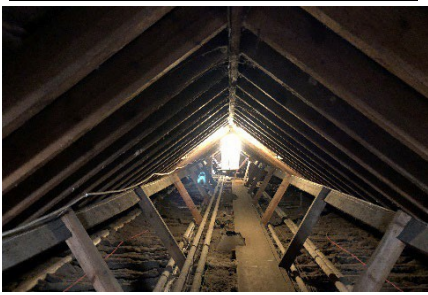
B4	<p>Large, two storey, brick built structure with a tiled pitched roof.</p> <p>In active use as kitchen and recreational area with bedrooms on 1st floor.</p> <p>Long roof void present along entire length.</p>	<p>Brickwork and tiles generally in good condition and no external roosting features noted.</p> <p>Internally, void unlined with access to tiles with numerous small gaps and larger gaps also present.</p> <p>Void accessible with board walks and containing heating/lighting systems.</p> <p>No evidence of bats observed during the external and internal inspections.</p>	<p>Visual inspections same as 2019.</p> <p>Brickwork and tiles in generally good condition, no obvious access points or external roosting features present.</p> <p>Roof void well lit, clean and unlined. A number of gaps to tiles were present offering limited roosting potential</p> <p>No evidence of bats observed during the external and internal inspections.</p>	<p>Low</p>

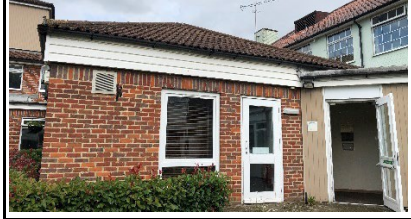
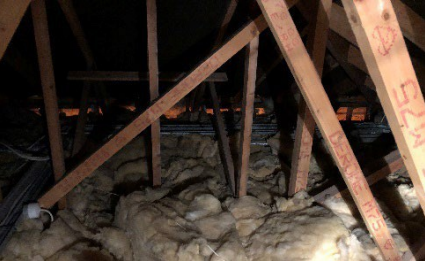
Building Ref	Building/ structure style	Notes 2019	Notes 2023	Category	Photograph
B5	<p>Small single storey building with tiled pitched roof.</p>	<p>Brickwork and tiles generally in good condition and no external roosting features.</p> <p>No obvious access points due to weal sealed brickwork and soffits.</p> <p>Void, clean, tidy, occasional cobwebs strung across void. Rodent droppings present.</p> <p>No evidence of bats or potential roost features.</p>	<p>Inspection provided same results as 2019.</p> <p>No external roosting features or obvious access points, brickwork and tiles in good condition.</p> <p>Roof void, clean and rodent droppings present.</p> <p>No evidence of bats or potential roost features.</p>	Negligible

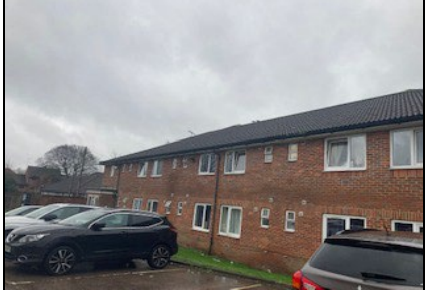
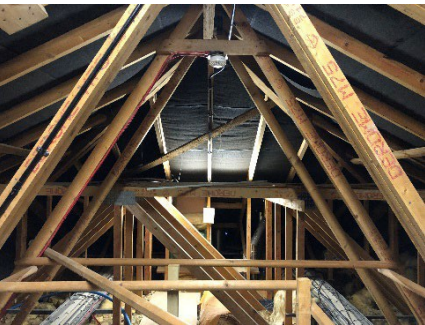
B6	<p>Large, modern, two story, brick-built structure with tiled pitched roof.</p> <p>In active use as residential block.</p> <p>Roof void present.</p>	<p>Brickwork in excellent condition, tiles sealed and in good condition and no external roosting features. Soffit boards tight and in good condition.</p> <p>No obvious access points externally.</p> <p>Internal void tidy, clean and well-sealed with limited space due to wooden trusses. Occasional cobwebs across internal space. Walkways and lighting system installed for access throughout the void.</p> <p>No evidence of bats or potential roost features.</p>	<p>Inspection provided same results as 2019.</p> <p>External features including brickwork, tiles and soffits in excellent condition. No external roosting features present.</p> <p>No evidence of bats or potential roost features.</p>	Negligible

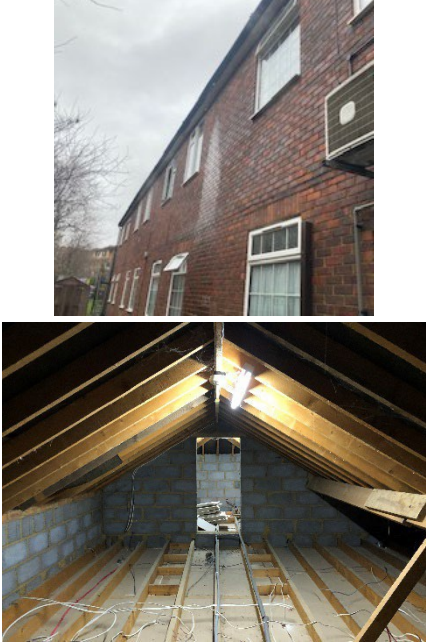
Building Ref	Building/ structure style	Notes 2019	Notes 2023	Category	Photograph
B7	<p>Large, modern, two story, brick-built structure with tiled pitched roof.</p> <p>In active use as residential block.</p> <p>Roof void present.</p>	<p>Brickwork in excellent condition, tiles sealed and in good condition and no external roosting features. Soffit boards tight and in good condition.</p> <p>No obvious access points externally other than two puck hole features. Checked with endoscope and no signs of use by bats, cobwebs present within.</p> <p>Large open void with lights and new lining with no signs of use by bats.</p>	<p>Inspection provided same results as 2019.</p> <p>Exterior of the building in excellent conditions. Two puck hole features still present, heavily cobwebbed.</p> <p>Large open void with lights and new lining with no signs of use by bats.</p>	Negligible.

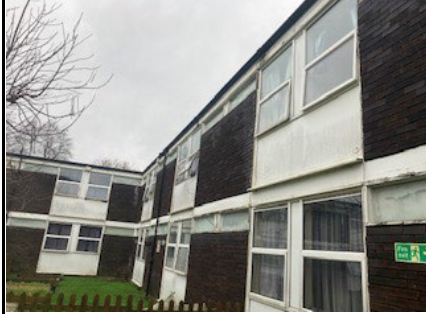
B8	<p>Large, t-shaped, modern, two storey breeze block built structure with flat concrete roof. Brick cladding along majority of building.</p> <p>Currently in active use as a residential block.</p> <p>No internal roof void.</p>	<p>Brickwork and cladding generally tight and in good condition.</p> <p>Large gap at northern end and occasional gaps where cladding coming away, examined with endoscope and no bats present.</p> <p>No evidence of bats recorded.</p>	<p>Visual inspections same as in 2019 with a number of brick cladding had slipped, examined with an endoscope no bats were present, very dirty with cobwebs presents.</p> <p>No evidence of bats.</p>	Negligible.

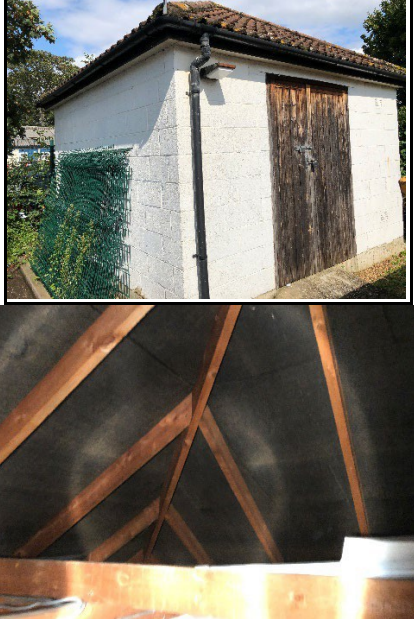
Building Ref	Building/ structure style	Notes 2019	Notes 2023	Category	Photograph
B9	<p>Small, brick built out building with pitched tiled roof.</p> <p>Small roof void.</p>	<p>Brickwork and tiles in excellent condition, tiles sealed at ends.</p> <p>No obvious access points, no external roosting features.</p> <p>Small roof void well sealed.</p> <p>No evidence of bats.</p>	<p>Inspection provided same results as 2019.</p> <p>No access points, well-sealed exterior.</p> <p>No evidence of bats.</p>	Negligible.

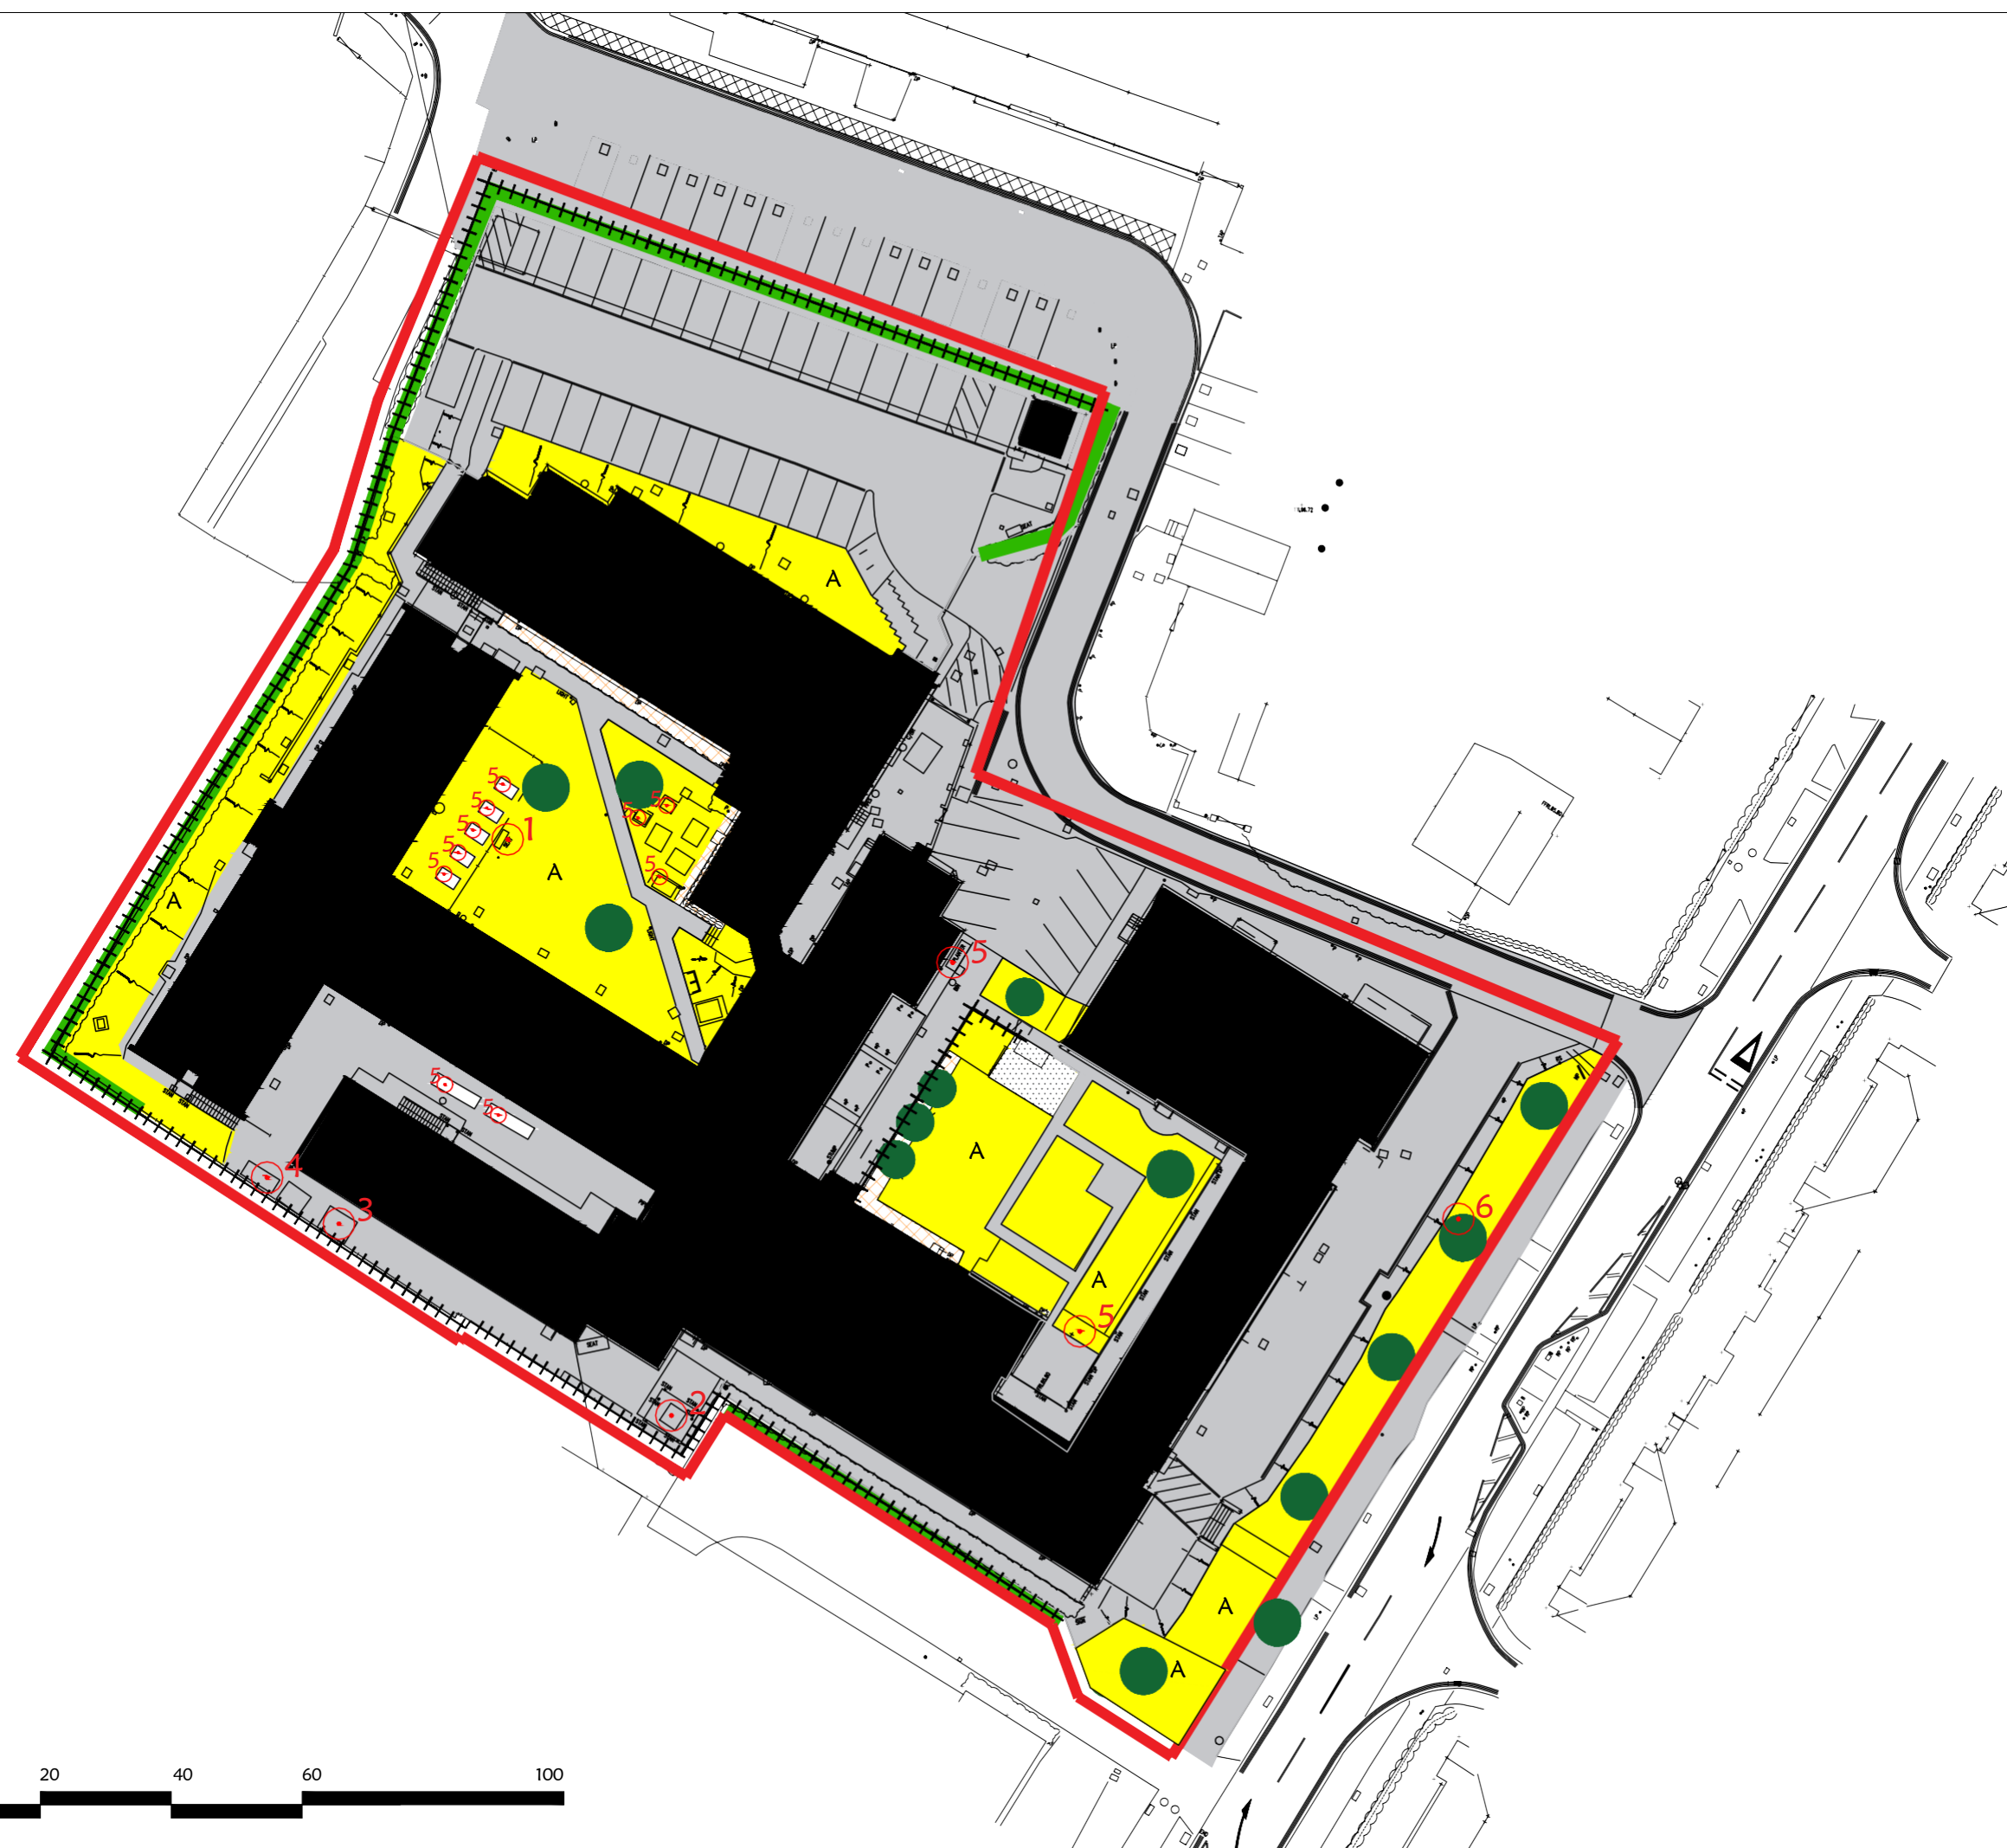
C. PHASE 1 HABITAT SURVEY PLAN

TARGET NOTES (1-5)
