Ground Investigation Report

43/ 45 Broadwater Road
Welwyn Garden City
Hertfordshire
AL7 3AX

EPS Project: UK13.1385
Report Status FINAL
Date Issued: 6th December 2013

43/ 45 BROADWATER ROAD, WELWYN GARDEN CITY

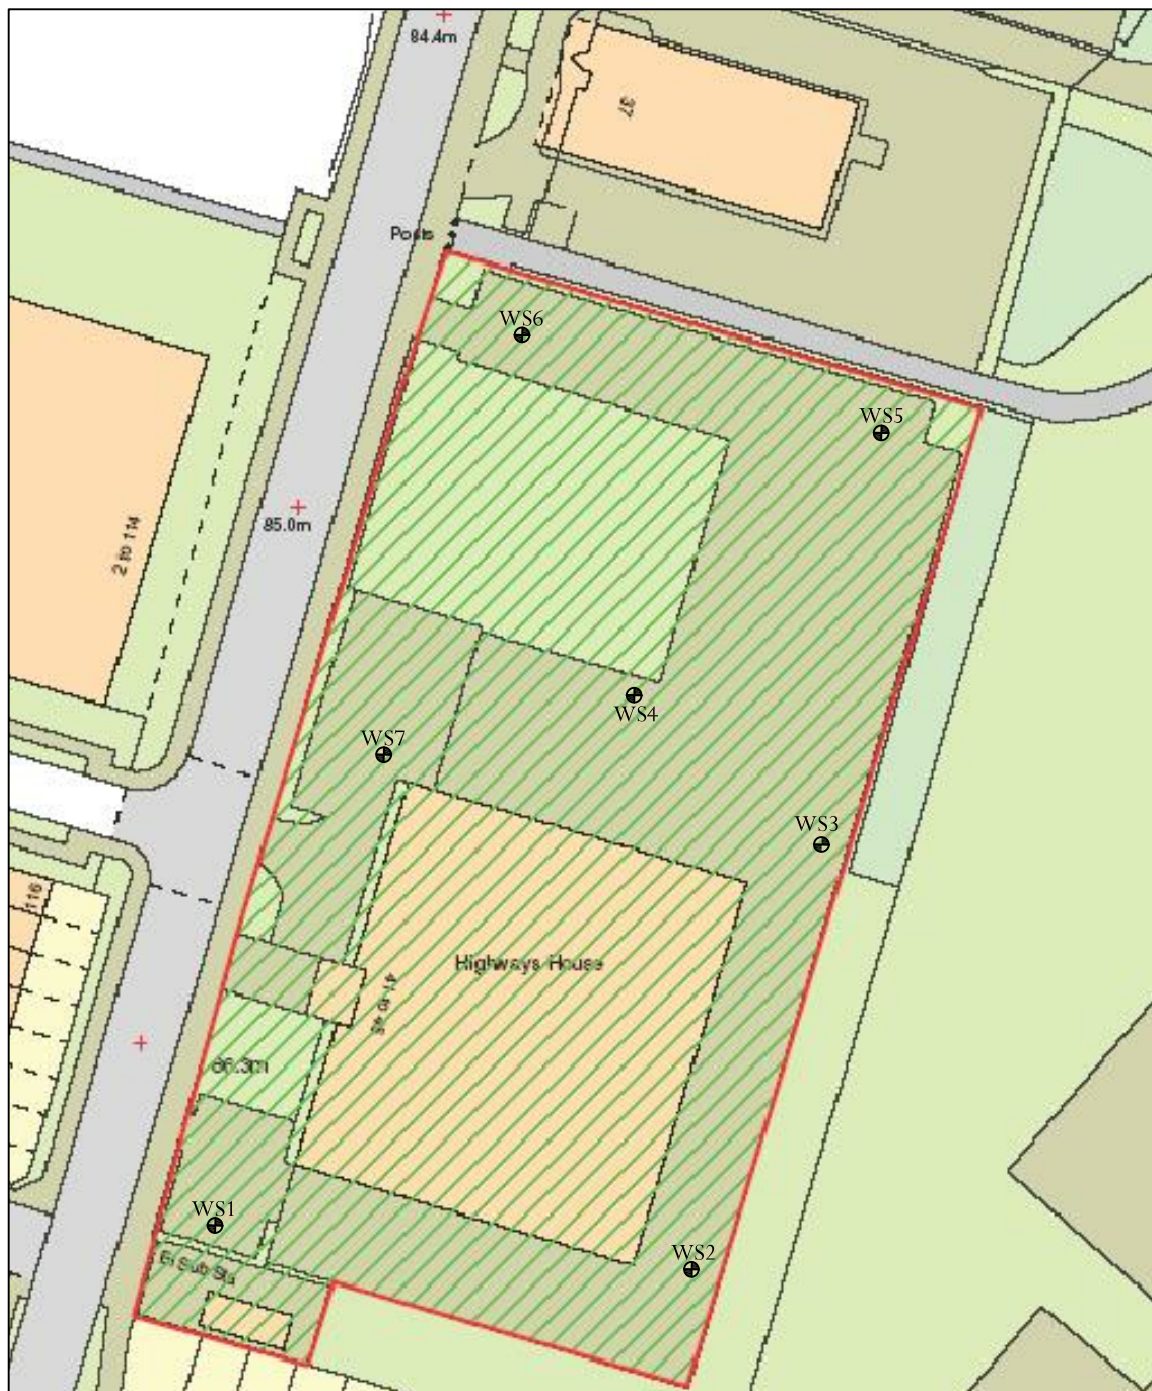
Dwg No: Corum/Broadwater/1213/03

- Approximate Site Boundary
- Approximate Borehole Location

A total of seven window sampler boreholes (WS1 to WS7) were formed across the site and the ground conditions encountered, from ground level, were generally found to comprise:-
