**Phase I Environmental Assessment,
Former Shredded Wheat Factory, Broadwater
Road, Welwyn Garden City**

**Broadwater Road, Welwyn Garden City
Delta-Simons Project No. 2342.17**

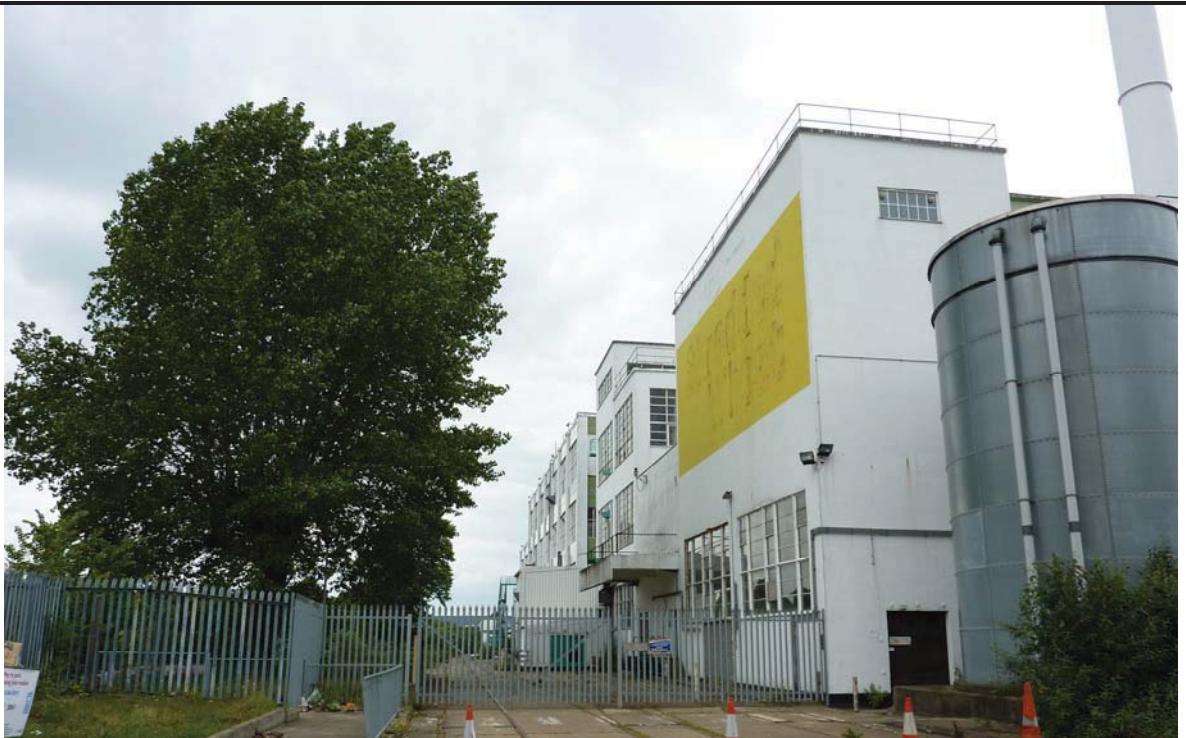
Cereal factory in the north of the Site, former boiler house location adjacent to the water tanks on the right and disused rail sidings visible in the road.

From anecdotal evidence, it is understood that a boiler house and associated diesel storage tanks were formerly located in the area of the current sprinkler tanks. In addition, the southern area of the main factory had historically been utilised as a print works for the packaging of cereal products. An underground storage tank (UST) is understood to have been located halfway down the vehicle access ramp. Upon inspection, the UST appeared to have been decommissioned and filled as the manhole cover has been concreted. The capacity, or what it had been used for, was not confirmed. A further UST was located to the north of the factory building, under the visitor car parking bays. However, Delta-Simons was informed that this UST had never been used.

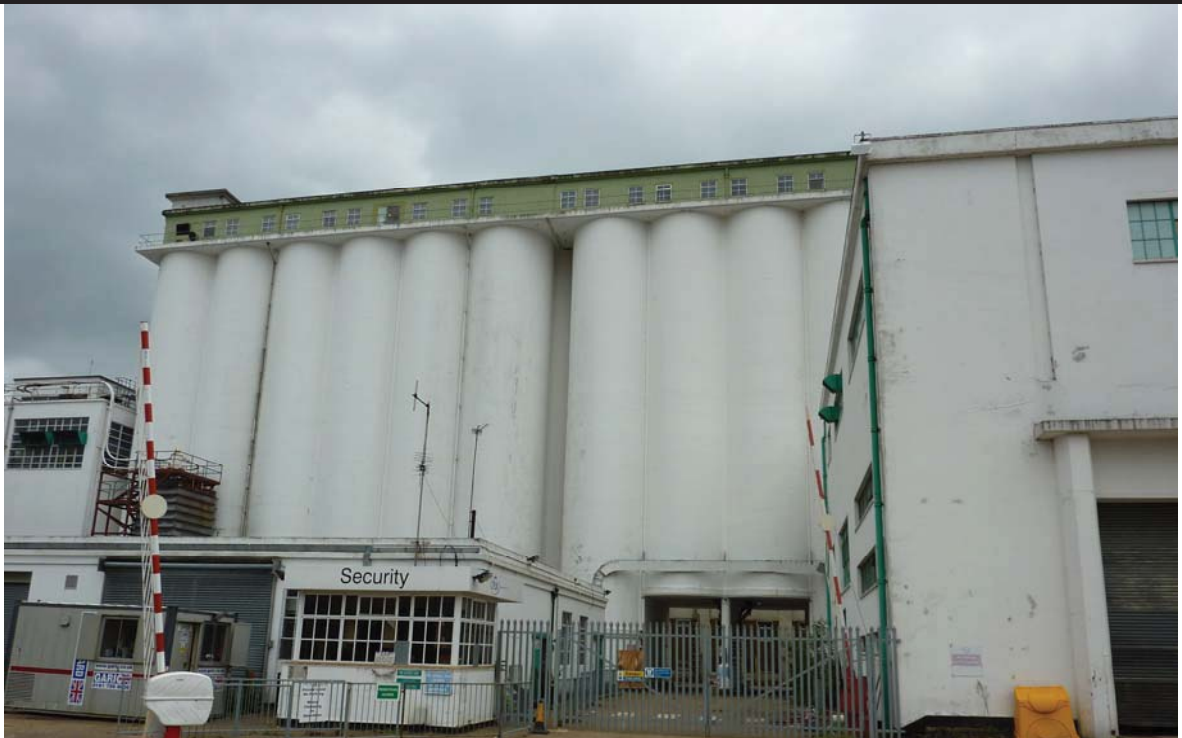
Grain silos within the former cereal factory.

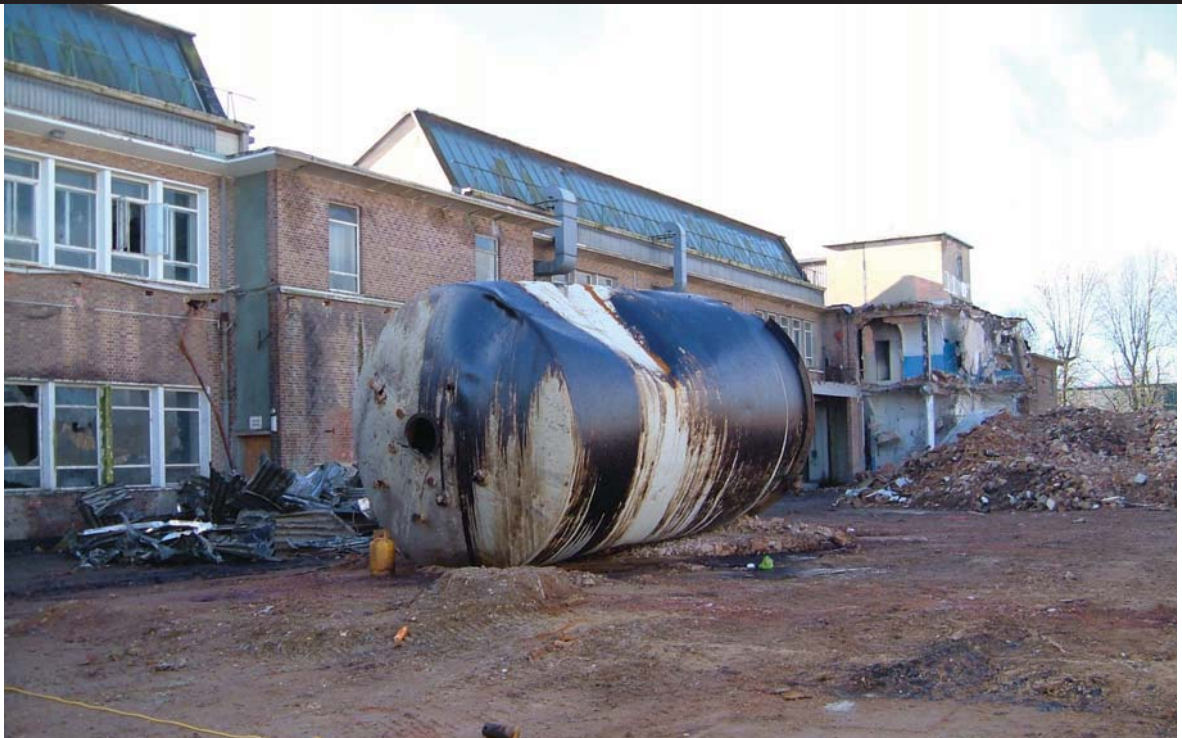
Fuel oil tank associated with the Polycell factory boiler house during demolition.

The tanks were removed by a specialist sub-contractor and removed from Site for recycling. Prior to removal the tanks were degassed and confirmed to be free of liquid contents. Following removal of the tanks the concrete bases were broken out and removed from the Site for disposal at an appropriate facility. The surrounding impacted soils were excavated to a depth of approximately three metres within an area of approximately 30 m by 30 m, localised highly impacted areas were excavated to approximately 4.5 m bgl. During the excavation the most significant contamination of the soils was noted around former pipework runs and the former off-set filling point. A selection of Site photographs from the tank pull and excavation phase are included as Appendix I.

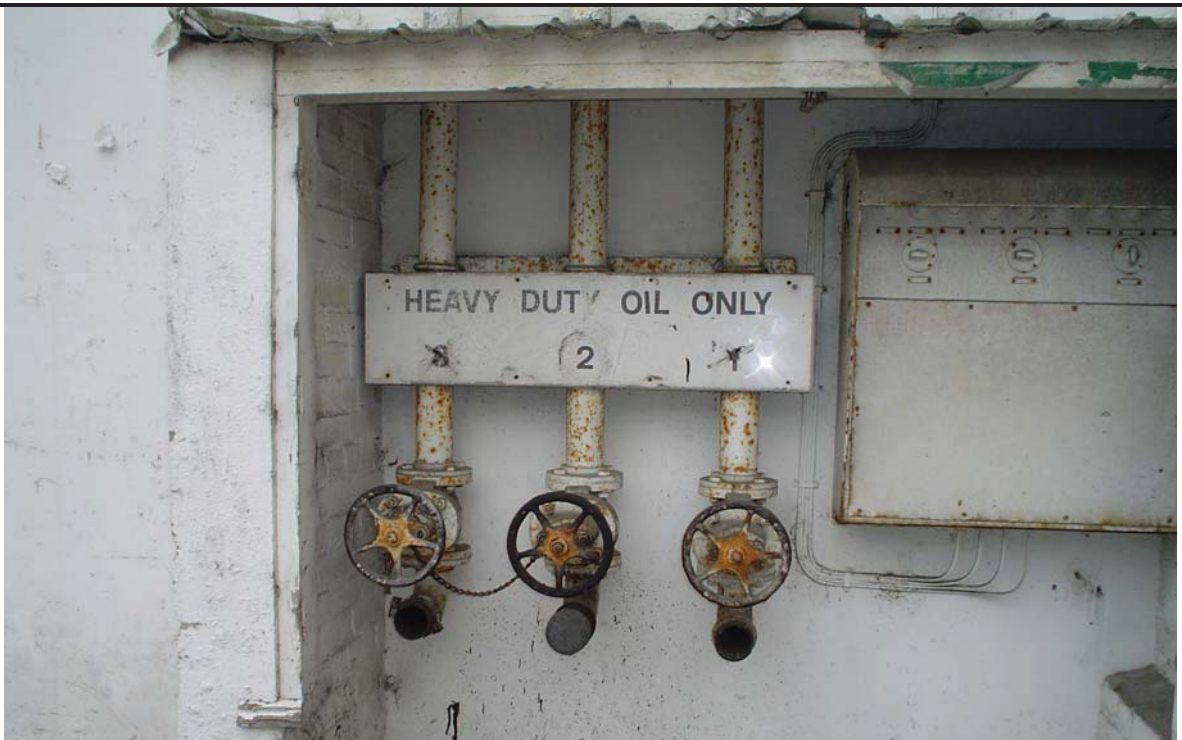
Fuel oil tank fill points associated with the Polycell factory boiler house.
