Environmental Report

WGC-One YMCA, Peartree Lane, Welwyn Garden City

Presented to Pinnacle Consulting Engineers

Delta-Simons Project No. 20-0093.01

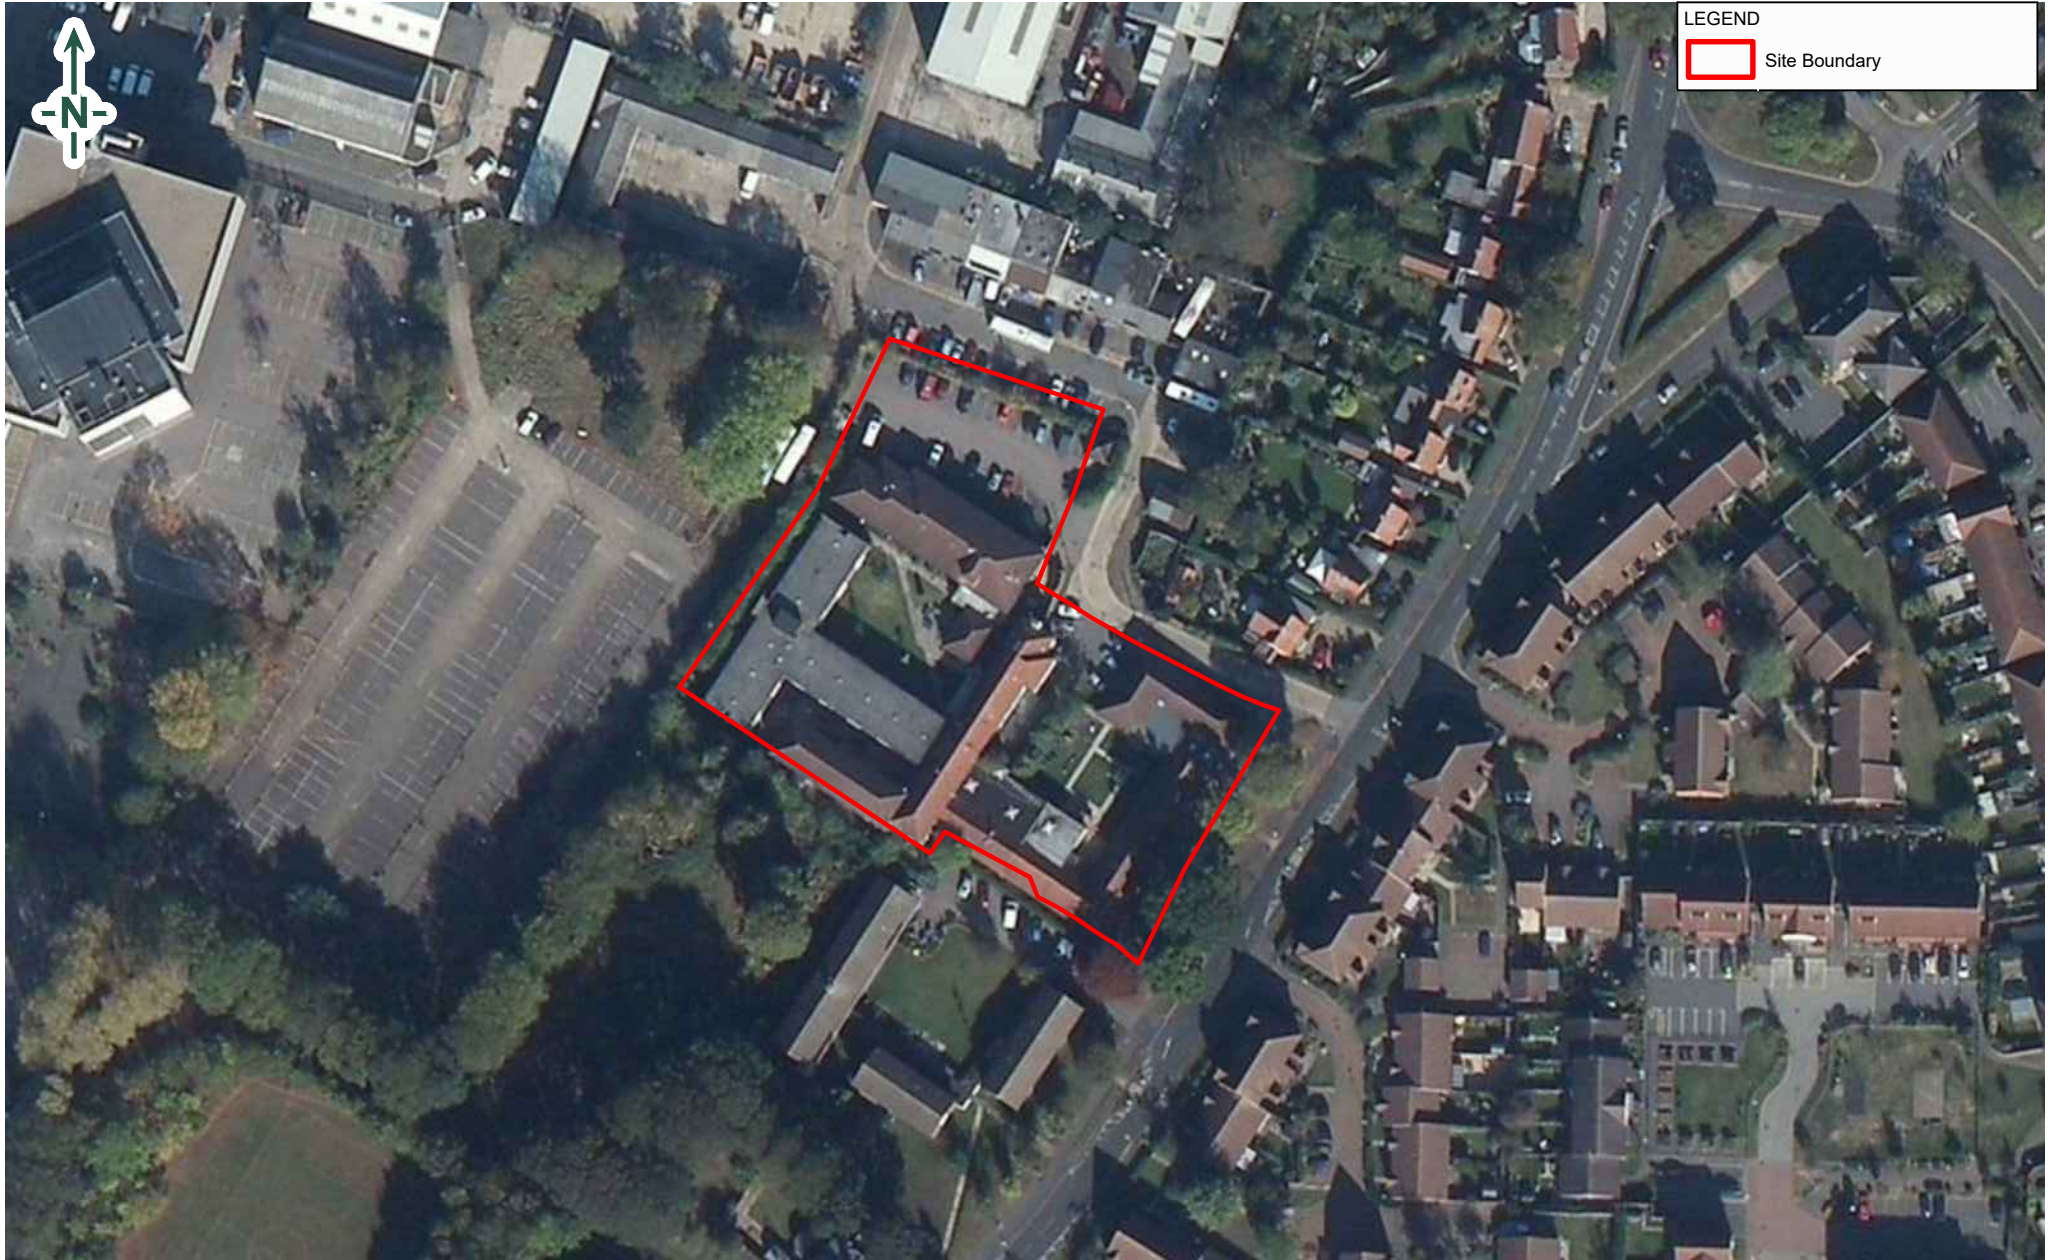
Figure 2 – Site Layout Plan

<p>Site Description & Walkover</p> <p>(Reconnaissance, Internet Air Photography)</p>	<p>Delta-Simons undertook a Site visit on 6th March 2020. A Site Layout Plan is included as Figure 2. Relevant Features identified during the walkover are summarised below.</p> <p>The Site was occupied by an active YMCA Hostel comprising a mixture of one and two storey buildings of brick construction. No access was afforded inside the existing buildings. Vehicular access and parking was noted along the northern area of the Site.</p> <p>The Site surfacing was noted to mainly comprise of either concrete and macadam in pedestrian and vehicular routes. The remainder of the Site comprised two soft landscaped courtyards in the central areas and soft landscaped areas along western, northern and eastern boundaries. A number of mature trees were noted along the eastern boundary.</p> <p>A number of manhole covers indicating buried utilities were noted across the Site.</p> <p>The car parking area in the north was noted to be raised by approximately 0.5 m above the remaining Site topography. In addition, a retaining wall approximately 1.0 m high was noted along the western area of the Site as part of a raised soft landscaped area.</p> <p>No evidence was observed during the Site walkover of potential Asbestos Containing Materials (ACMs), however, the presence within existing building construction cannot be discounted. The presence for plant/ boiler rooms within buildings cannot be discounted.</p>

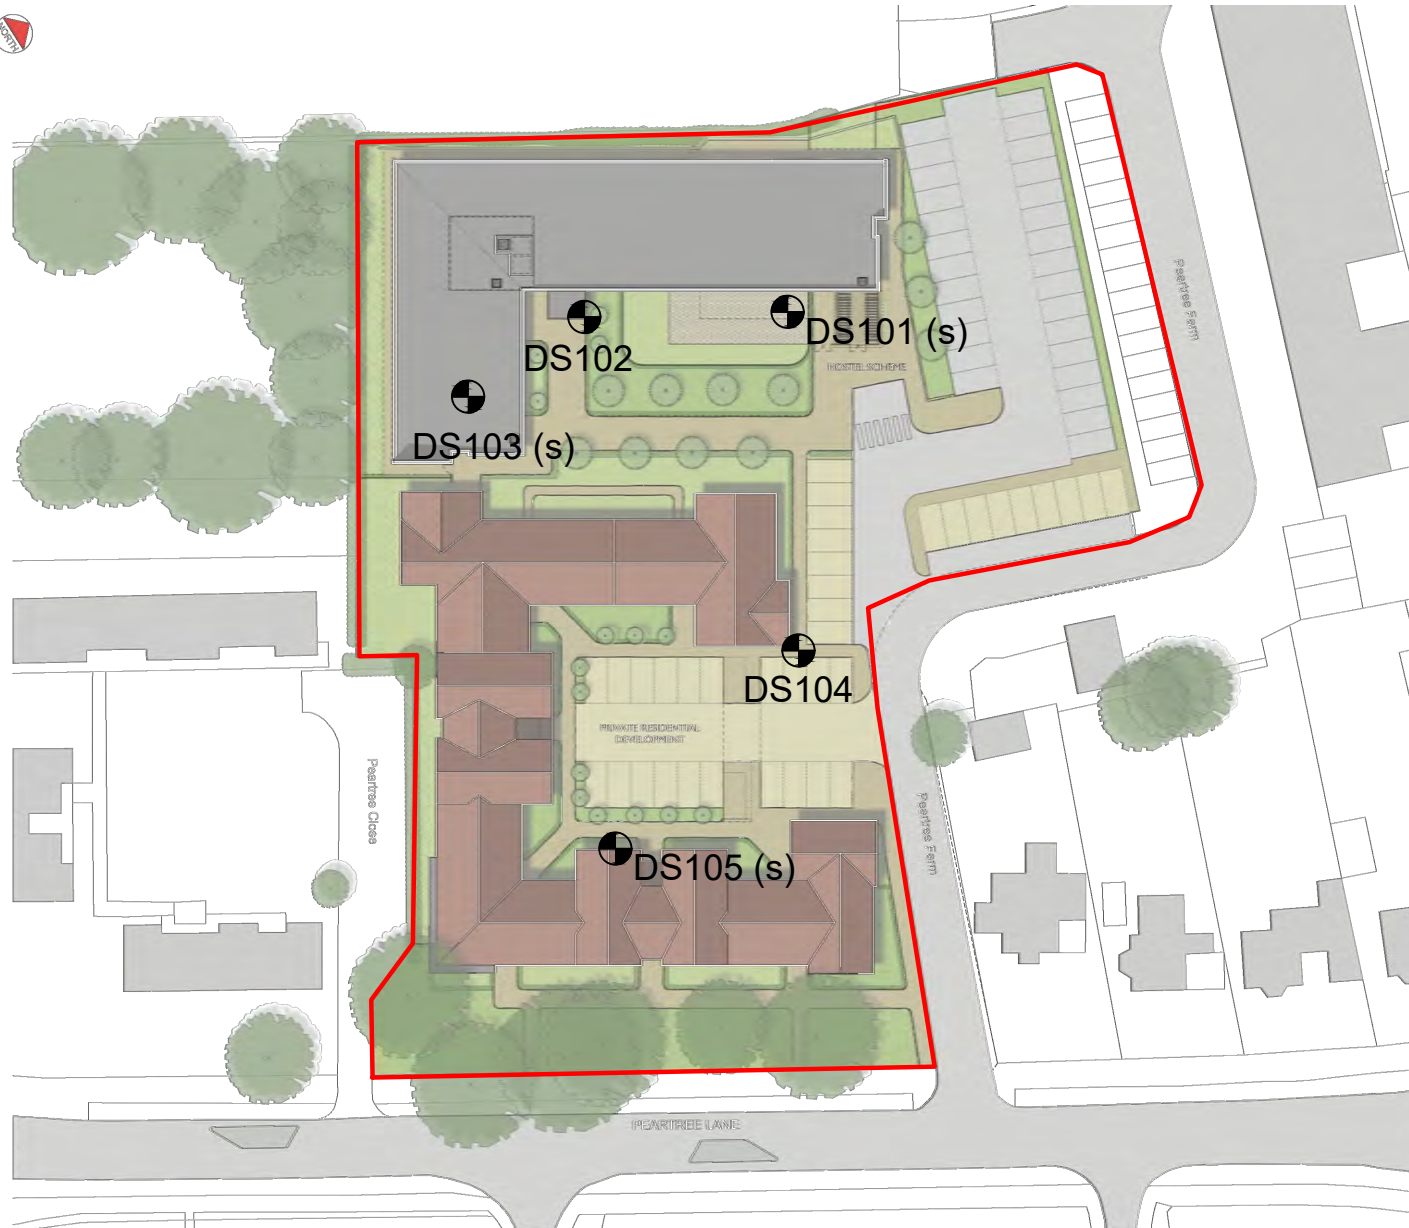
Figure 3 – Approximate Intrusive Location Plan

The locations of the investigations are shown on Figure 3 and the field records are provided in Appendix C.

Three of the dynamic sampler boreholes has been fitted with a gas/water monitoring standpipe of 50 mm internal diameter UPVC slotted and plain casing to the required depth as appropriate, capped by a gas tap bung and cover generally in accordance with BSENISO 22475-1:2006 for an open standpipe. The locations of the monitoring installations are shown on Figure 3.

LEGEND	
	Site Boundary
	Dynamic Sampler Borehole
	Standpipe Installation

Scope of Investigation	Dynamic Sampler Boreholes— 5 No. Monitoring Well Installs – 3 No. Monitoring rounds – 2 No. Site Area = 0.67 hectares.																																																											
Site Specific Investigation Limitations	Intrusive locations were set out to avoid underground services.																																																											
Geology from the Investigation Works	Made Ground was encountered across the Site generally comprising a limited thickness of gravelly clayey sandy Topsoil with brick and flint underlain by gravelly clay with brick fragments. Made Ground was identified to a maximum depth of 0.68 m bgl. The underlying natural soils comprised soft to firm light brown slightly sandy gravelly clay and clayey gravelly sands with flints. Coarse sandy flint gravel was identified within DS103 between 3.40 m bgl and 4.00 m bgl. There were no visual or olfactory indications of significant contamination. The natural soil was considered to be generally representative of the published superficial geology for the Site of the Lowestoft Formation. Bedrock (chalk) was not encountered. Groundwater was identified during drilling within DS105 only at 3.50 m bgl. See Appendix C for further details.

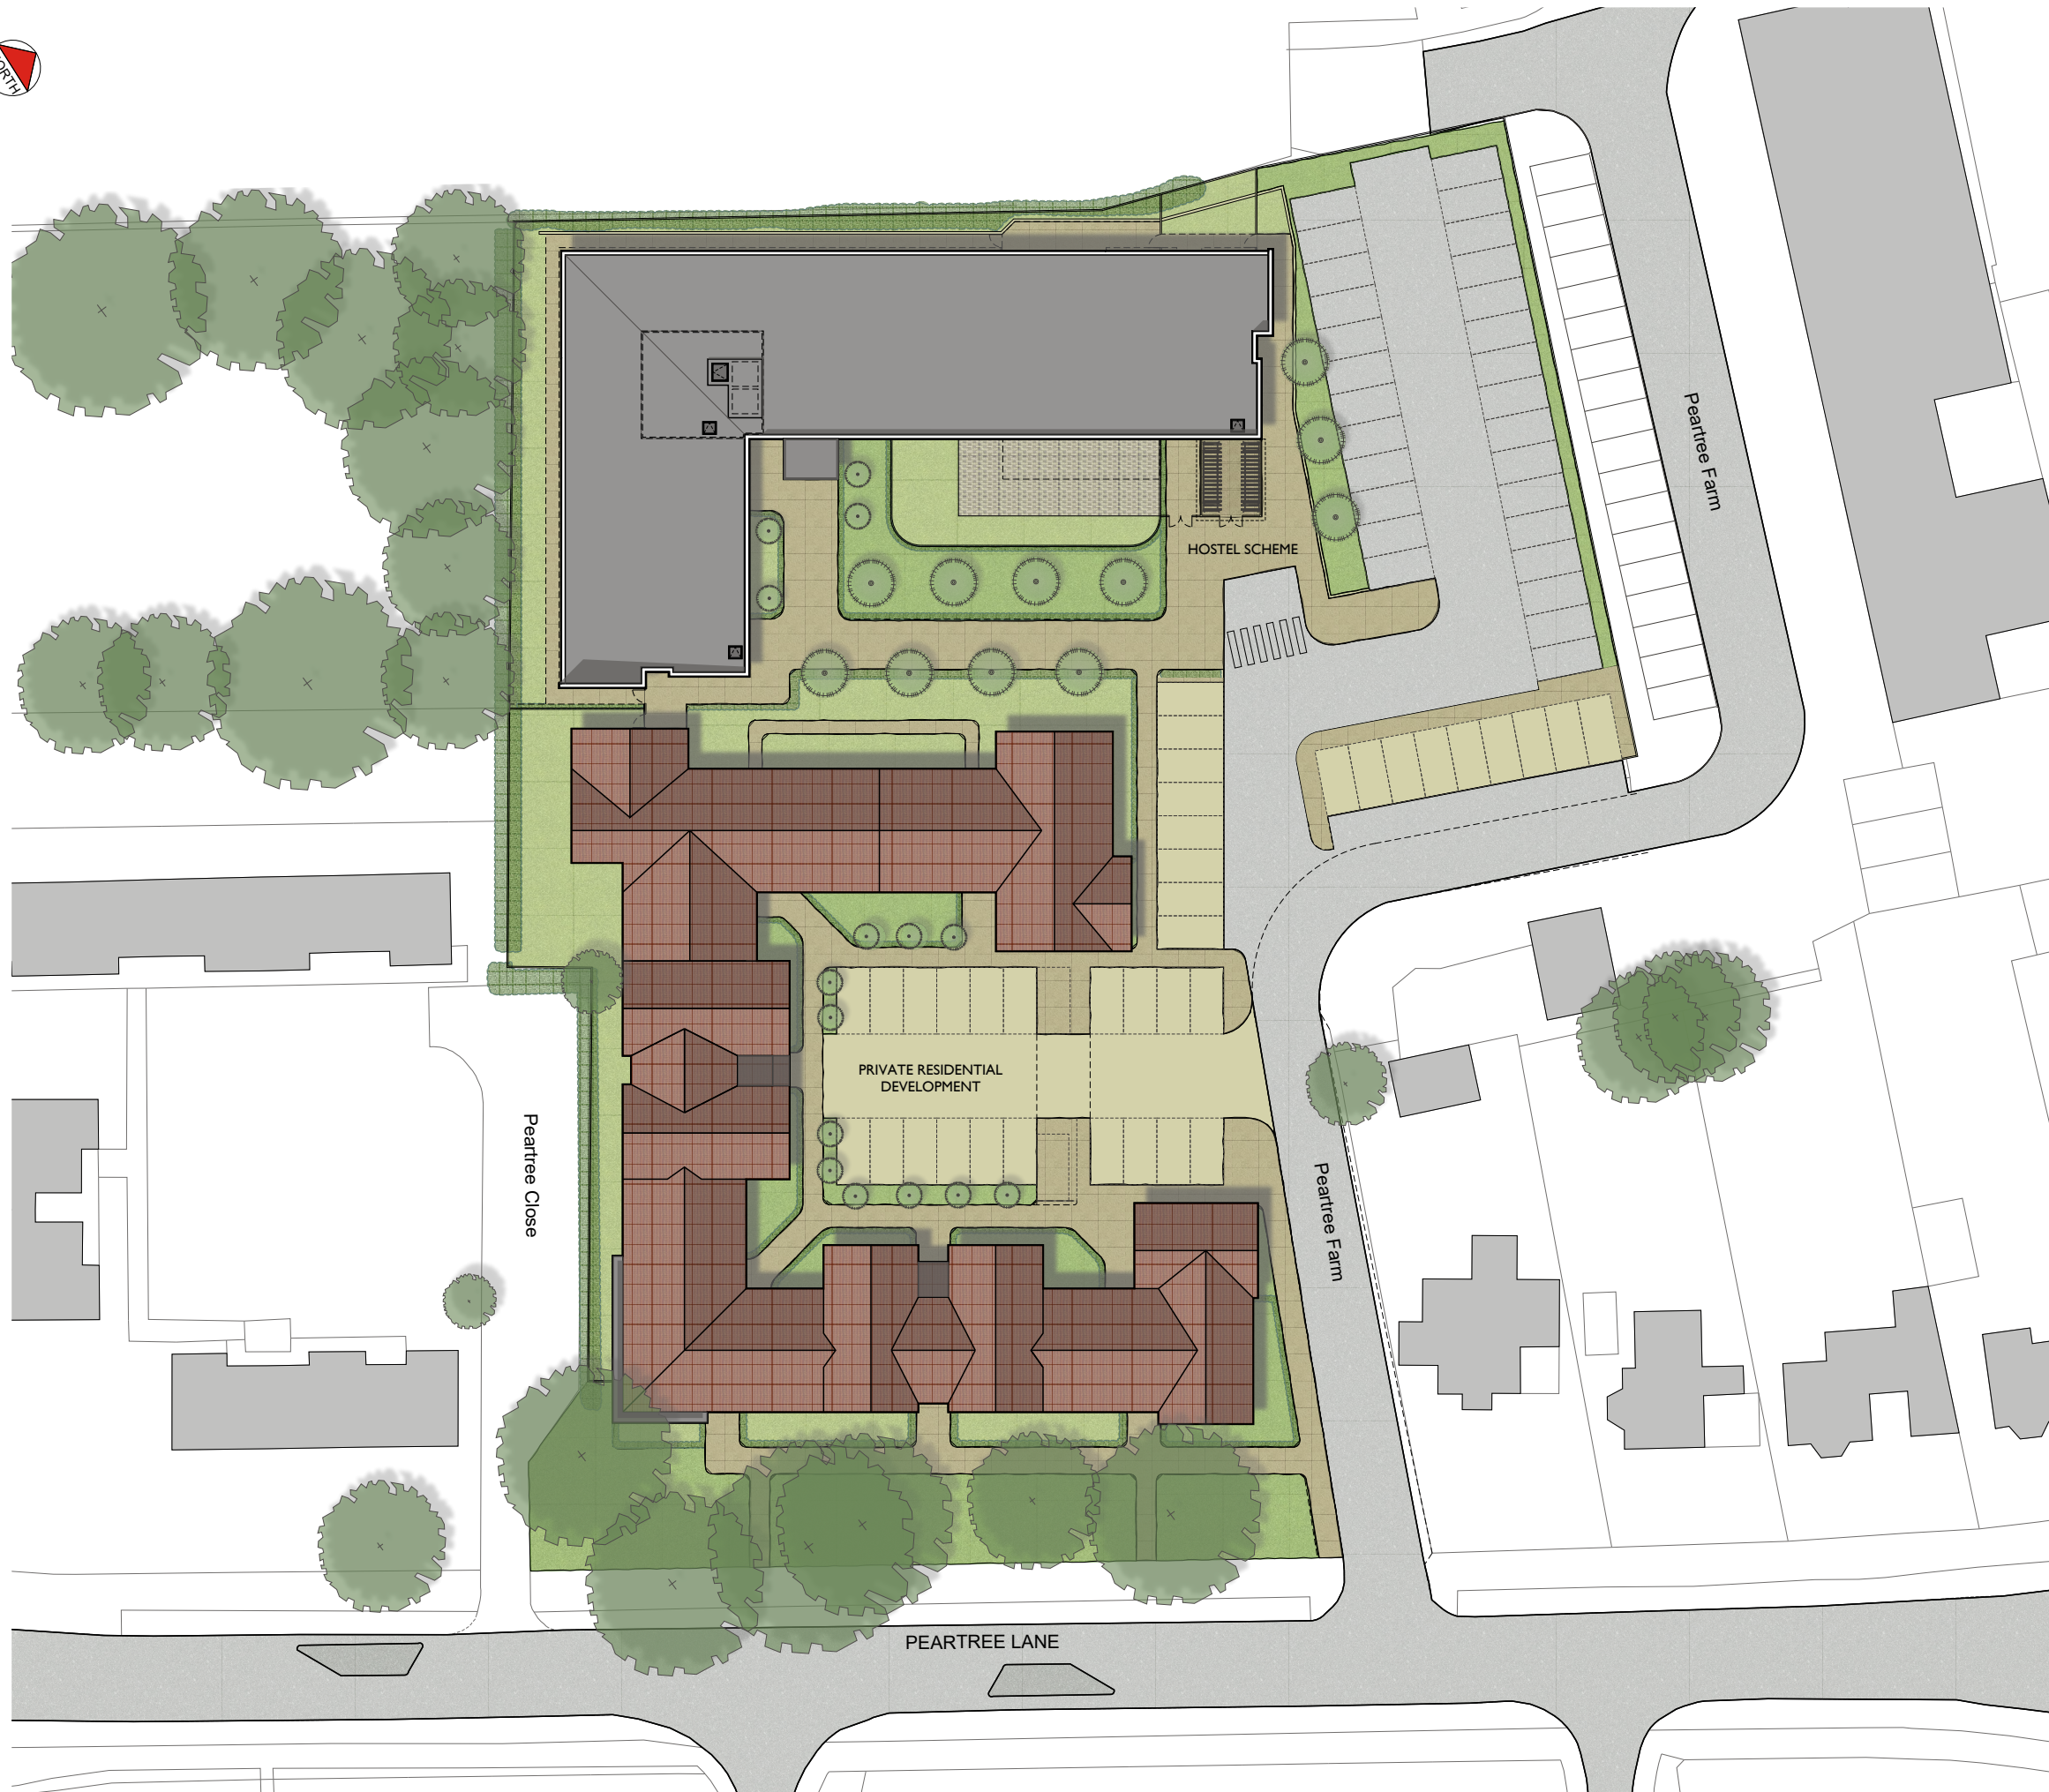
Drawing 1 – Proposed Development Plan

It is understood that the proposed development comprises the demolition of all structures at the Site and the construction of a four-storey 100 bed YMCA Hostel and a 2, 3 and 4 storey building providing up to 43 residential apartments as detailed in Welwyn Hatfield Borough Council Planning Application 6/2019/2714/OUTLINE. The Proposed Site Layout is included as Drawing 1.
