WHBC - New Deck Car Park, Campus West

Flood Risk Assessment and Drainage Strategy

Ref: 190997/A Marshall

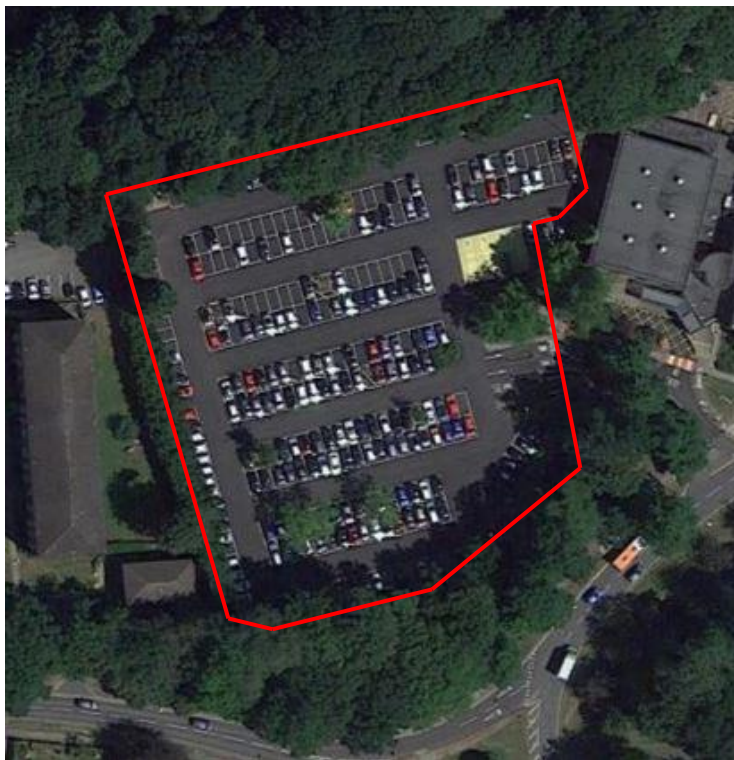
Figure 2.1 Site location plan

2.1.2 Refer to Figure 2.1 below for the application site boundary.

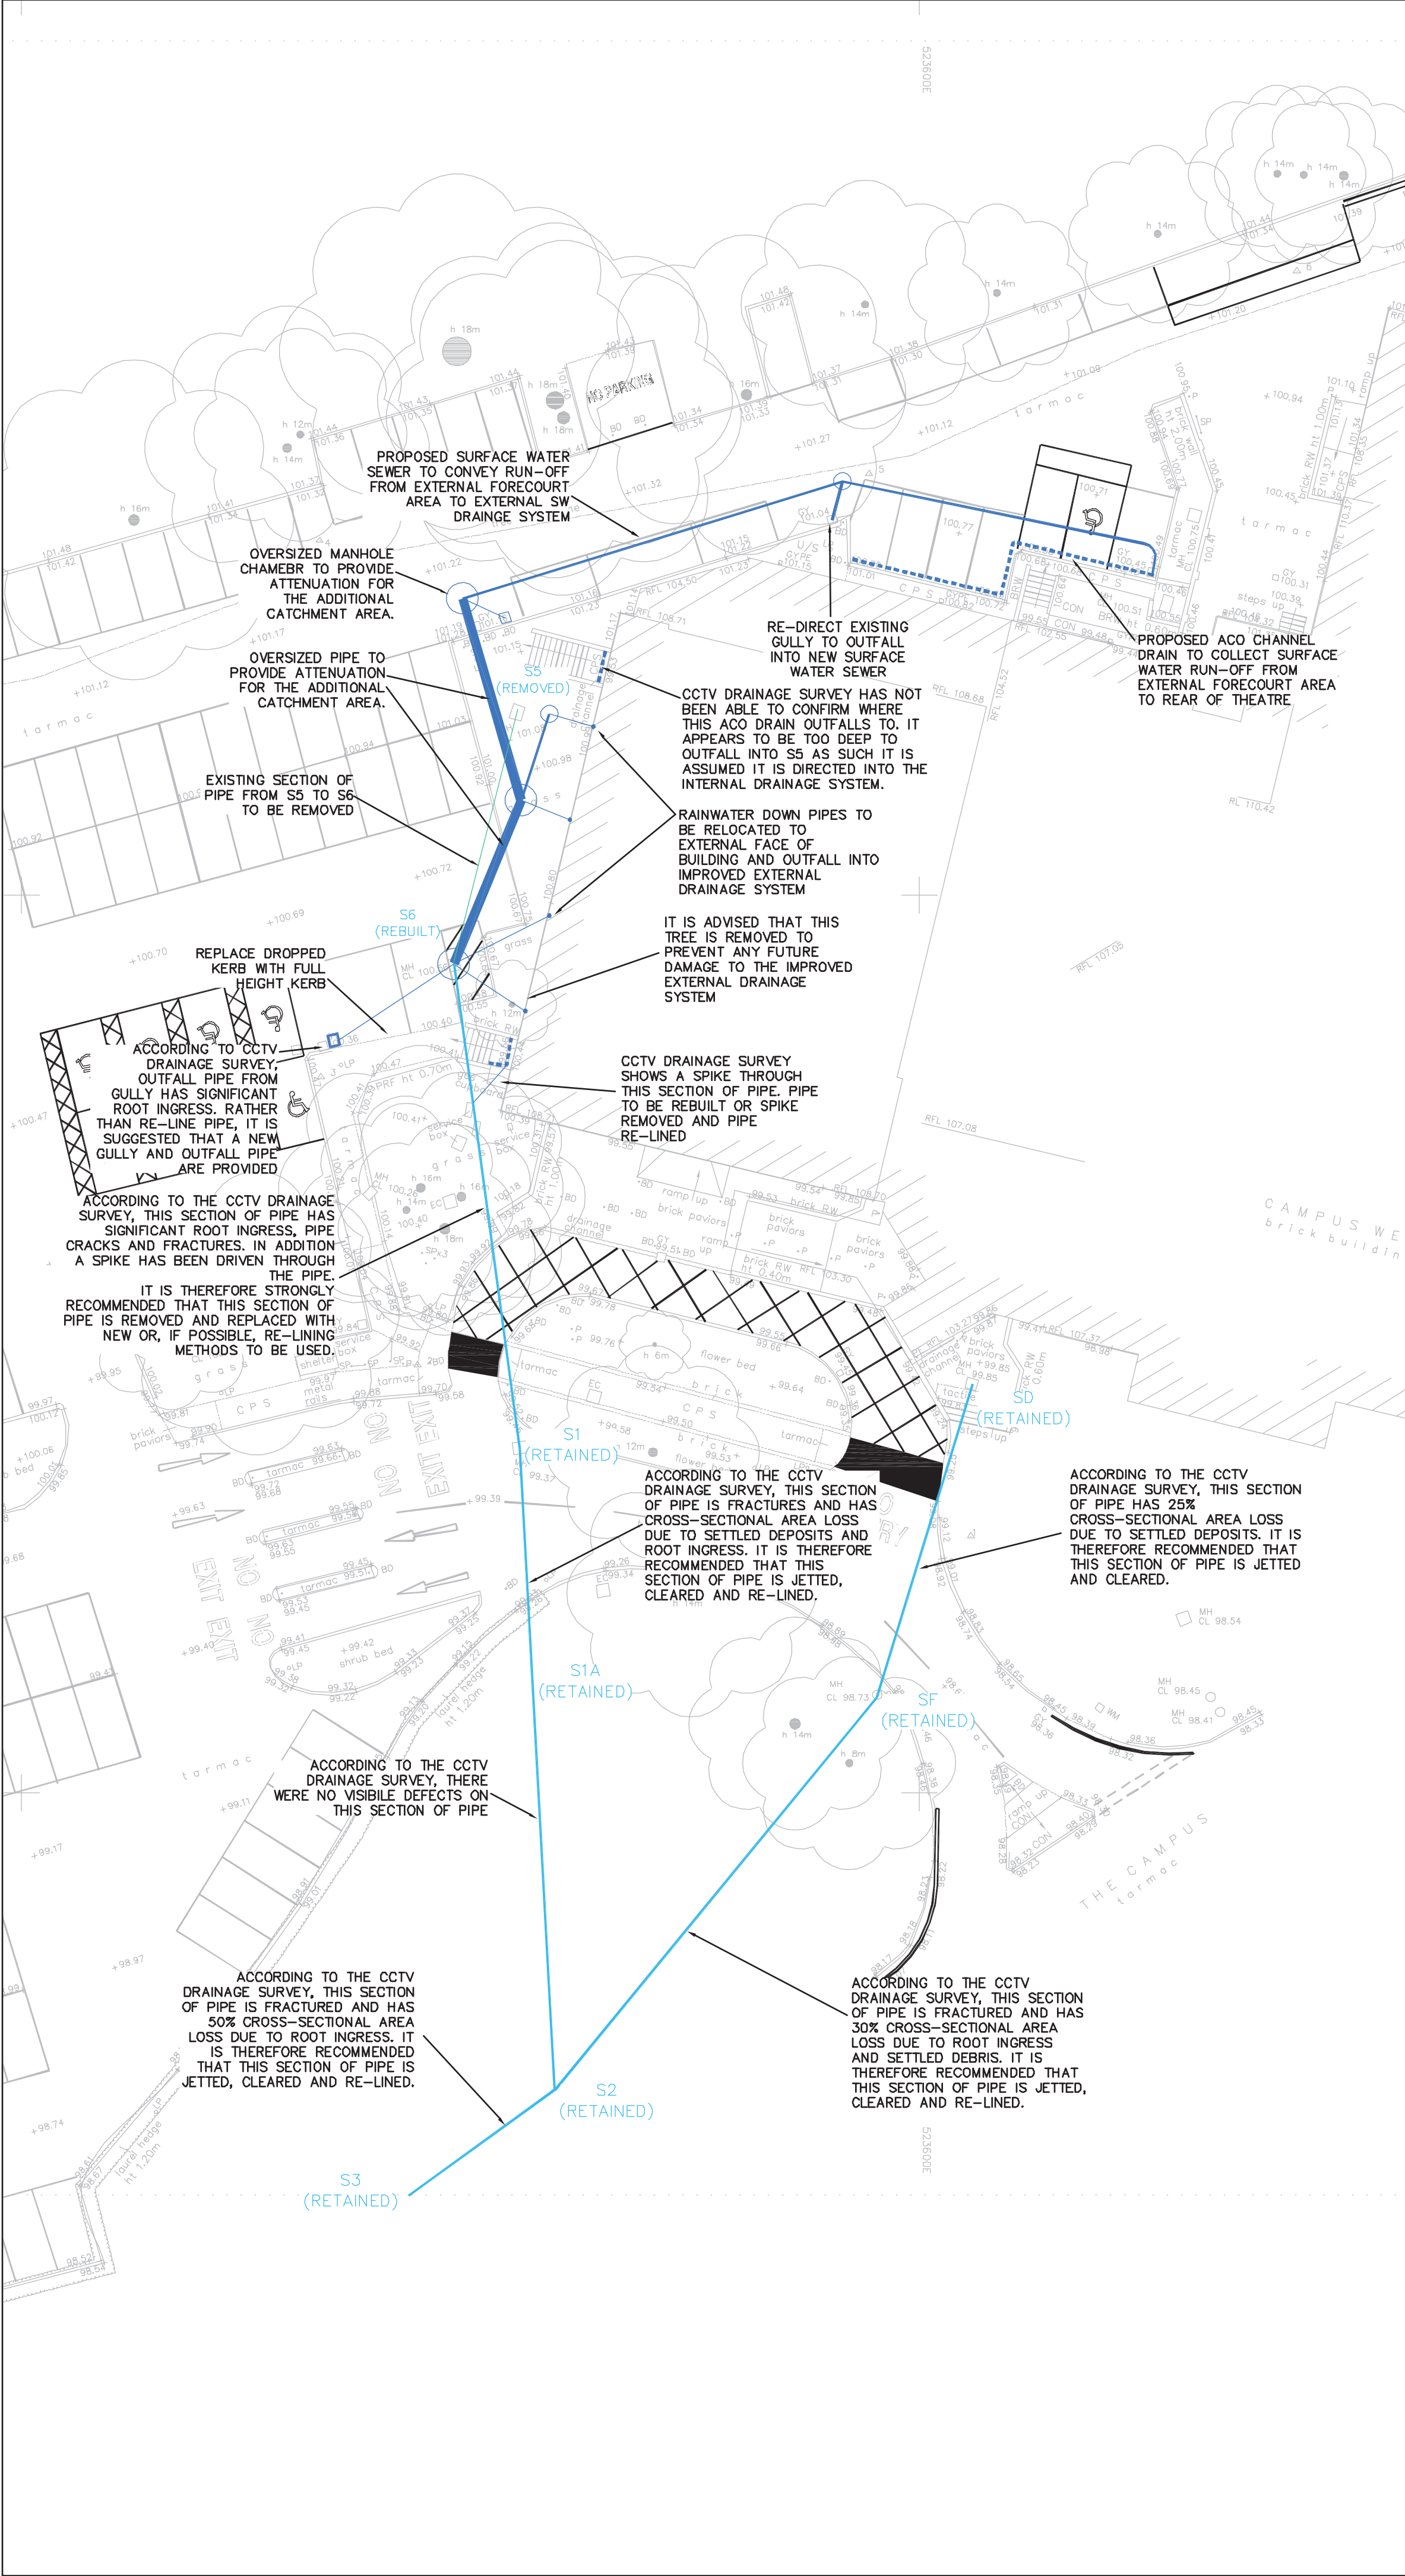
APPENDIX E – EAS DRAWING 2486-SK04

- 4.5.7 The proposed works identified on drawing 2486-SK04, which are due to be delivered in Sept / Oct 2020, include the provision of attenuation storage using oversized pipes and manholes, as well as the re-lining of damaged sections of pipe work.

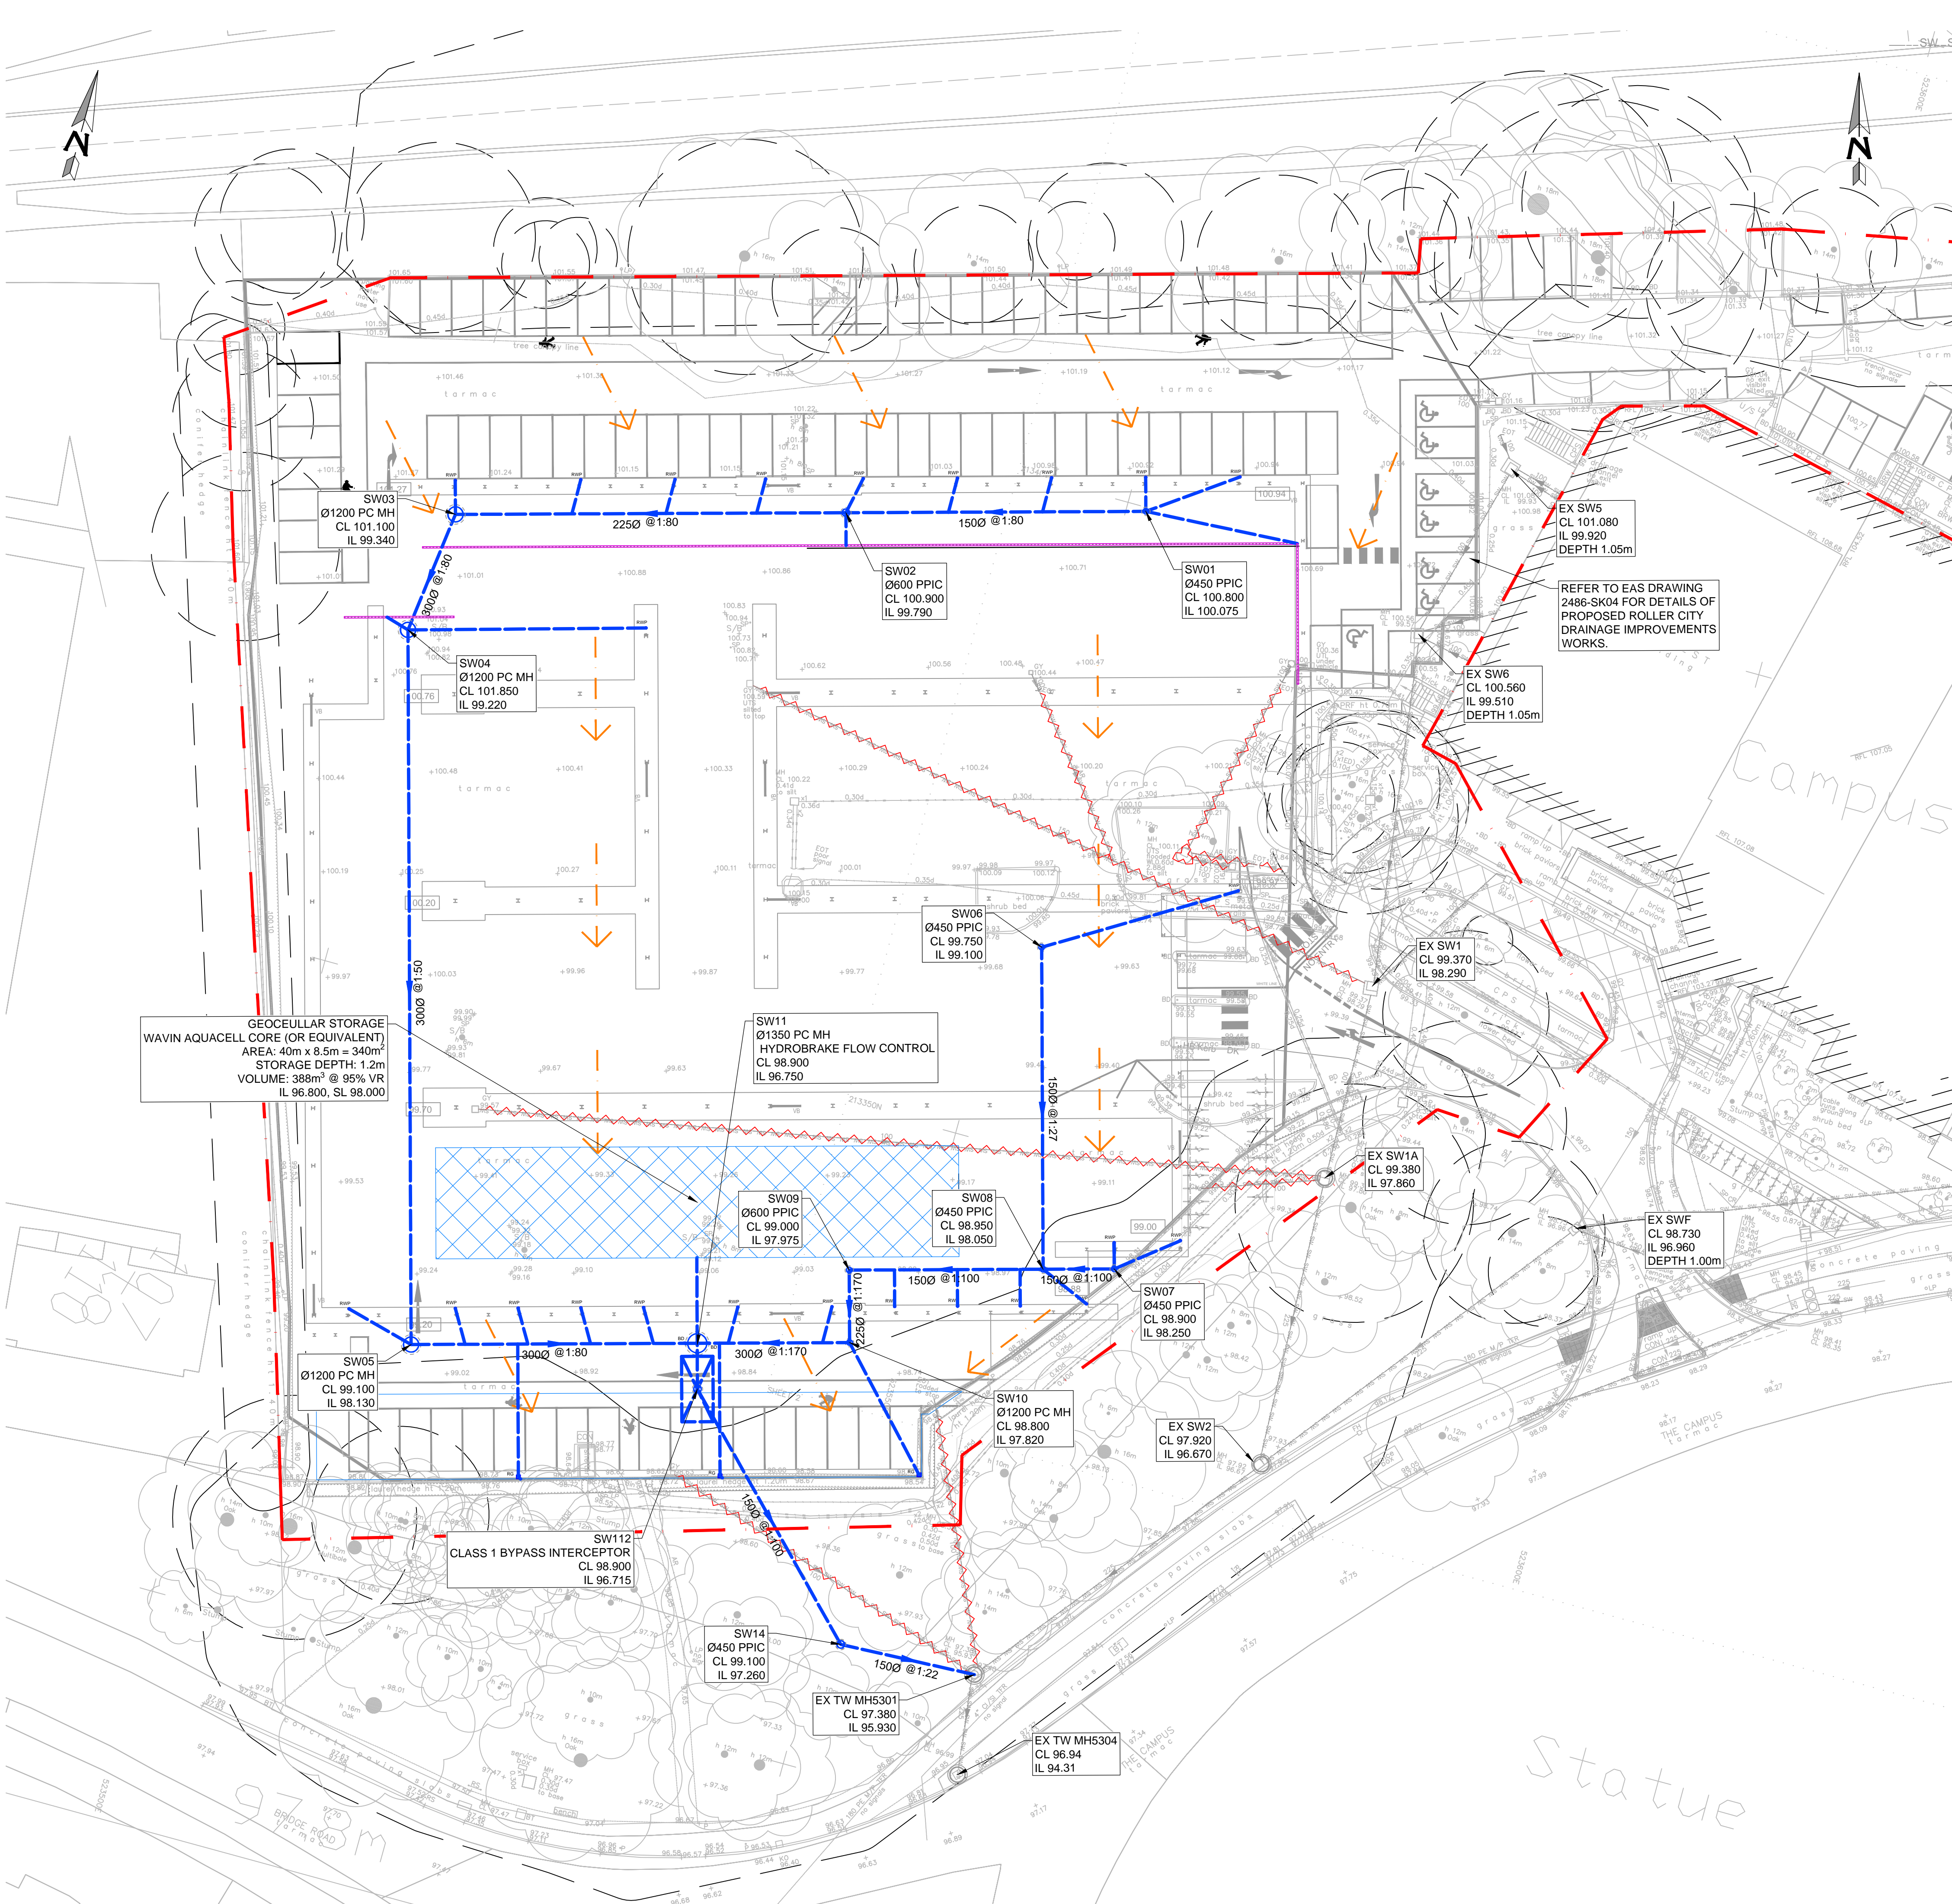
APPENDIX F – DRAINAGE STRATEGY

6.4.2 The scheme will incorporate catch pit manholes upstream of the geocellular storage structure to provide pre-treatment and sediment reduction. A class 1 bypass separator will be incorporated to ensure discharge concentrations do not exceed 5mg/litre of oil under normal conditions.
