12 Harpsfield Broadway

Budget Planned Maintenance Schedule

## **12 Harpsfield Broadway - Planned Maintenance Schedule**

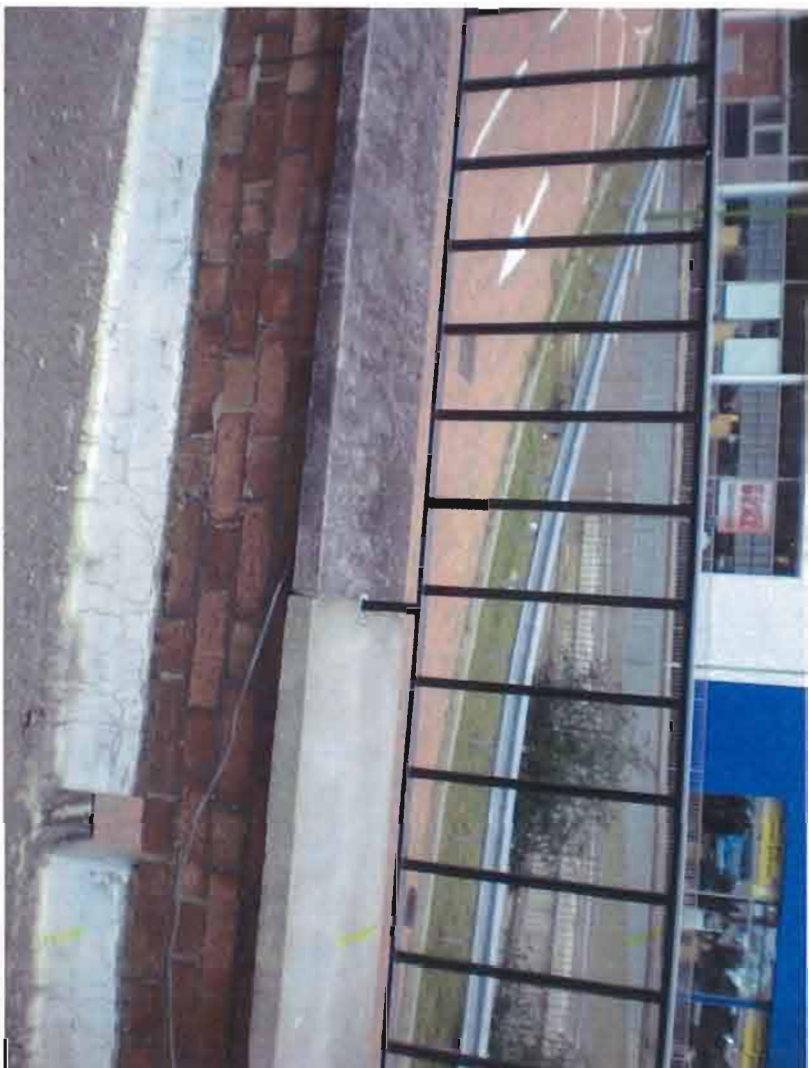
25	1 <sup>st</sup> floor roof/rear elevation – upstands	Cracking forming to upstands – Photo 29 & 30	Water penetration over time	Fill cracks and apply UV repellent paint to prolong life	B	1	1130
26	1 <sup>st</sup> floor roof/rear elevation	Paint to areas of railings becoming thin. – Photo 31 &	Metal work would deteriorate through exposure to elements	Metal work to be prepared and re painted.	B	1	500

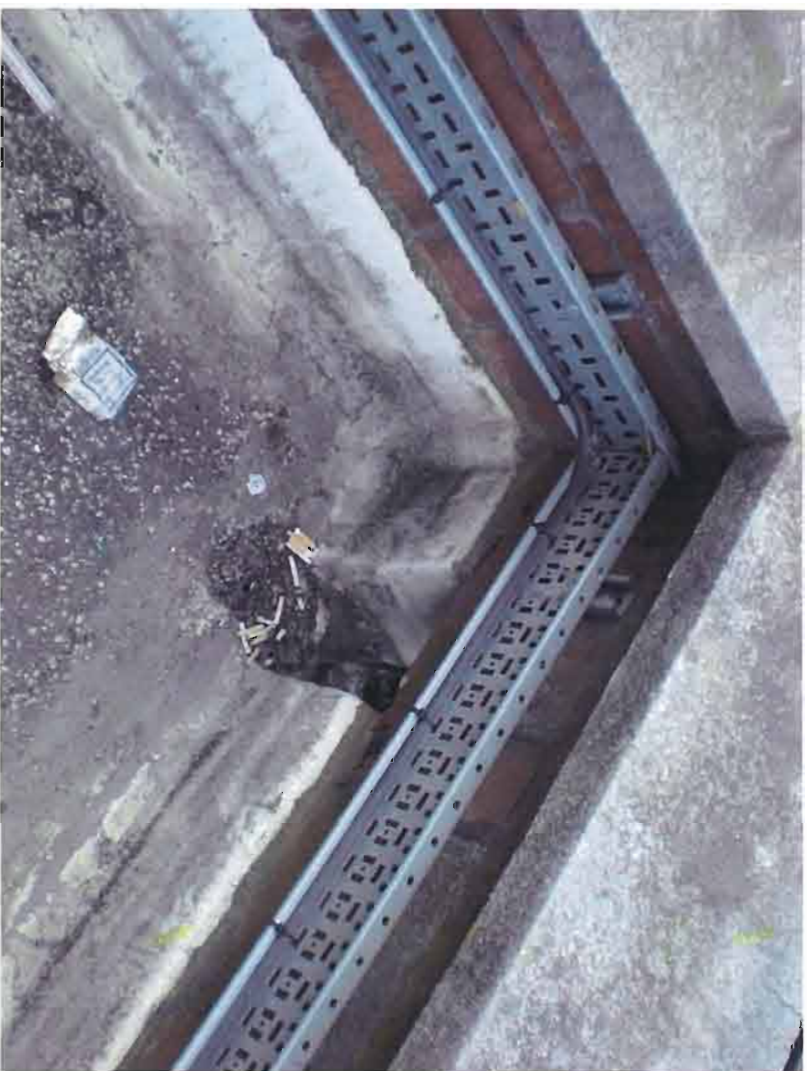
Item	Location	Issue	Risk	Works Required	Priority	Year	Cost (£)
		32					
27	1 <sup>st</sup> floor roof	Corner coping damaged. – Photo 33	Deterioration of coping and wall beneath.	Remove old coping and replace. (Note handrail to be removed to enable replacement to be fitted)	C	3	95
28	1 <sup>st</sup> floor roof	Drainage outlets by polycarbonate roof need cleaning – Photo 34	Rain water over flowing and causing damage to structure beneath	Clean rainwater hoppers	A	1	50
29	1 <sup>st</sup> floor roof	One coping above drain outlet needs replacing	Deterioration of coping and wall beneath.	Remove old coping and replace. (Note handrail to be removed to enable replacement to be fitted)	C	3	95
30	1 <sup>st</sup> floor roof/rear elevation	Lead flashing beneath concrete stairs has failed – Photo 35	Rain water penetrating into ground floor.	Re work or re place lead flashing.	A	1	175
31	1 <sup>st</sup> floor roof/rear elevation	Hairline cracking to concrete stair case – Photo 35	Water penetration to cracking causing concrete to blow.	Concrete staircase to be sealed.	C	2	235

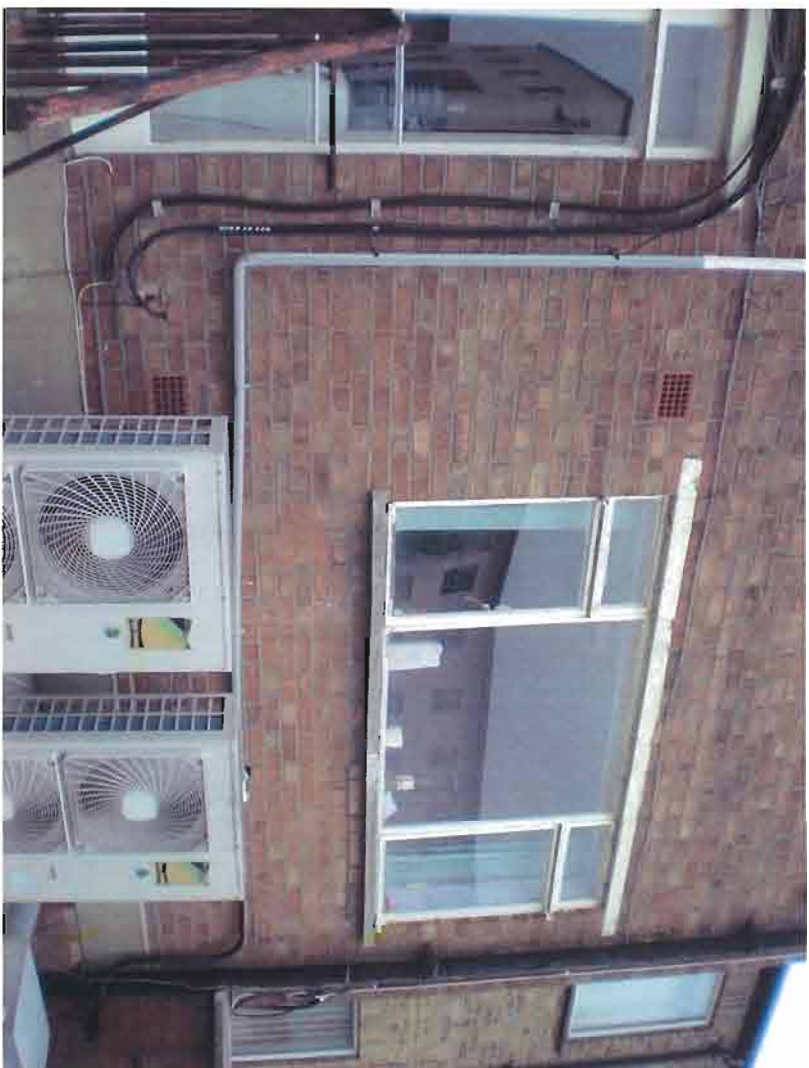
Item	Location	Issue	Risk	Works Required	Priority	Year	Cost (£)
34	1 <sup>st</sup> floor rear elevation	Mortar joints weathered at low level wall, in low level area. (Ventilation area for non foot traffic) – Photo 37	Risk of wall becoming unstable and failing	Rake out mortar joints and re point	C	3	200
35	1 <sup>st</sup> floor roof/rear elevation	Extractor ducting needs to be properly supported, in low level area. (Ventilation area for non foot traffic)	Point loads from feet will cause puncture to roof covering.	Investigate if puncturing has occurred and repair and place feet on appropriate supports.	B	1	370
	<b>1<sup>st</sup> and 2<sup>nd</sup> floor elevations from flat roof, accessed from 1<sup>st</sup> floor office</b>						
36	1 <sup>st</sup> and 2 <sup>nd</sup> floor roof/rear elevations	Cast iron down pipe and hopper discharging onto roof needs decoration – Photo 38	Deterioration of down pipe and hopper	Decoration of down pipe and hopper	B	1	45
