ARBORICULTURAL ASSESSMENT REPORT

| | Risk Address: | 10 Hook Lane, Northaw, Potters Bar, Hertfordshire, EN6 4DA |
| Refs: | PRI Ref: | 144074 |

| Arborist Name: | Will Hinde | Date: | 16 th March 2020 |

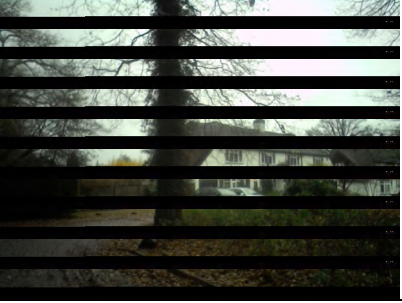
| <p>T1 - Oak (English)</p> | <p>Location of trees to LHS PH property, between PH fence and roadside ditch</p> |

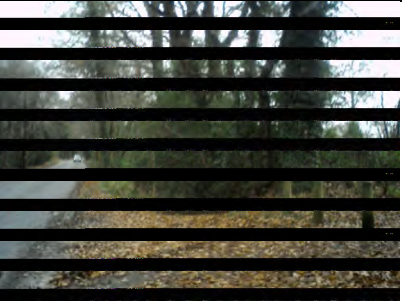
| <p>Location of trees to LHS PH property, between PH fence and mainly within boundary of roadside ditch</p> | <p>T2 - Oak (English)</p> |
