Forest Lodge
The Ridgeway
Cuffley
Hertfordshire

Survey of cracking in garage
and recommendation for amelioration

Heave / settlement damage
Tree survey

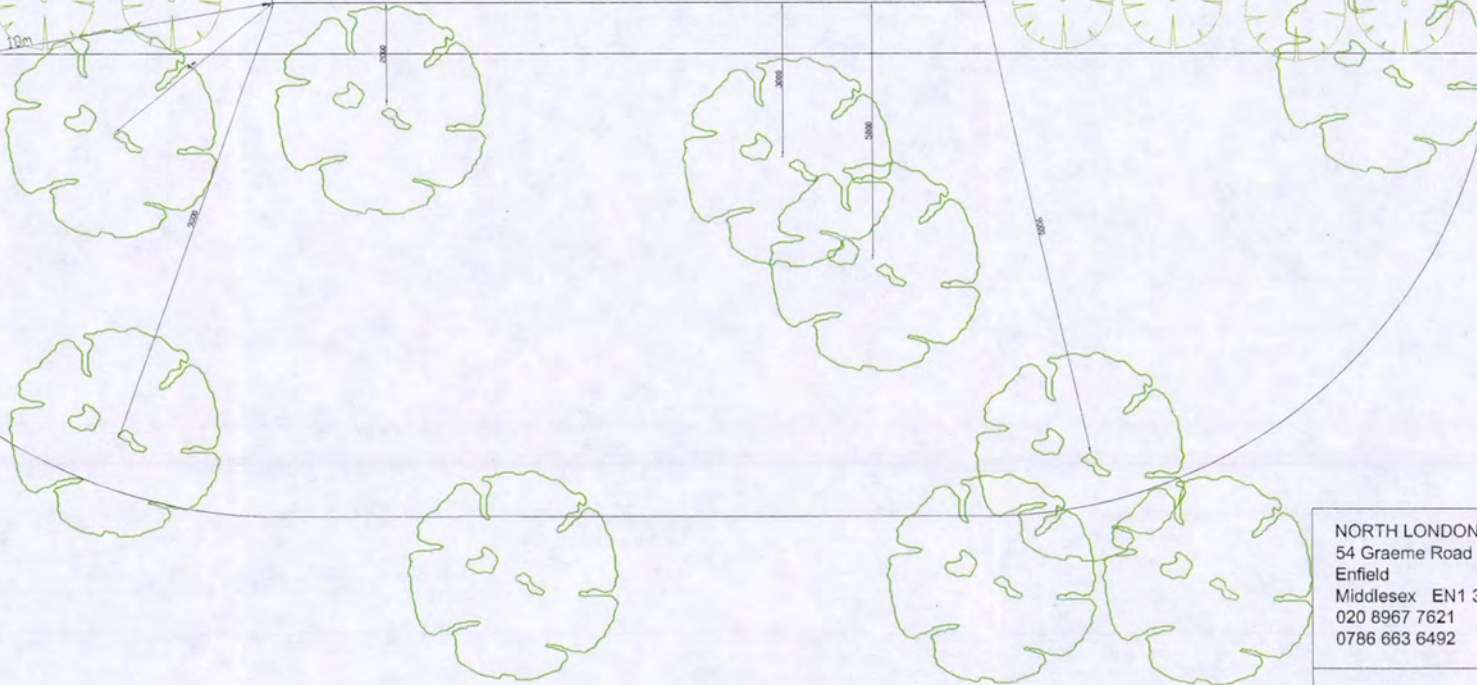
Beech trees are noted to have a moderate water demand and to reach a potential mature height of 20 metres. This may result in the shrinkage of soils at a foundation depth of 1 metre within a circle of 16 metres or so from the base of the tree.

The extent and distribution of the cracking within the rear wall of the garage demonstrates that the removal of moisture from the clay subsoil is causing shrinking of that clay subsoil along the entire rear wall foundation.

Numerous beech trees
