Project Name: <b>Comet Way Hatfield</b>	Project Number:	Date: <b>13/06/2018</b>	Contact:	
--	-----------------	----------------------------	----------	--

#### Survey 1 - S3 downstream to HD1002

#### Survey 2 - S3 upstream to S4

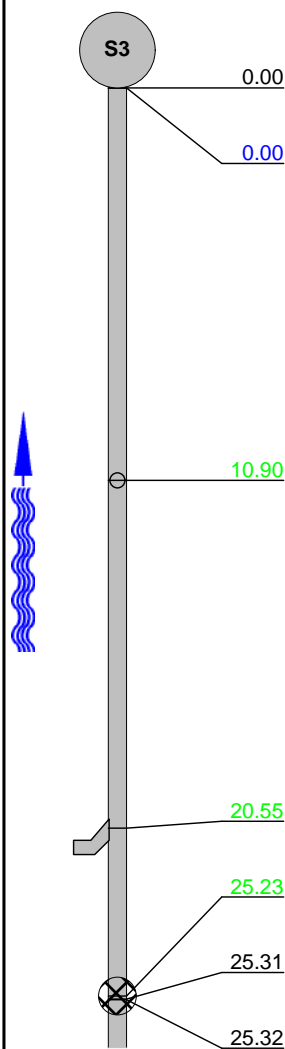
This drain run is structurally sound and in good order. Manhole S4 was however found to be buried. Sonar tracing was carried out with the location area of the manhole being marked with blue paint.

0.00	ST	ST: Start of survey	(Misc) 0
	0.00	WL	WL: Water level 10%	(Serv) 0
	10.90	JN	JN: Junction from 12 O'Clock 150 mm diameter	(Constr) 0
	20.55	JN	JN: Junction from 1 O'Clock 150 mm diameter	(Constr) 0
	25.23	MH	MH: Manhole S4	(Constr) 0
	25.31	FH	FH: Finish survey	(Misc) 0
	25.32	GP	General condition photograph	(Misc) 0
