Project Name: Comet Way Hatfield	Project Number:	Date: 13/06/2018	Contact:	
--	-----------------	----------------------------	----------	--

Survey 1 - S3 downstream to HD1002

Survey 2 - S3 upstream to S4

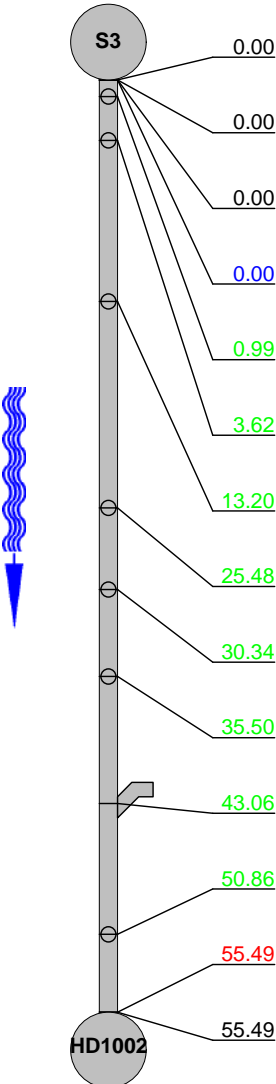
GP	General condition photograph	(Misc) 0

GP	General condition photograph	(Misc) 0	
	ST	ST: Start of survey	(Misc) 0

WL	WL: Water level 10%	(Serv) 0	
	CN	CN: Connection from 12 O'Clock 150 mm diameter	(Constr) 0

CN	CN: Connection from 12 O'Clock 150 mm diameter	(Constr) 0	
	JN	JN: Junction from 12 O'Clock 150 mm diameter	(Constr) 0

JN	JN: Junction from 12 O'Clock 150 mm diameter	(Constr) 0	
	JN	JN: Junction from 12 O'Clock 150 mm diameter	(Constr) 0

JN	JN: Junction from 12 O'Clock 150 mm diameter	(Constr) 0	
	JN	JN: Junction from 11 O'Clock 150 mm diameter	(Constr) 0	
	CN	CN: Connection from 12 O'Clock 150 mm diameter Slightly Protruding	(Constr) 0	
	JDL	JDL: Joint displaced, large (over 1.5 times the pipe wall thickness)	(Struct) 1	
	FH	FH: Finish survey Risk of getting camera stuck	(Misc) 0
