Project-informationProject name :
37200367 - Queenswood School, HatProject Number :
37200367Contact :
Emma DoughtyDate :
22/05/2017

Draincare Ltd has been requested to undertake an investigation of the drainage at the above site.

OUTLINE DRAINAGE PLAN A – QUEENSWOOD SCHOOL

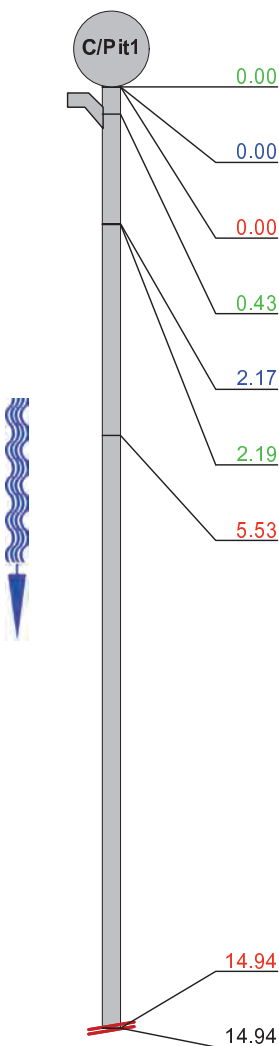
0.00	CP	Start node type, catchpit reference number: C/Pit1		(Constr) 0
	0.00	WL	Water level 0 % of the vertical dimension		(Serv) 0
	0.00	FM	Fracture, multiple, from 12 O'Clock to 12 O'Clock		(Struct) 3
	0.43	JN	Junction from 3 O'Clock diameter: 150 mm - RWDP		(Constr) 0
	2.17	RTJ	Roots, tap at joint		(Serv) 3
	2.19	SR	Sealing ring intruding from 9 O'Clock to 3 O'Clock		(Constr) 1
	5.53	FM	Fracture, multiple, from 12 O'Clock to 12 O'Clock		(Struct) 3
	14.94	B	Broken pipe, from 12 O'Clock to 12 O'Clock	6_6_31_A.jpg	(Struct) 4
	14.94	SA	Survey abandoned - Unable to pass broken pipe		(Misc) 0

Structural Defects					Constructional Features				
Service Defects					Miscellaneous Features				
STR no def	STR peak	STR mean	STR total	STR grade	SER no def	SER peak	SER mean	SER total	SER grade
4	80	16.4	245	4	0	0	0	0	1

Photo: 6_6_31_A.jpg, 00:01:28
 14.94m, Broken pipe, from 12 O'Clock to 12 O'Clock

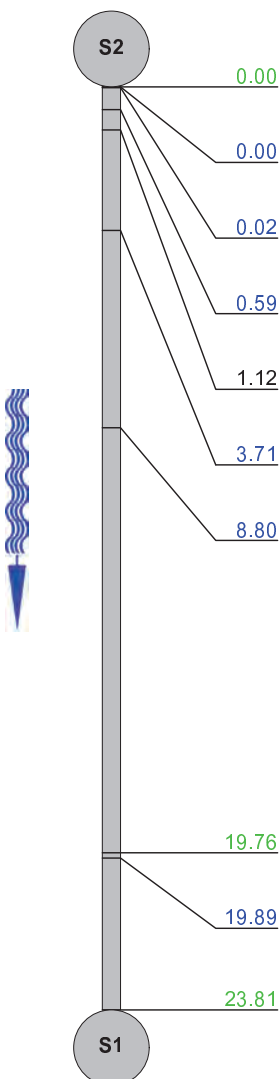
S2			
0.00	MH	Start node type, manhole reference number: S2		(Constr) 0
0.00	WL	Water level 20 % of the vertical dimension		(Serv) 0
0.02	LR	Line deviates right		(Serv) 0
0.59	WL	Water level 30 % of the vertical dimension		(Serv) 0
1.12	CUW	Loss of vision, camera under water		(Misc) 0
3.71	WL	Water level 10 % of the vertical dimension		(Serv) 0
8.80	WL	Water level 0 % of the vertical dimension		(Serv) 0
19.76	SR	Sealing ring intruding from 12 O'Clock to 4 O'Clock		(Constr) 1
19.89	LR	Line deviates right		(Serv) 0
23.81	MHF	Finish node type, manhole reference number: S1		(Constr) 0
S1				
Depth: 1.1

Structural Defects					Constructional Features				
Service Defects					Miscellaneous Features				
STR no def	STR peak	STR mean	STR total	STR grade	SER no def	SER peak	SER mean	SER total	SER grade
1	5	0.21	5	1	0	0	0	0	1
