# ARBORICULTURAL ASSESSMENT REPORT

<b>For:</b>	<b>Client:</b>	Sedgwick International UK
	<b>Insurer:</b>	Axa Insurance
<b>Site:</b>	<b>Policyholder:</b>	Mr Wadmore
	<b>Risk Address:</b>	10 Hook Lane, Northaw, Potters Bar, Hertfordshire, EN6 4DA
<b>Refs:</b>	<b>PRI Ref:</b>	118020
	<b>Client Ref:</b>	6873723
	<b>Insurer Ref:</b>	12125047A

<b>Arborist Name:</b>	Sarah MacKinnon	<b>Date:</b>	07/12/2018
<b>QC</b>	Margaret MacQueen	<b>Date</b>	20/12/2018

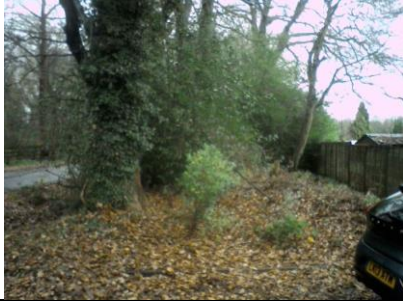
<p>T1 - Oak (English)</p>	<p>Location of trees to LHS PH property, between PH fence and roadside ditch</p>

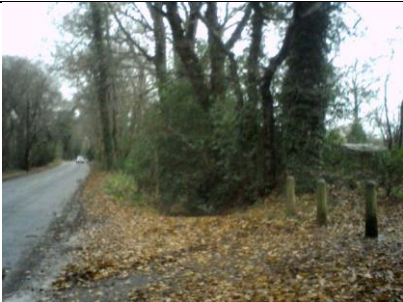
<p>Location of trees to LHS PH property, between PH fence and mainly within boundary of roadside ditch</p>	<p>T2 - Oak (English)</p>
