## COLLAPSED GARDENERS STORE | NORTHAW HOUSE PLANNING & HERITAGE STATEMENT

July 2022

Issue 1

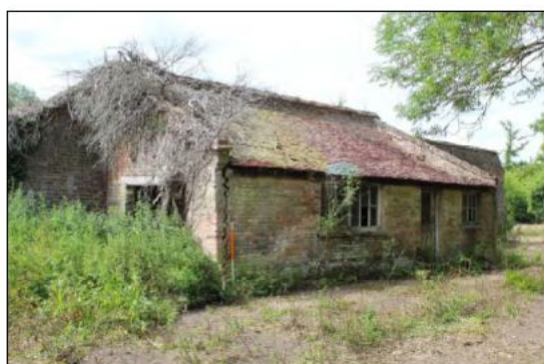
- 4.101 Outbuilding 2 (Photos 146 and 147) comprises a mono-pitched roof structure that is abutted to the northern wall of the Walled Garden. The building incorporates a large opening within the eastern elevation, possibly for the ingress and egress of larger garden equipment, whilst the northern elevation incorporates a single doorway and two casement windows to each of the two internal rooms. The structure is constructed of brick, laid in English bond. Each gable end of the roof incorporates a small, brick parapet.

Photo 146: Overview of eastern and northern elevations of Outbuilding 2

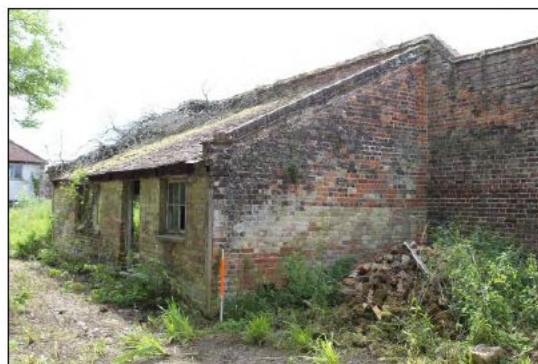
Photo 147: Overview of western and northern elevations of Outbuilding 2
