MSCP Welwyn Garden City

**Proposed Surface Water Drainage Technical Note
and Maintenance Regime**

Document №: BWG-AKSW-XX-XX-RP-C-0001

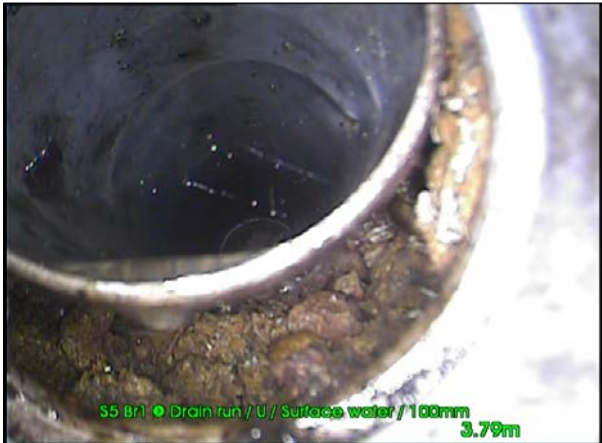
Place : Welwyn Garden city	Road : Campus West Car park	Date : 19/06/2019	Section number : 3	PLR Suffix : X
--------------------------------------	---------------------------------------	-----------------------------	------------------------------	--------------------------

Section 3: Manhole S5 along Branch Br1 upstream to Rwdp K - displaced joint found where pipe diameter reduces to 55mm causing survey to cease due to camera unable to pass displaced joint. Rwdp K tested to confirm running clear into S5.

Photo: 4_4_20_A.jpg, 00:01:36

3.91m, Survey abandoned - unable to continue due to displaced joint & reduction in pipe diameter

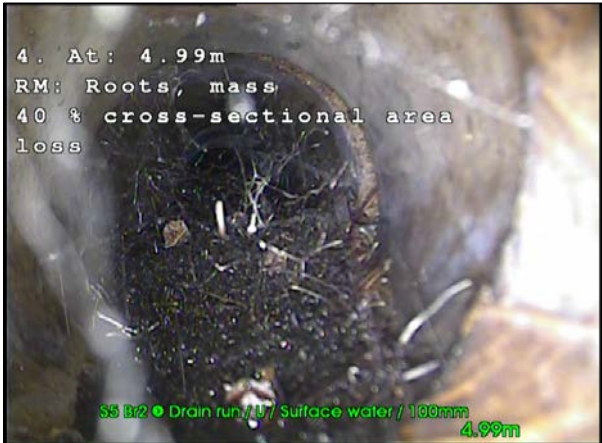
Place : Welwyn Garden city	Road : Campus West Car park	Date : 19/06/2019	Section number : 4	PLR Suffix : X
--------------------------------------	---------------------------------------	-----------------------------	------------------------------	--------------------------

Section 4: Manhole S5 along Branch Br2 upstream to Rwdp L - substantial root ingress found within, high pressure jetting to be undertaken to clean & facilitate re-survey.

Photo: 5_5_24_A.jpg, 00:00:37

4.99m, Roots, mass 40 % cross-sectional area loss

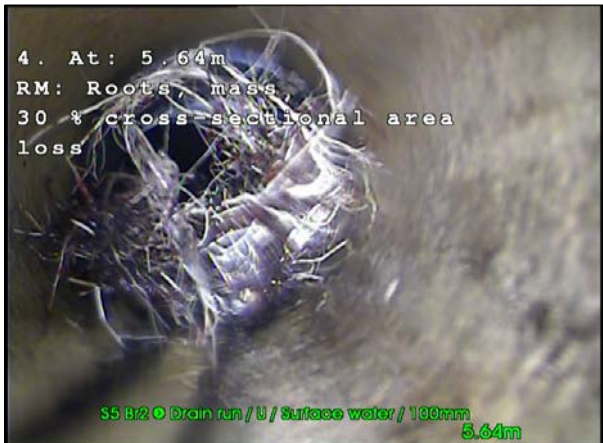
Place : Welwyn Garden city	Road : Campus West Car park	Date : 19/06/2019	Section number : 5	PLR Suffix : X
--------------------------------------	---------------------------------------	-----------------------------	------------------------------	--------------------------

Section 5: Manhole S5 along Branch Br2 upstream to Rwdp L following high pressure jetting works - substantial root ingress still found within, further high pressure jetting to be undertaken to clean & facilitate re-survey.

Photo: 6_6_29_A.jpg, 00:00:43

5.64m, Roots, mass 30 % cross-sectional area loss

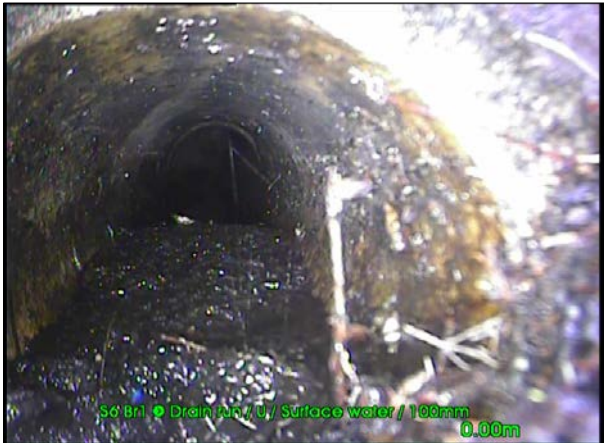
Place : Welwyn Garden city	Road : Campus West Car park	Date : 19/06/2019	Section number : 8	PLR Suffix : X
--------------------------------------	---------------------------------------	-----------------------------	------------------------------	--------------------------

Section 8: Manhole S6 along Branch Br1 to Rwdp M - root ingress and settled deposits found within, high pressure jetting to be undertaken to clean & facilitate re-survey.

Photo: 9_9_448_A.jpg, 00:00:12

0.17m, Settled deposits, fine, 35% cross-sectional area loss

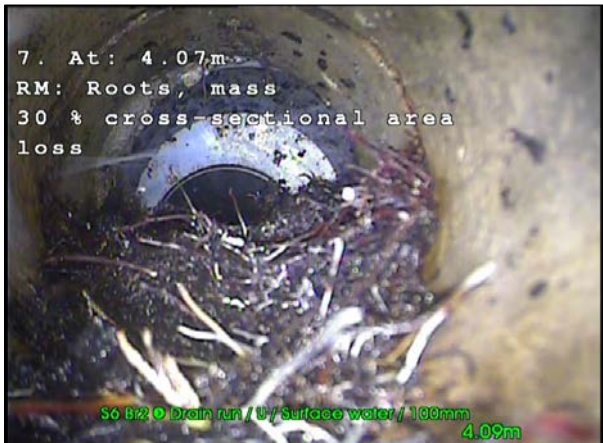
Place : Welwyn Garden city	Road : Campus West Car park	Date : 19/06/2019	Section number : 9	PLR Suffix : X
--------------------------------------	---------------------------------------	-----------------------------	------------------------------	--------------------------

Section 9: Manhole S6 along Branch Br2 upstream to Rwdp N - crack and substantial root ingress found within, high pressure jetting to be undertaken to clean & facilitate re-survey.

Photo: 10_10_62_A.jpg, 00:00:48

4.07m, Roots, mass 30 % cross-sectional area loss

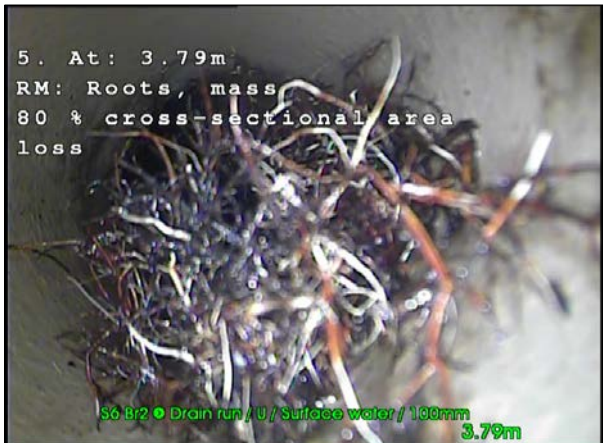
Place : Welwyn Garden city	Road : Campus West Car park	Date : 19/06/2019	Section number : 11	PLR Suffix : X
--------------------------------------	---------------------------------------	-----------------------------	-------------------------------	--------------------------

Section 11: Manhole S6 along Branch Br2 upstream to Rwdp N following high pressure jetting works - crack and substantial root ingress still found within, further high pressure jetting to be undertaken to clean & facilitate re-survey.

Photo: 12_12_75_A.jpg, 00:00:25

3.79m, Roots, mass 80 % cross-sectional area loss

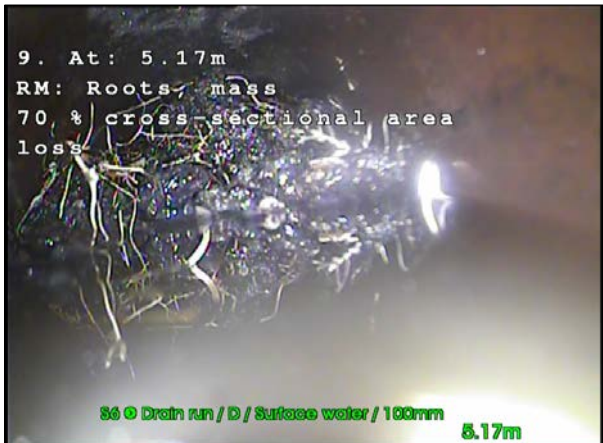
Place : Welwyn Garden city	Road : Campus West Car park	Date : 19/06/2019	Section number : 14	PLR Suffix : X
--------------------------------------	---------------------------------------	-----------------------------	-------------------------------	--------------------------

Section 14: Manhole S6 downstream to Manhole S1 - settled deposits, medium displaced joint and substantial root ingress found within, high pressure jetting to be undertaken to clean & facilitate re-survey.

Photo: 15_15_102_A.jpg, 00:00:49

5.17m, Roots, mass 70 % cross-sectional area loss

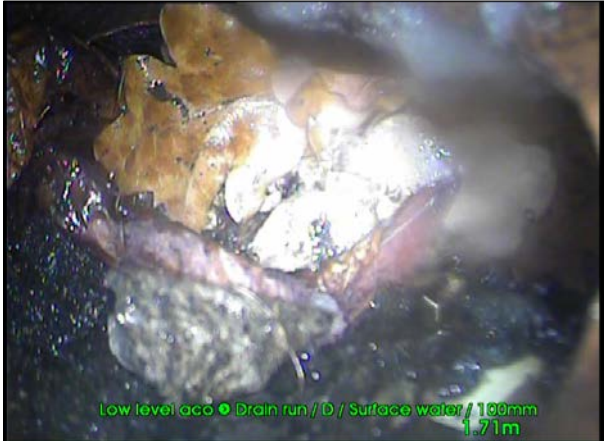
Place : Welwyn Garden city	Road : Campus West Car park	Date : 19/06/2019	Section number : 15	PLR Suffix : X
--------------------------------------	---------------------------------------	-----------------------------	-------------------------------	--------------------------

Section 15: Low Level Aco downstream to Blind Junction on to pipework between S6 & S1 - pipework between S6 & S1 found to be full of silt debris.

Photo: 16_16_463_A.jpg, 00:01:18

1.73m, Finish node type, major connection without manhole
 reference number: Blind junction on to pipework between S6 &
 S1 (pipework between S6 & S1 full of silt)

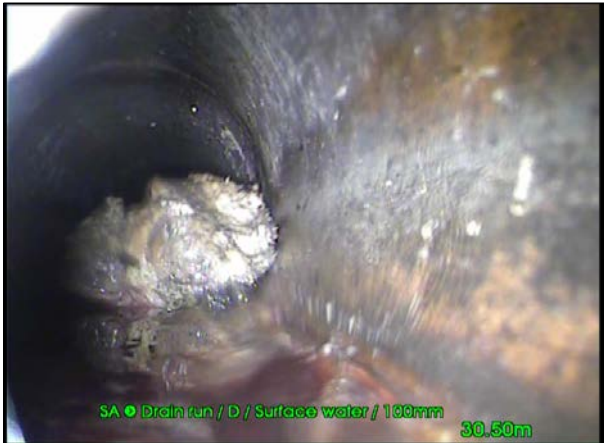
Place : Welwyn Garden city	Road : Campus West Car park	Date : 19/06/2019	Section number : 18	PLR Suffix : X
--------------------------------------	---------------------------------------	-----------------------------	-------------------------------	--------------------------

Section 18: Manhole SA downstream through internal Manholes SB, SC & SD (no Manhole SE) to Manhole SF - settled deposits found within, high pressure jetting to be undertaken to clean & facilitate re-survey.

Photo: 19_19_477_A.jpg, 00:08:06

29.21m, Settled deposits, other, 25% cross-sectional area
loss, Start (loose / pushed)

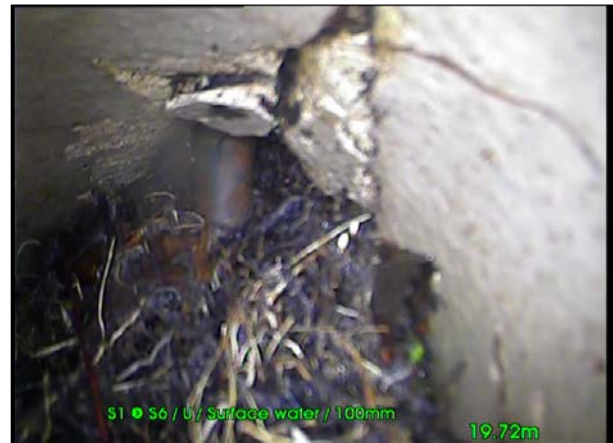
Section 21: Manhole S1 upstream to Manhole S6 following high pressure jetting works - root ingress, broken pipe, hole in pipe, fracture, crack and rod / spike protruding through pipe from 12 O'Clock to 6 O'Clock, further high pressure jetting to be undertaken to clean & facilitate re-survey.

Photo: 22_22_181_A.jpg, 00:02:52

19.75m, Other obstacles protruding through wall, at 12 o'clock, 40% cross-sectional area loss

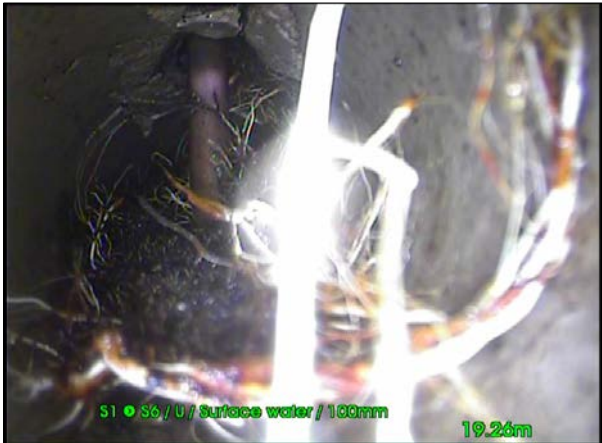
Place : Welwyn Garden city	Road : Campus West Car park	Date : 20/06/2019	Section number : 22	PLR Suffix : X
--------------------------------------	---------------------------------------	-----------------------------	-------------------------------	--------------------------

Section 22: Manhole S1 upstream to Manhole S6 following further high pressure jetting works - root ingress, broken pipe, hole in pipe, fracture and rod / spike protruding through pipe from 12 O'Clock to 6 O'Clock, further high pressure jetting to be undertaken to clean & facilitate re-survey.

Photo: 23_23_196_A.jpg, 00:02:08

19.2m, Other obstacles protruding through wall, at 12 o'clock,
40% cross-sectional area loss (rod / spike)

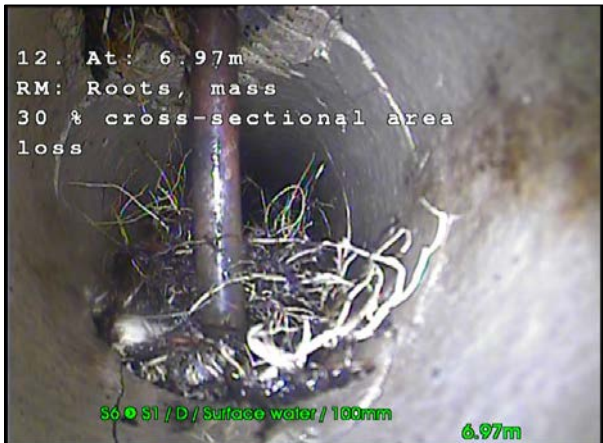
Place : Welwyn Garden city	Road : Campus West Car park	Date : 20/06/2019	Section number : 24	PLR Suffix : X
--------------------------------------	---------------------------------------	-----------------------------	-------------------------------	--------------------------

Section 24: Manhole S6 downstream to Manhole S1 following further high pressure jetting works - root ingress, broken pipe, hole in pipe, fractures and rod / spike protruding through pipe from 12 O'Clock to 6 O'Clock, further high pressure jetting to be undertaken to clean & facilitate re-survey.

Photo: 25_25_215_A.jpg, 00:01:21

6.97m, Roots, mass 30 % cross-sectional area loss

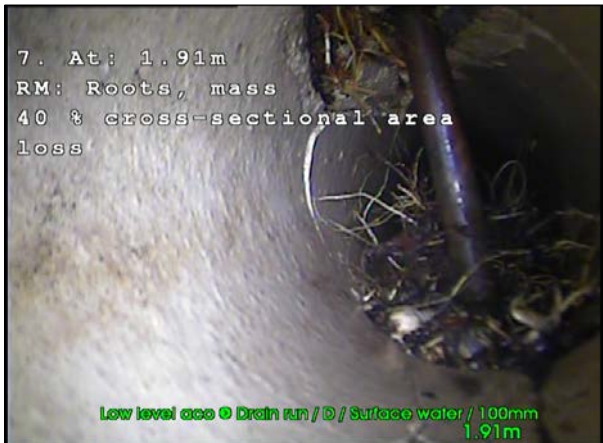
Photo: 26_26_223_A.jpg, 00:00:27

1.91m, Roots, mass 40 % cross-sectional area loss

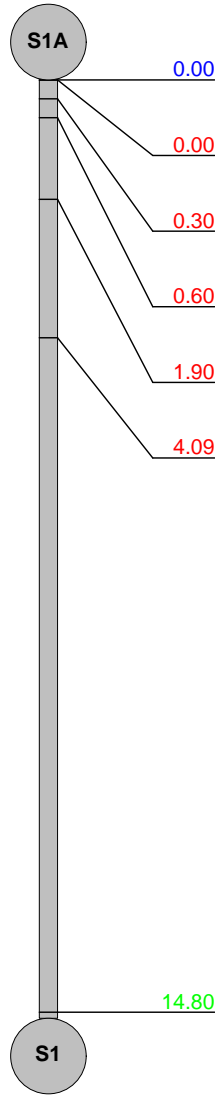
RF	Roots, fine		(Serv) 2
0.00	F1	FM	Fracture, multiple, from 6 to 11 o'clock, End		(Struct) 4
0.30		FM	Fracture, multiple, from 12 to 12 o'clock	30_30_498_A.jpg	(Struct) 4
0.60		D	Deformed sewer/drain, 5%	30_30_499_A.jpg	(Struct) 2
1.90	S1	FM	Fracture, multiple, from 6 to 11 o'clock, Start	30_30_257_A.jpg	(Struct) 4
4.09	F1	FM	Fracture, multiple, from 6 to 11 o'clock, End		(Struct) 4
14.80	MHF		Finish node type, manhole reference number: S1		(Constr) 0
Depth: 1.04

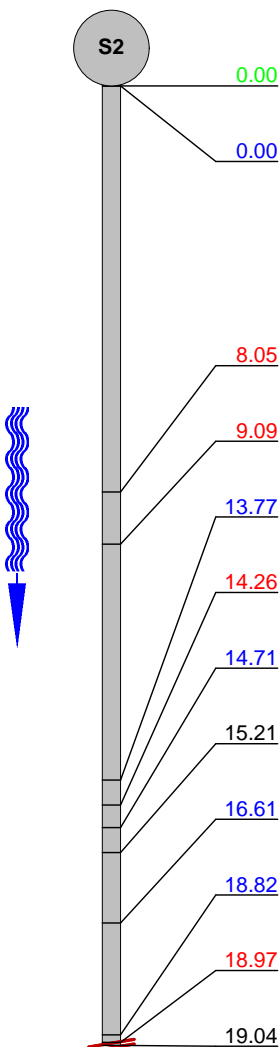
0.00	MH	Start node type, manhole reference number: S2			(Constr) 0
0.00	WL	Water level 0 % of the vertical dimension			(Serv) 0
8.05	FL	Fracture, longitudinal, at 12 o'clock			(Struct) 3
9.09	CL	Crack, longitudinal, at 3 o'clock			(Struct) 2
13.77	WL	Water level 10 % of the vertical dimension			(Serv) 0
14.26	FM	Fracture, multiple from 12 O'Clock to 3 O'Clock		31_31_264_A.jpg	(Struct) 4
14.71	WL	Water level 30 % of the vertical dimension			(Serv) 0
15.21	CUW	Loss of vision, camera under water			(Misc) 0
16.61	RM	Roots, mass 10 % cross-sectional area loss			(Serv) 3
18.82	RM	Roots, mass, 50% cross-sectional area loss		31_31_506_A.jpg	(Serv) 5
18.97	FL	Fracture, longitudinal, at 1 o'clock			(Struct) 3
19.04	SA	Survey abandoned (to be HP Jetted & re-surveyed)			(Misc) 0

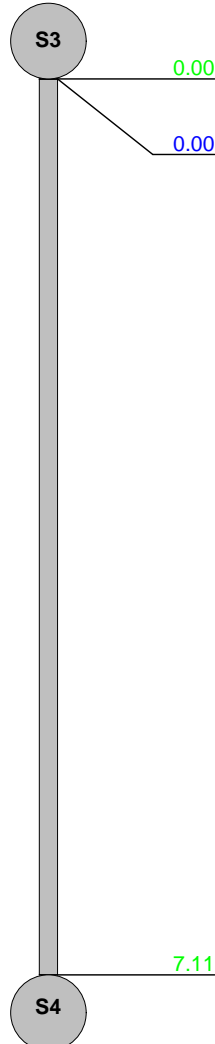
MH	Start node type, manhole reference number: S3		(Constr) 0
		WL	Water level 0 % of the vertical dimension		(Serv) 0
		MHF	Finish node type, manhole reference number: S4		(Constr) 0

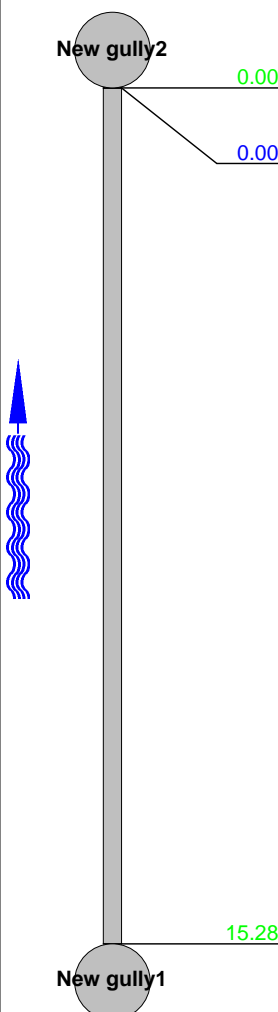
GY	Start node type, gully reference number: New gully2		(Constr) 0				
		WL	Water level 0 % of the vertical dimension		(Serv) 0				
			GYF	Finish node type, gully reference number: New gully1		(Constr) 0			
Structural Defects			Constructional Features						
Service Defects			Miscellaneous Features						
STR no def	STR peak	STR mean	STR total	STR grade	SER no def	SER peak	SER mean	SER total	SER grade
0	0	0	0	1	0	0	0	0	1

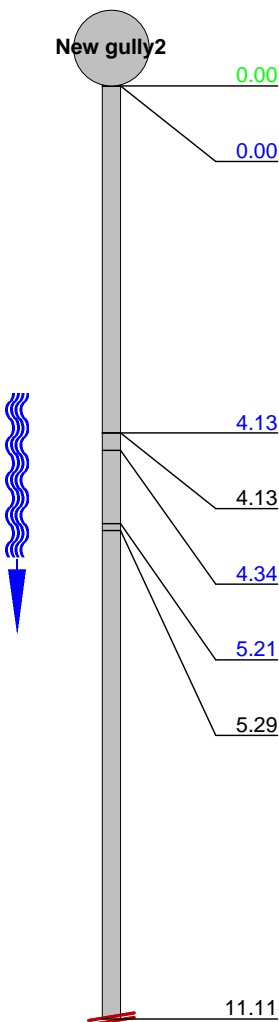
0.00	GY	Start node type, gully reference number: New gully2		(Constr) 0
	0.00	WL	Water level 0 % of the vertical dimension		(Serv) 0
	4.13	WL	Water level 5 % of the vertical dimension		(Serv) 0
	4.13	SC	Dimension of drain/sewer changes 150 mm high 150 mm wide		0
	4.34	WL	Water level, 10% of the vertical dimension		(Serv) 0
	5.21	WL	Water level, 25% of the vertical dimension		(Serv) 0
	5.29	CUW	Loss of vision, camera under water		(Misc) 0
	11.11	SA	Survey abandoned - camera underwater with no view		(Misc) 0
