Stage 1 Road Safety Audit and Designers Response

Northaw Road, Cuffley Proposed Site Access - Option 2

Stage 1 Road Safety Audit

November 2014

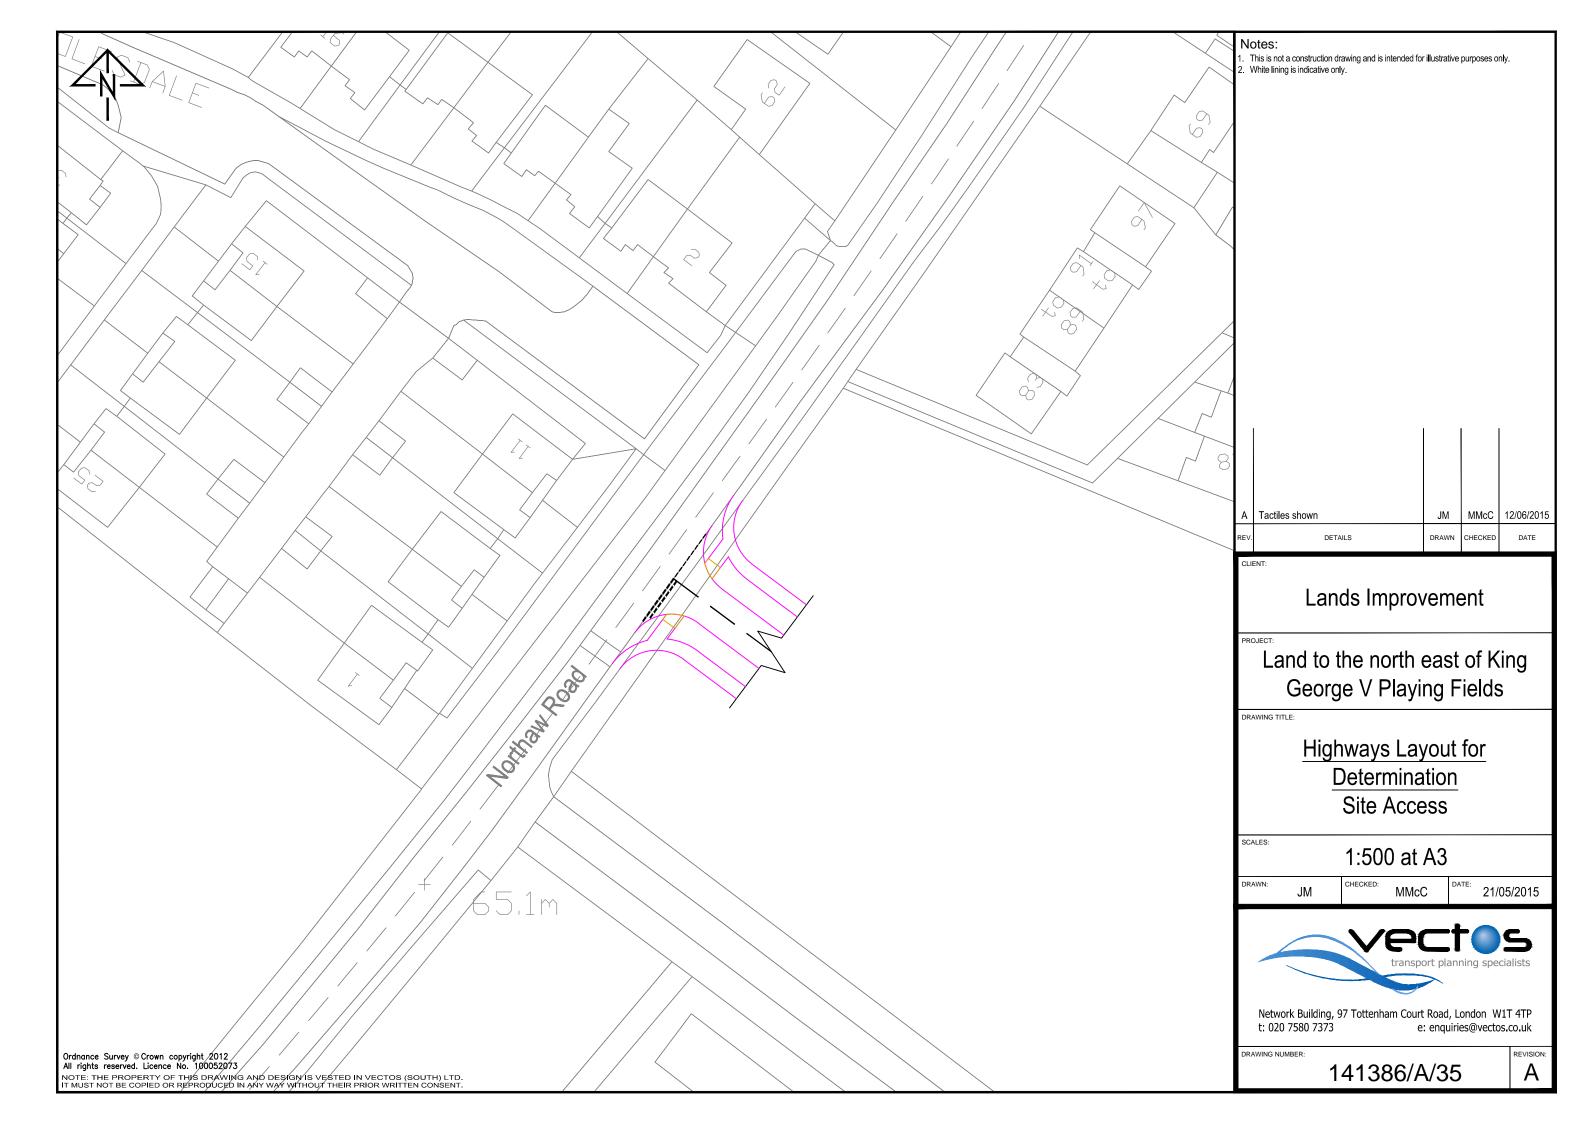
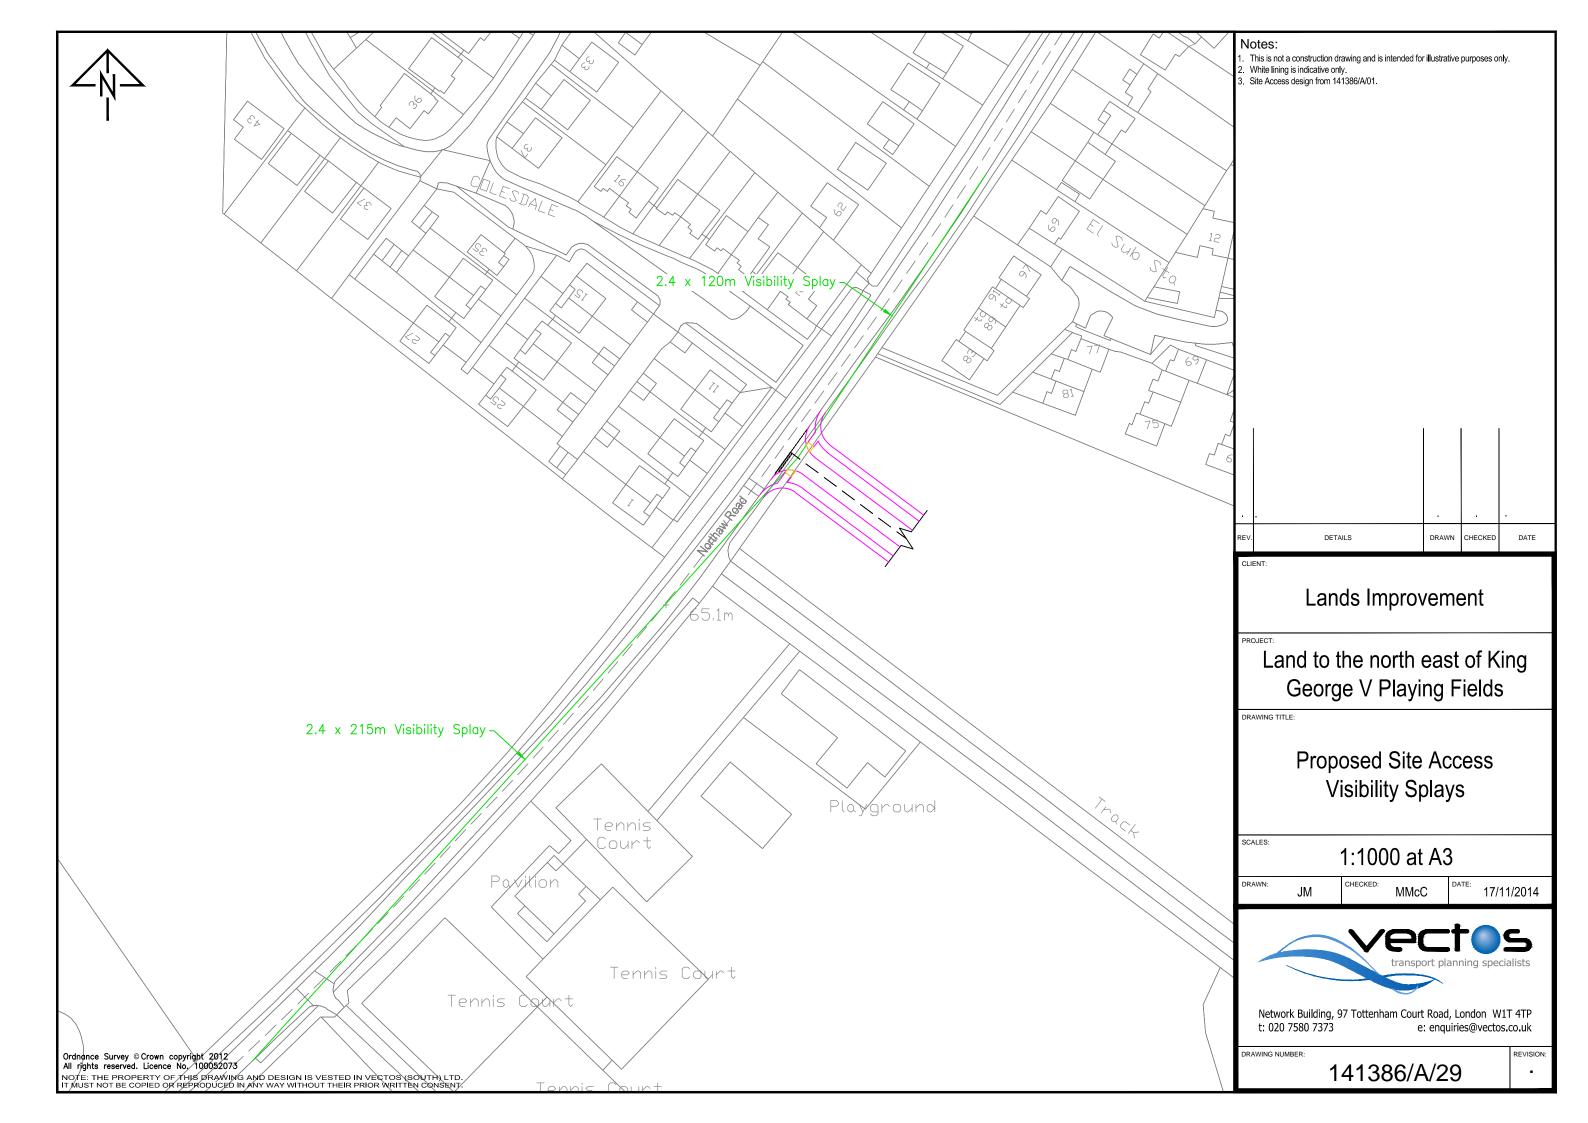
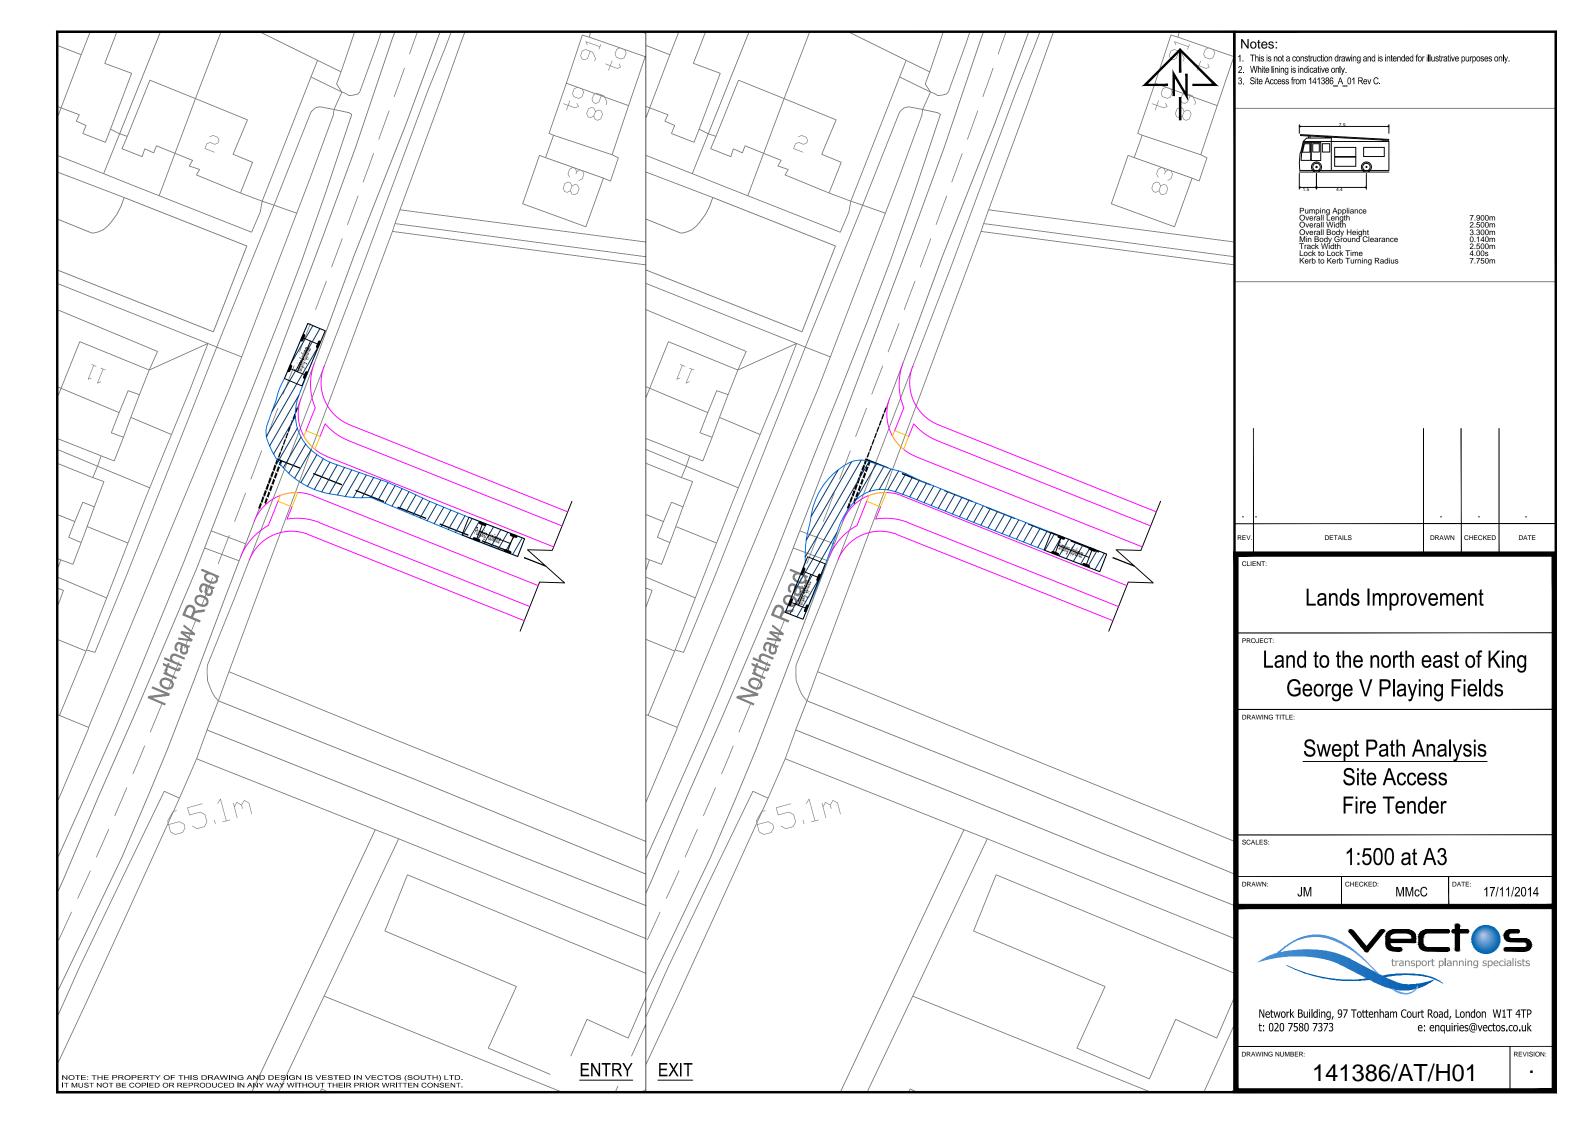
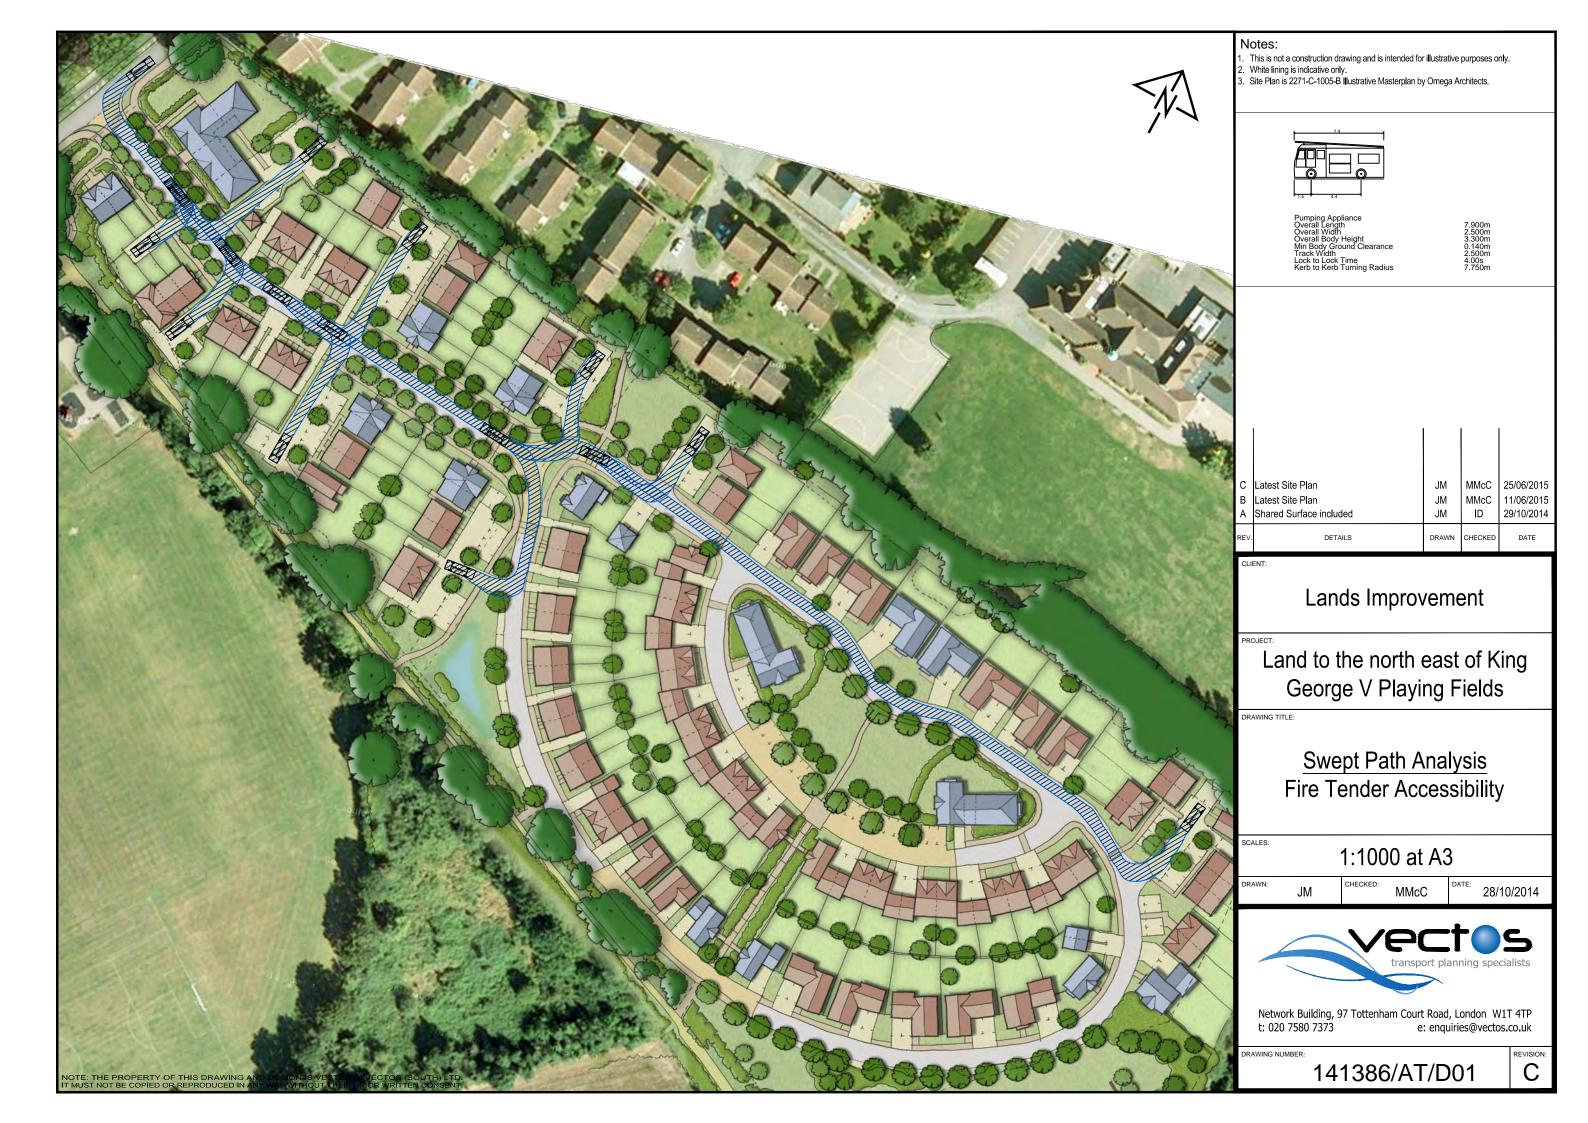
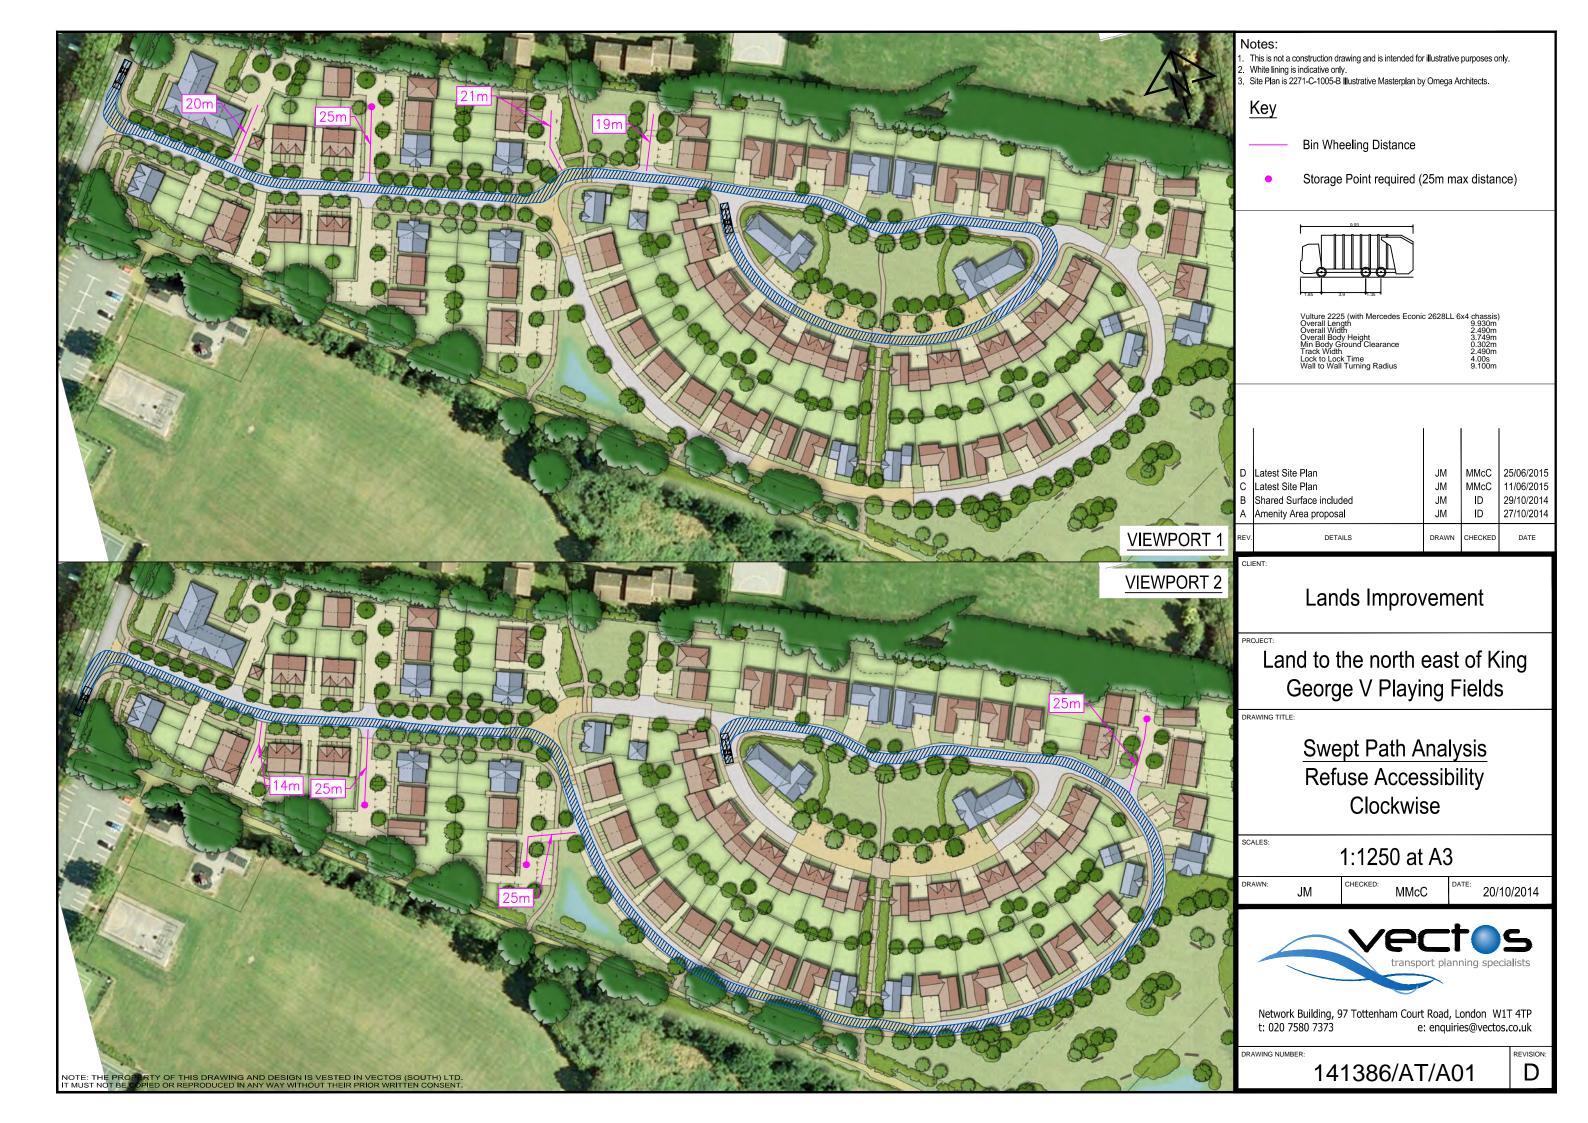
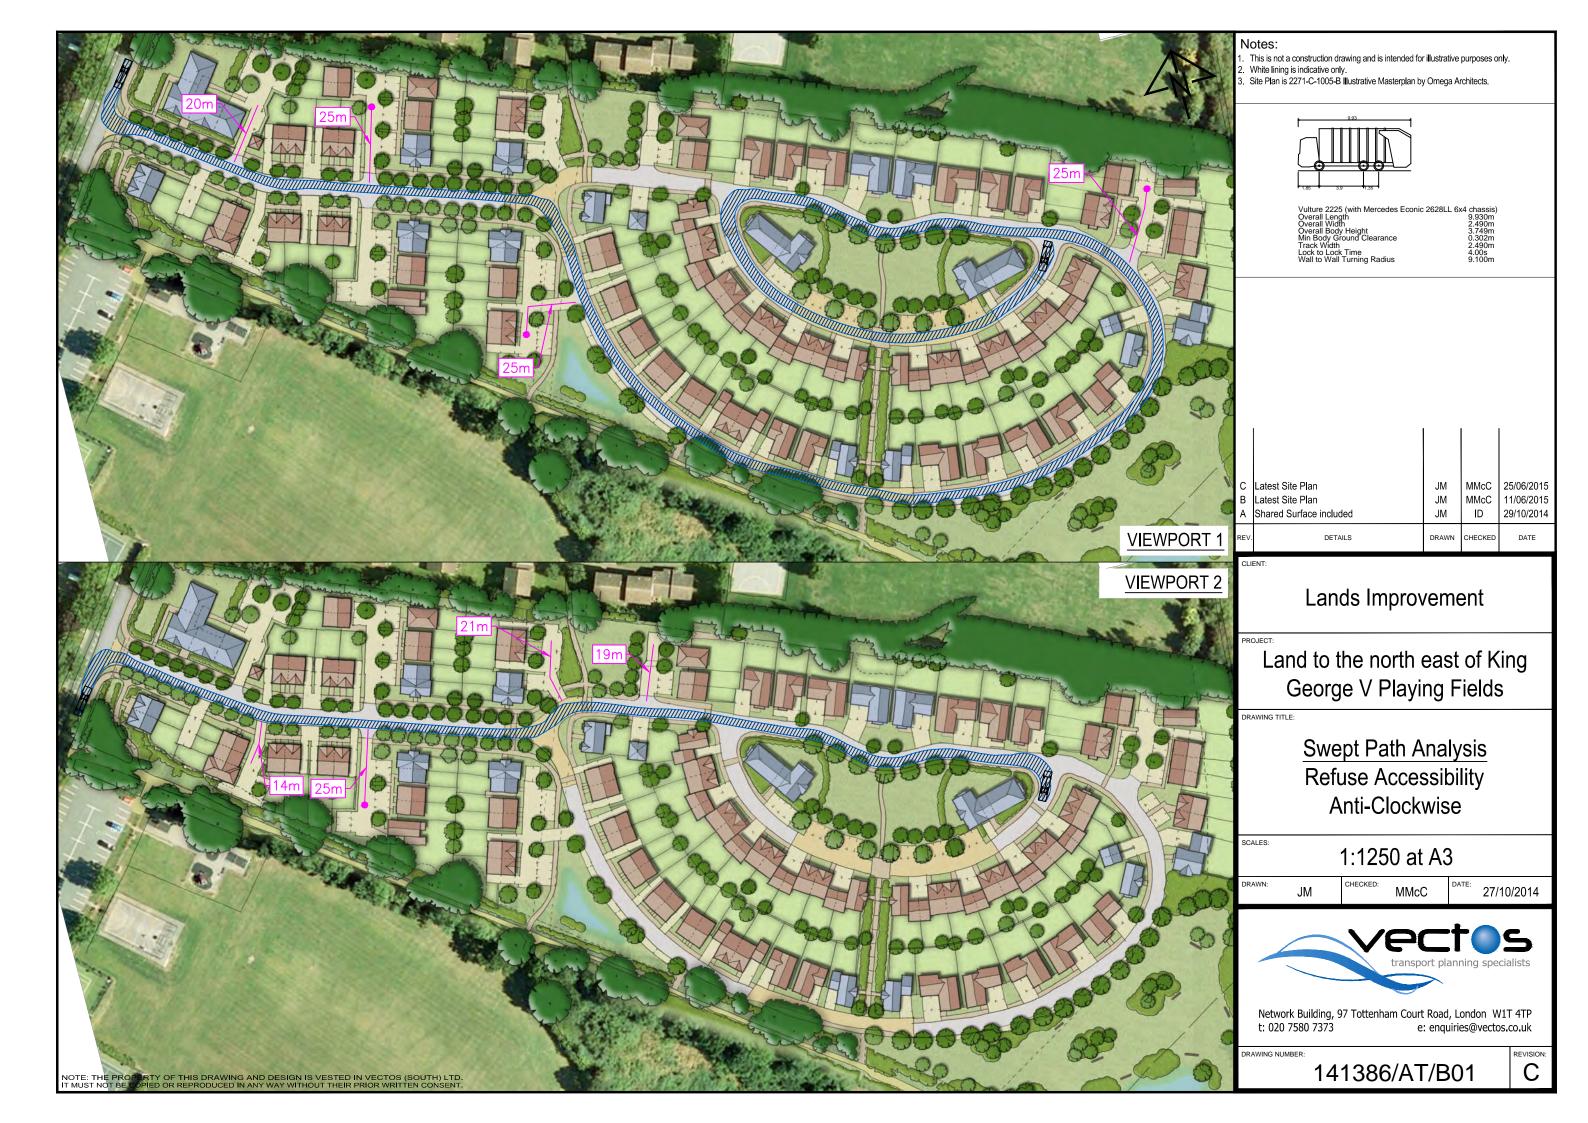
Proposed Site Access and Swept Path Analysis

3.4	Location: General Summary: Swept path tracking has been provided for a refuse vehicle and fire tender. The swept path manoeuvre for the refuse vehicle is very tight and appears to cross over the footways on the western side of Northaw Road, resulting in potential conflict with pedestrians.	Ensure swept path manoeuvres can be accommodated within the carriageway.	Noted. The swept path analysis of the refuse truck has been checked and this confirms that the manoeuvres can be undertaken within the carriageway. The updated drawing is included at Appendix A .
