Oshwal Association of the UK

Details pursuant to Condition 1 and 2 (part) of a Full Application, reference 6/2016/0995/FULL and Listed Building Consent 6/2016/0347/LB for an Erection of a single Storey Rear Extension and Internal Alterations at Oshwal Centre Coopers Lane Road Northaw Potters Bar EN6 4DG.

Saloria Architects Ltd

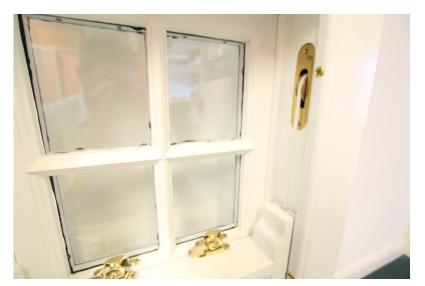
Bespoke design for timber framed doors and windows -(Sample for the outlook of the material)

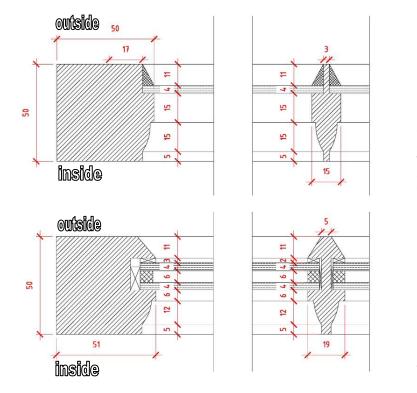
Existing section of the frame and the muntin (image not in scale) (abstract of details from the survey and drawing attached to application 6-2018-0136-LB.

Proposed section of the thin line frame and the muntin (4-6-4) (image not in scale).

3.3.9 The following images show there will be no particular difference in details between muntin, compared to the existing sash windows. The shape of the frame and the muntin will be the same. The minor differences are due to the different obligations under policies within the Building Control Approved Document Part K.
