Details pursuant to Condition 1, 2, 3 and 5 of a Full Application, reference 6/2016/0995/FULL and Listed Building Consent reference 6/2016/0347/LB, dated 6 April 2016 for an Erection of a single Storey Rear Extension and Internal Alterations at Oshwal Centre Coopers Lane Road Northaw Potters Bar EN6 4DG.

Saloria Architects Ltd

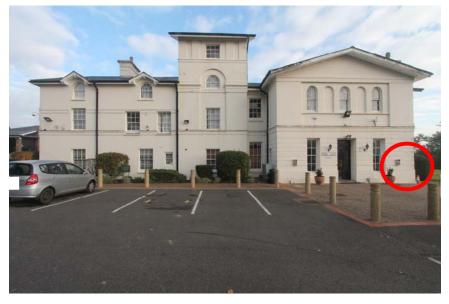
#### Detail of the rustication on the front elevation

- 3.4.2 Details of the eaves, parapets, verges, abutments and chimney stacks (scale 1:5) are shown drawing No. 6842-40-P0
- 3.4.3 The following photos show the rustication detail used on the proposed extension which is modelled on the classical details found in the historic main front elevation of the house.

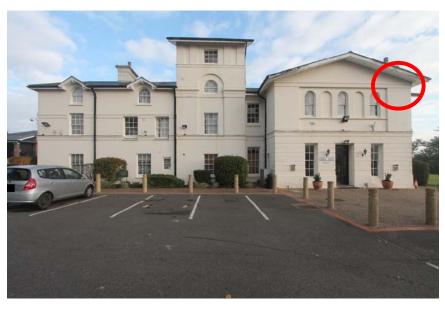
Detail cornice on the front elevation which has been used on the eaves of the extension (see drawing 6842-40-P0)

### 3.4.4 The following photo show the detail of the eaves on the main front elevation of the house.

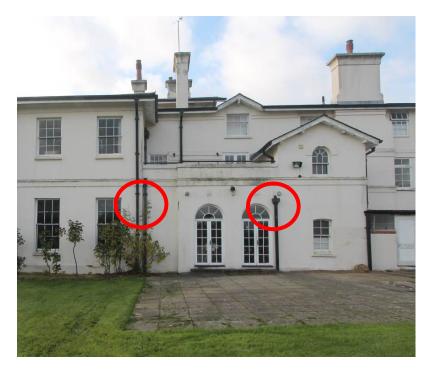
Details of the existing cast – iron pipes

- 3.5.2 Details of all visible rainwater goods shall be found in drawing No. 6842-38-P0 and drawing No. 6842-39-P0.
- 3.5.3 all rainwater goods are cast- iron colour black as reported in point 3.2.4.

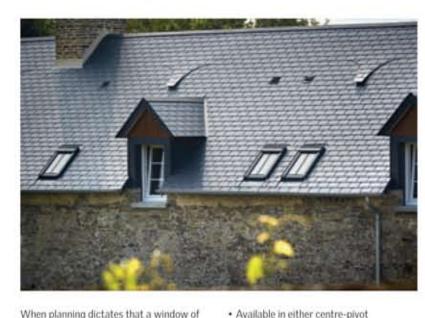
## VELUX conservation roof windows

When planning dictates that a window of traditional external appearance is required, conservation roof windows should be considered. All of our conservation roof windows have the same technical features of a VELUX roof window but in a traditional black conservation style.
