Heritage Statement

**Oshwal Centre,
Coopers Lane Road
Northaw EN6 4DG**

Saloria Architects Ltd

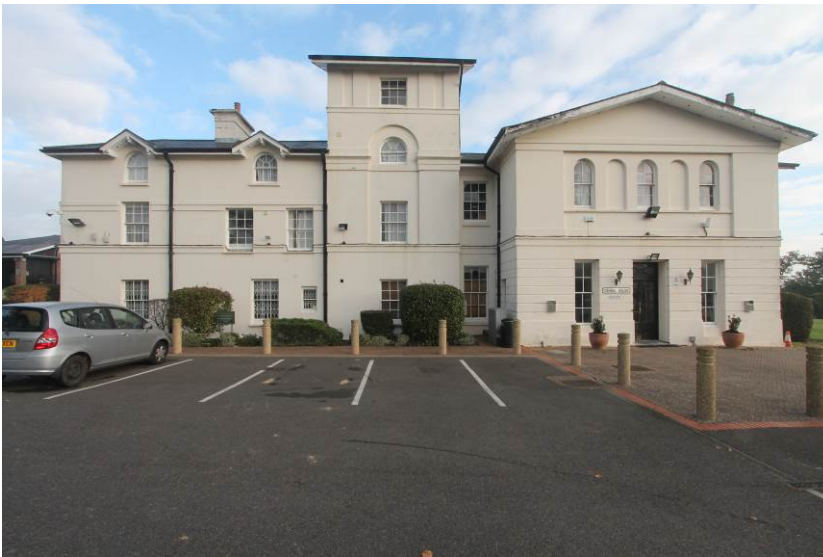
front (south) elevation of
Oshwal House

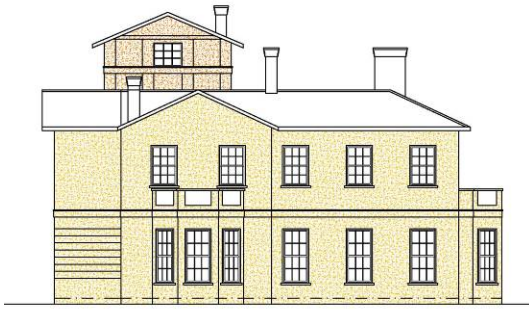
east elevation scheme

The schemes below show dating and significance of the building and consequently of the render.

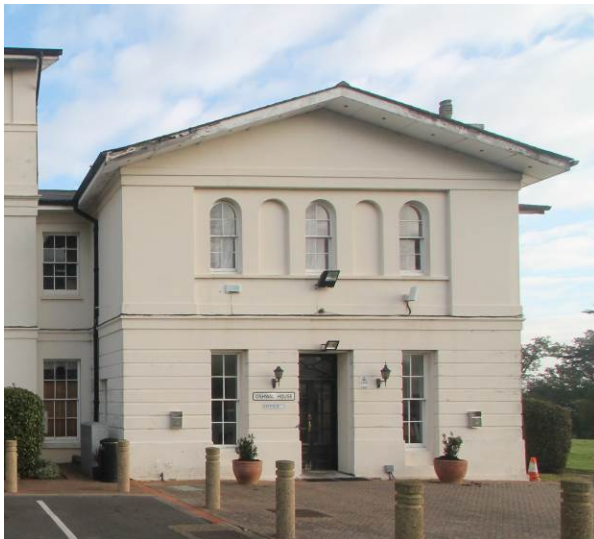
original house: front elevation
(south) of Oshwal House

- 4.02 The original part of Oshwal House is a two-storey building. The main entrance elevation is divided into a ground floor with rustication and a narrow window either side of the door recess. At first floor, three Romanesque arched windows and two blind windows sit within a slight recess with a floor band above and below. The elevation terminates as a gable end, creating the impression of a neo-classical pediment.

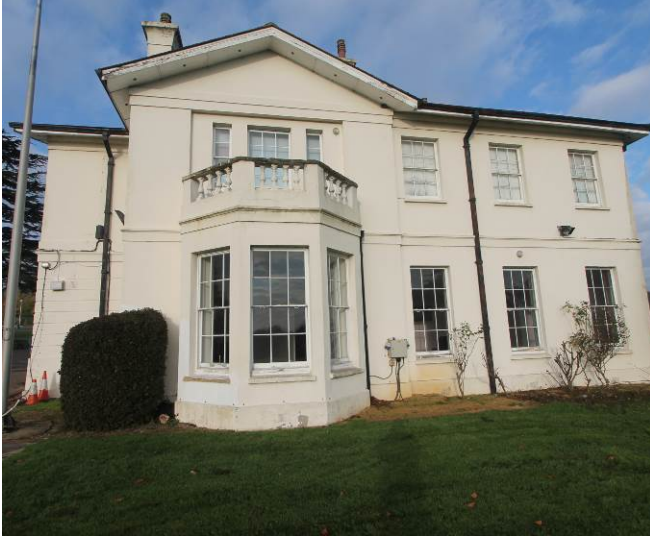
original house: east elevation of Oshwal House

- 4.03 The east elevation features a partial gable, off-centre to the left-hand side, upon which sits a single-storey bay consisting of three windows at ground floor level, with a decorative parapet at first floor level. Three windows, a central window flanked each side by a narrow side light sit in a similar recess to the entrance elevation, overall creating a similar appearance to the south elevation. The rustication to the south elevation is visible on the return wall of the entrance gable but does not continue onto the partial gable itself or anywhere else on the east elevation. To the right of the partial gable the original house continues, consisting of three large windows to the ground floor and three to the first floor, generally aligned and separated by the floor band and ceiling band which continue the full width of the elevation. The right-hand part terminates in a hipped roof.

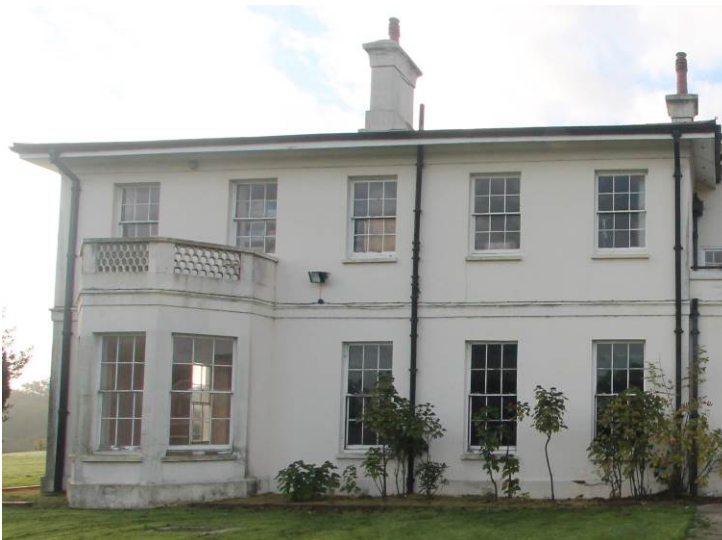
original house: rear elevation (north) of Oshwal House

- 4.04 On the rear elevation there is another single-storey bay of three windows, similarly offset to the left of centre as the east elevation, with a decorative parapet with a honeycomb panel design. To the right of this at the ground floor three windows roughly equally punctuate the wall. At the first floor five windows are spaced regularly, to align with the three windows at ground floor level, continuing the pattern above the parapet. The floor and ceiling band continue the full width of the original elevation without interruption, and the roof structure terminates in hipped corners at both ends.

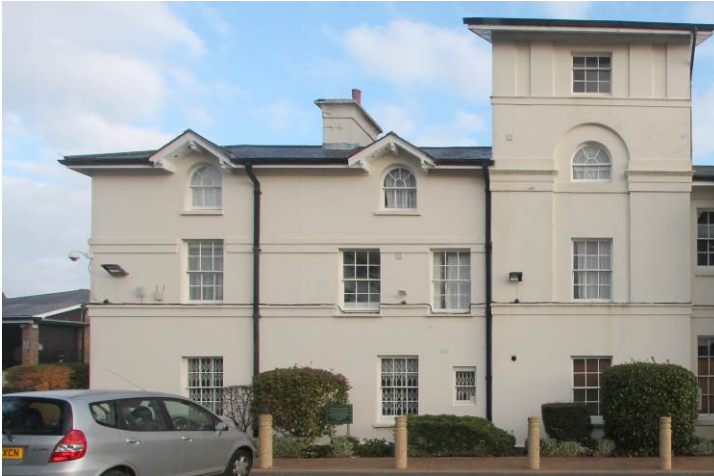
southwest wing and tower: front elevation (south) of Oshwal House

- 4.05 The tower and the south west wing are a later addition to the original house, probably added in the later Victorian Period after the main house was substantially complete. The tower is a four-storey gabled structure on the south elevation with no decorative features to the ground floor, and one window centrally located. The subsequent windows above are aligned with this, comprising another window at the first floor, a Romanesque arched window above that which is roughly at the level of the adjacent eaves, and a further window at the top level. The first and second floor windows are slightly recessed in a similar manner to the original house (with the top of the recess mirroring the arch of the window), and there is some decorative recessing to the top storey.

- 4.06 To the left of the tower the south west wing is comprised of three storeys and a variety of window types. On the south elevation these are of mostly similar appearance to the ground floor of the tower, except for a small ancillary window at the ground floor, and the two small arched windows at the third floor which sit in small breaks in the eaves line which appear as partial gables or dormer windows in the hipped roof. The windows are

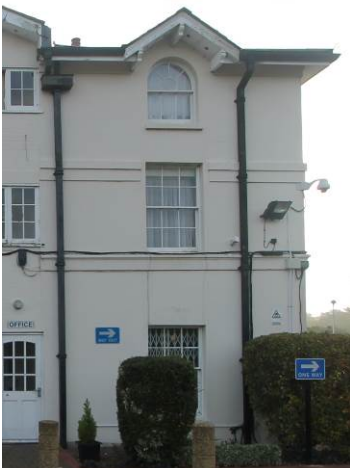
southwest wing: west elevation of Oshwal House

- 4.08 On the west elevation some of the order is restored, as the windows align to each other and generally mirror the arrangement of windows at the left-hand side of the south elevation, including the partial gable to the arched window at the second floor, and the banding which is broken by the first-floor window.

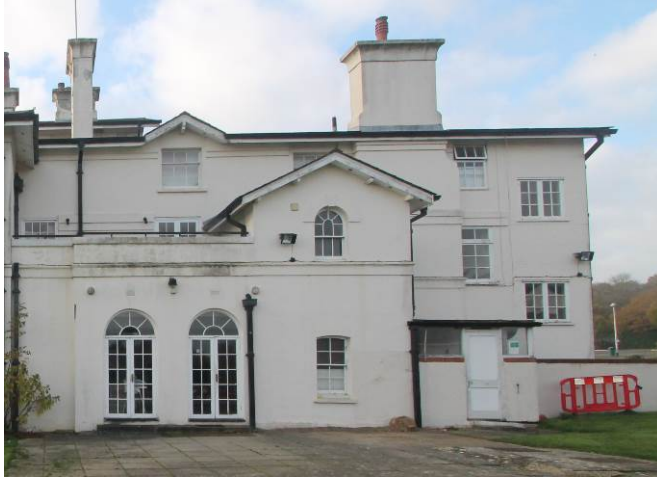
northwest wing: rear elevation
(north) of Oshwal House

4.09 The final part of the house is the northwest wing, which encompasses several later additions to the original and southwest wing. This wing has very little in common with the oldest part of the house and appears to have already been subject to a number of additions and alterations prior to its occupation by OAUk, to the extent that many of the original openings have been lost. These have been replaced by side hung or top hung casement windows at a variety of levels. One partial gable similar in form to those of the south west wing is present on the north elevation, though the window within it does not feature the same Romanesque arch. Floor bands are partial on the north elevation but missing entirely on the west elevation and closer reflect the levels of the south west wing than the original house.

Attached to the main part of the north elevation is the C20 'old extension', which predates the OAUk occupation. This consists of a part single-storey, part two-storey addition including a modest roof terrace at first floor level which is accessed by glazed French doors which mimic the newer side-hung windows in style and appearance. The two-storey part terminates in a gable, under which sits an arched window with a prominent lintel and keystone in a style which is not replicated anywhere on the original house or the extensions.

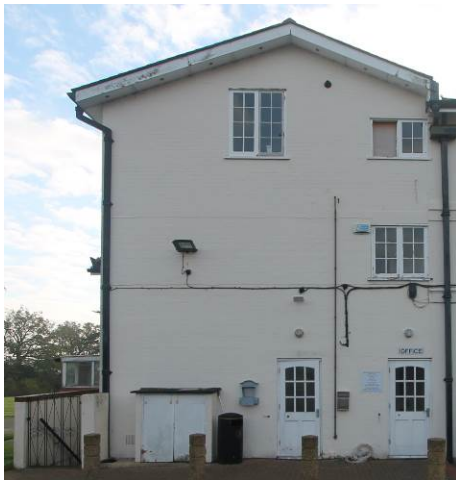
northwest wing: west elevation of
Oshwal House

On the west elevation, the northwest wing terminates in a full gable, and the windows at first and second floor level are of side-hung casement type. The two half-glazed doors at the ground floor are of a humbler domestic style.

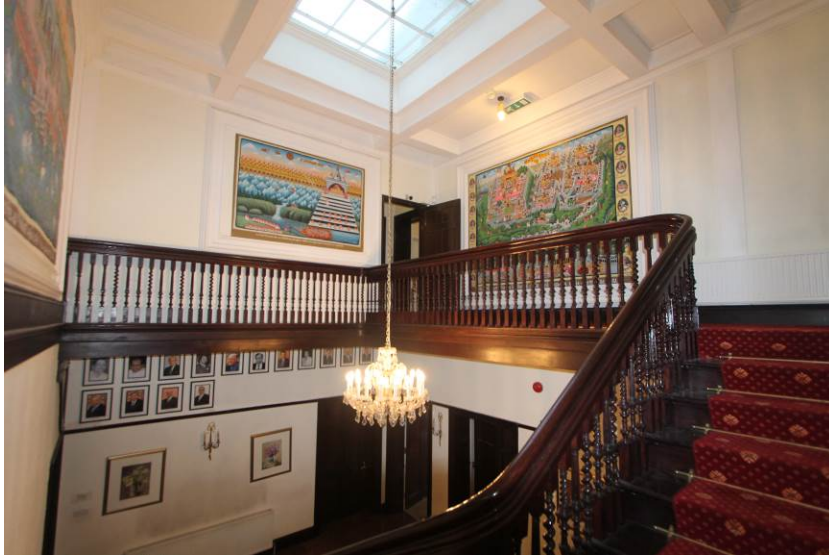
1.1 – (3913) –
Entrance and main
staircase
Figure 1.0 Room 1

- a. rake out occurring cracks;
- b. repoint the plaster;
- c. wax and maintain exposed timber fixtures and fittings

- 5.04 The entrance hall and the main staircase (Room 1 in image 1.0) will be cleaned. Where found, cracking on the walls will be raked out and filled with appropriate materials to suit the age and construction. The walls will be repainted with the same colour. The wooden balustrade and other decorative timber elements will be brushed and waxed in the traditional way to preserve the wood without altering the current appearance. **Overall there will be no change to the existing appearance.**

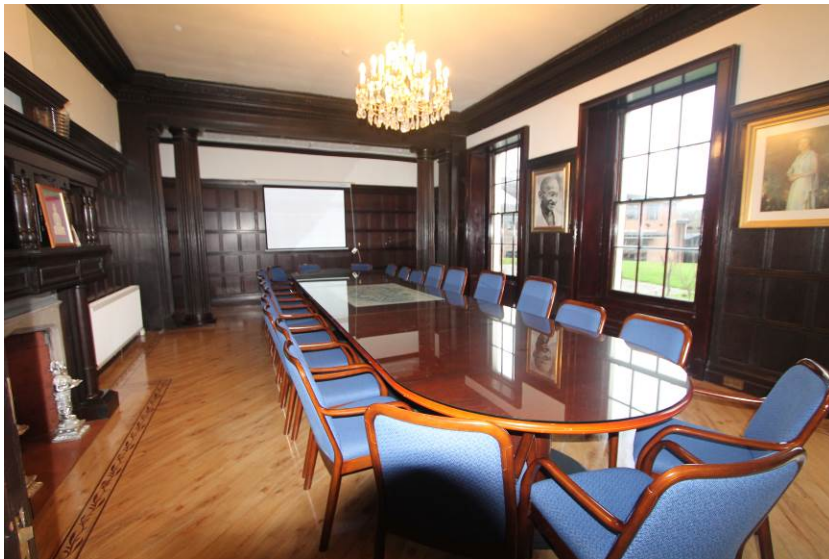
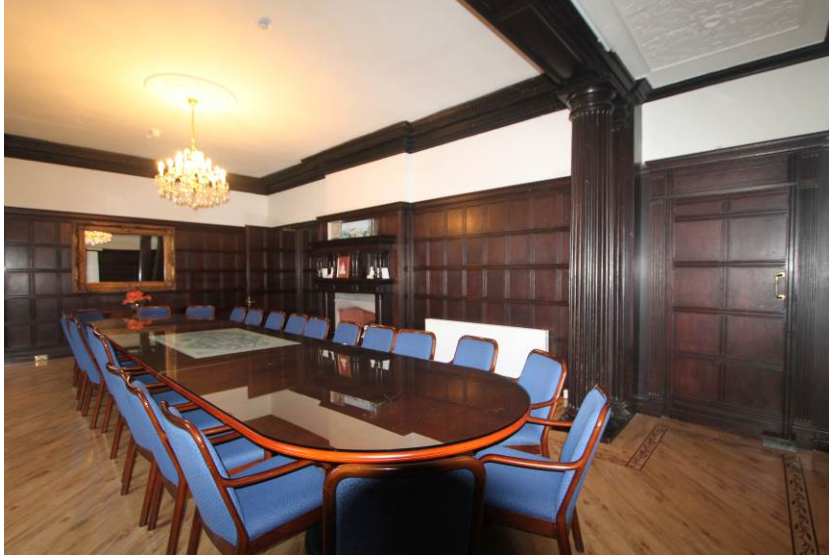
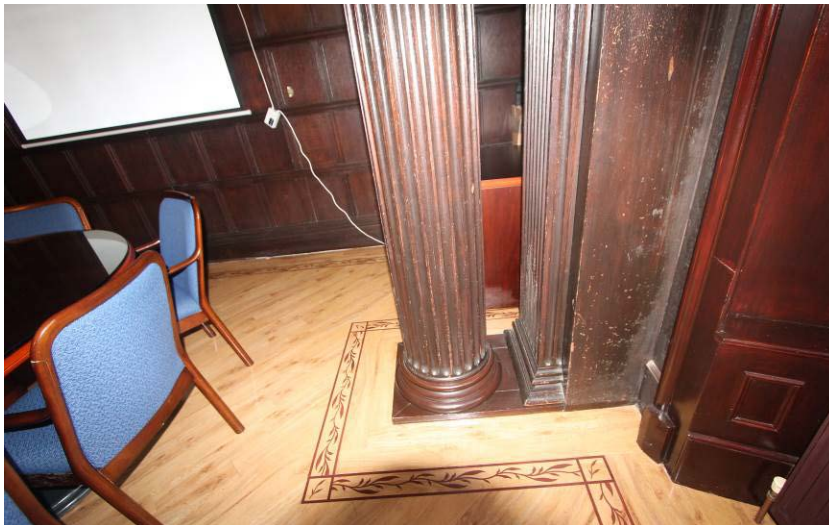
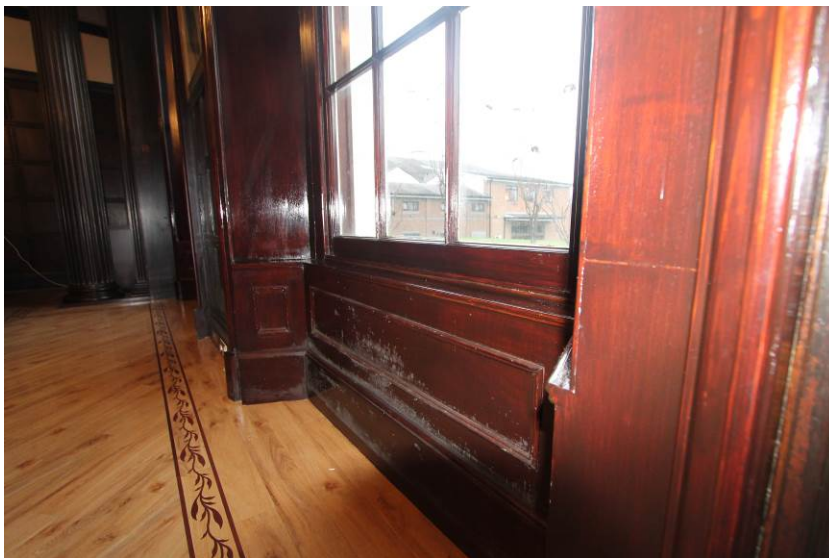
2.0 – (4026) –
Board Room
Figure 1.0 Room 2

**2.2 – (4036) –
Board Room
Figure 1.0 Room 2**
detail of the right-hand
side column

**2.3 – (4037) –
Board Room
Figure 1.0 Room 2**
detail of the existing
panelling under
the window.

5.05 The Board Room (Room 2) will be cleaned and all cracks discovered on the walls will be raked out and filled appropriately. The walls will then be repainted with the same colour. The wooden panelling, fireplace surround and decorative elements will be brushed and waxed in the traditional way to preserve the wood without altering the current appearance. **Overall there will be no change to the existing appearance.**

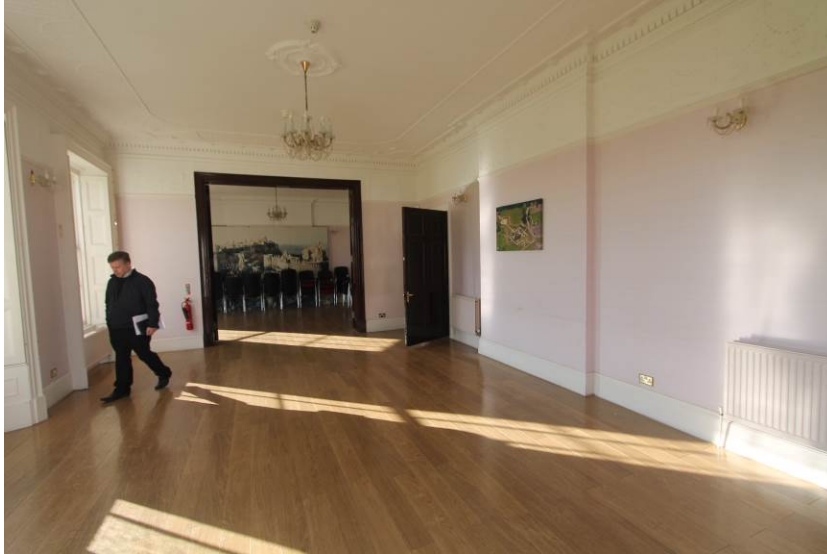
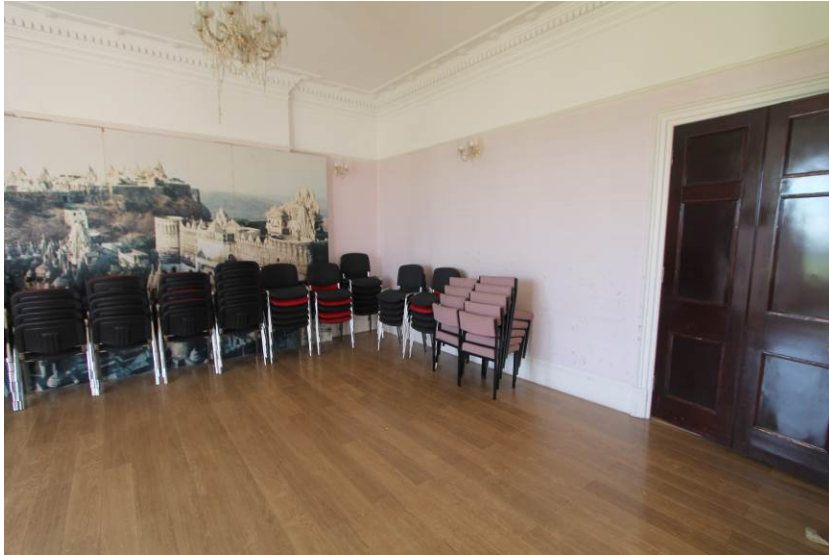
3.0 – (3718) –
Bridge Room
Figure 1.0 Room 3
looking toward
Room 4

4.0 – (3719) –
Bridge Room
Figure 1.0 Room 4

- 5.06 The Bridge Rooms (Rooms 3 and 4) will be cleaned and all cracks discovered on the walls will be raked out and filled appropriately. The walls will then be repainted with the same colour. The wooden panelling and decorative elements will be brushed and waxed in the traditional way to preserve the wood without altering the current appearance.

- 5.07 The Bridge Rooms are amongst the most used rooms in Oshwal House, as Oshwal Centre offers a diverse programme of activities for members, including yoga and traditional dance classes as well as card game evenings and youth activities. The high volume of traffic in these rooms has had a detrimental impact on the finish of the walls especially where chairs have been stored or pushed up against the paintwork.

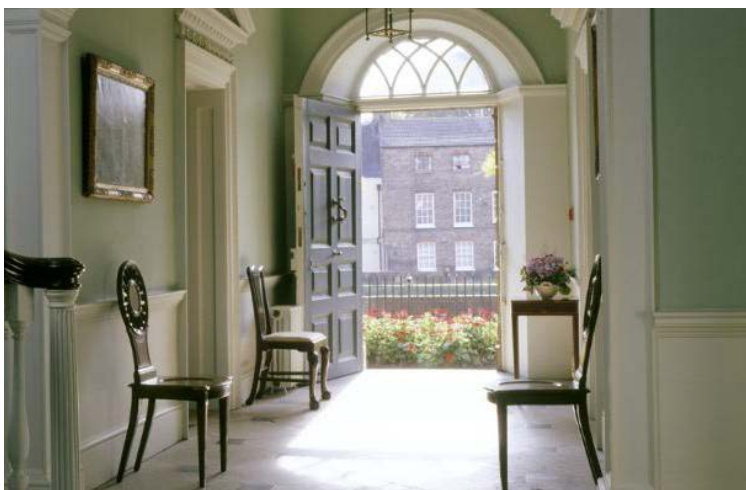
4.5 – example of wainscoting in a Georgian House (Peckover House)

- 5.08 A wainscot of 1.2m height is proposed to be superimposed to the walls in order to prevent future damage to the plaster as a result of these continuing uses of these rooms. This wainscot will divide the wall into three parts as is common in many late Georgian interiors (see images 4.6).

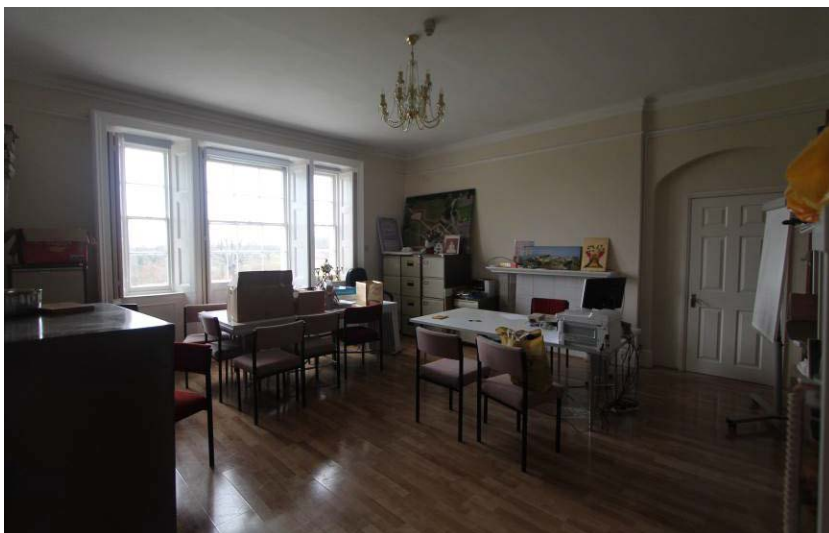
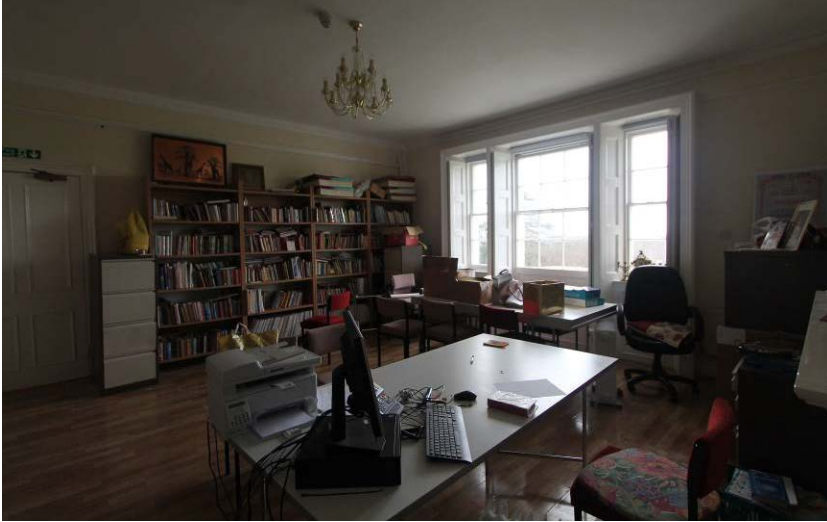
6.2 – (3921) –
Library
Figure 5.0 Room 24

Door leads to Storage
Figure 5.0 Room 23

- a.** rake out occurring cracks;
- b.** repoint the plaster;
- c.** wax and maintain exposed timber fixtures and fittings

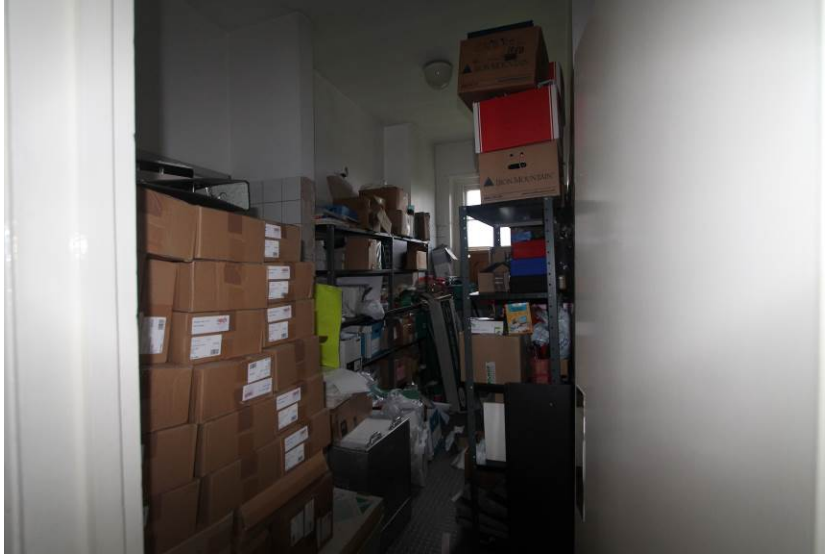
7.0 – (3937) – Storage
 Figure 5.0 Room 27
 Presence of existing drainage and tiling indicates previous use as bathroom or kitchen and is ideal for kitchenette use

- 5.15 Two further rooms open along the corridor to the West Wing (Room 29). They are Rooms 27 (image 7.1) and 28 (images 8.1 and 8.2). Although these two rooms form part of the oldest part of the listed building they have previously undergone partial transformation by the previous owner.
- 5.16 The smallest room (Room 27) is now used as a storage space. However, there is some evidence including existing tiles and a waste water downpipe on the external elevation that indicate that in the past this room was used as either a bathroom or kitchen. In any case no original features remain.
- 5.17 The proposal seeks to return this space into use as a modest kitchenette for the preparation of hot drinks with a place for users to sit. It is proposed to reuse the existing external waste water pipework to join the drainage system.

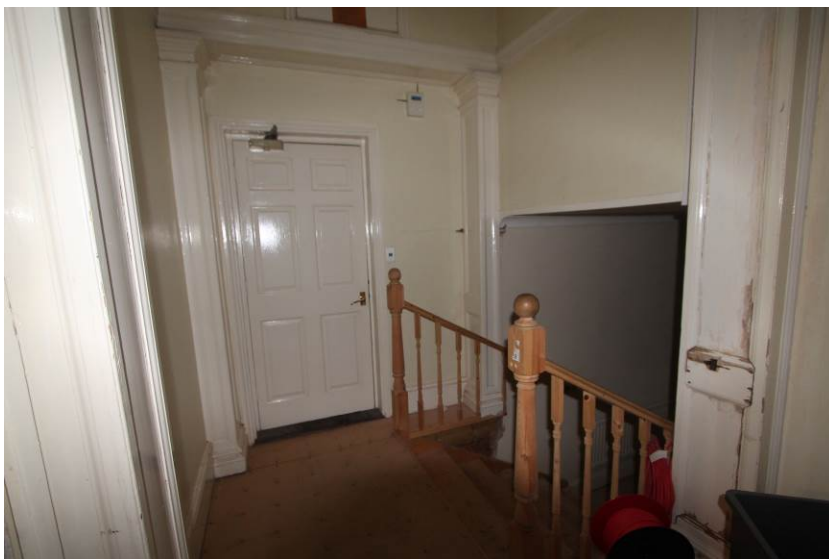
**9.0 – (3945) –
Corridor**
Figure 5.0 Room 29

Door to Lift Shaft
Figure 5.0 Room 30

- 5.20 At the end of the corridor (Room 29) there is an enclosed space now used as storage (Room 30) which was previously a functional elevator. The lift shaft and car are still in place and presumably date from either the 1950s or 1960s.
- 5.21 This application seeks permission to reinstall a lift on the same footprint. Currently there is no way for a mobility-impaired person to access the first floor, which precludes these persons from staying in the current accommodation or to access the library and archive.
- 5.22 The proposed lift would open onto the corridor (Room 29) at the same level as the proposed disabled bedroom (Room 28), the proposed kitchenette (Room 27) and the existing Library and Archive in the older part of the house without need for further intrusive works.
