## **Objection to amended designs for 6/2022/2714/HOUSE**

This objection relates to the amended designs submitted on 26<sup>th</sup> January 2023.

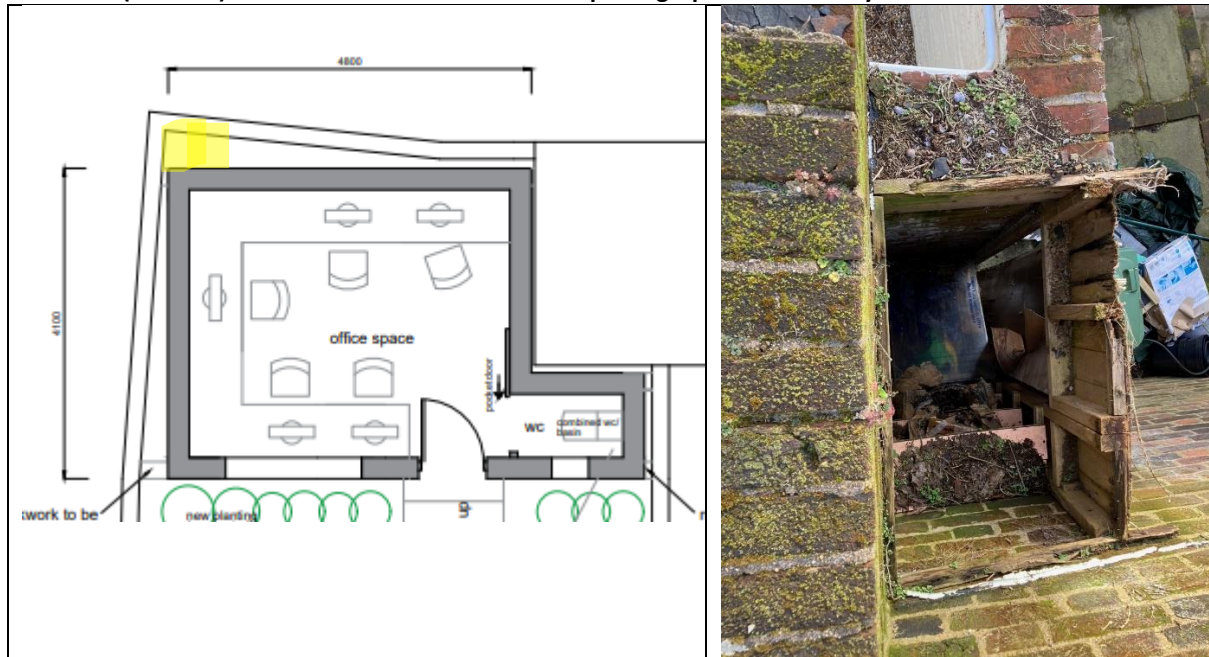
Plan highlighting the rear (east) side of the new office. In reality there is a rectangular inset in the wall in the northeast (rear left) corner. All the brick walls in the photograph are boundary walls.

Once the building is complete, it will be impossible to repair the gutter and significant sections of the boundary walls. Normally a gutter can be accessed either from the ground via a ladder or from the roof. The setting of the office inside high boundary walls and with a steep pitch for the roof makes it impossible to do either. If the mortar/cement which attaches the lead gutter to our wall should develop any defect, this will allow water etc to enter the void. It will not be possible to repair this without removing at least the roof of the office.

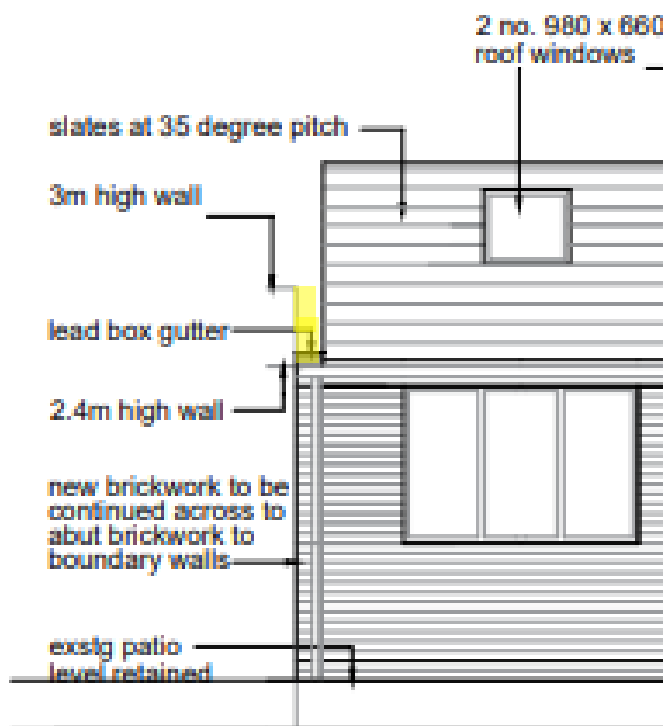
Section to illustrate how the roof rises 1.5m above the gutter. There is restricted access from the other side of the boundary wall due to the configuration of the outbuildings which are against the wall. A ladder cannot be used, and the gutter is still 0.5m below the top of the wall. If someone were to perch on the wall, they would need to repoint / repair a narrow gully 0.5m below their feet.

We assume the construction process will be i) erect the 2.5m walls of the office ii) affix the lead gutter iii) erect the roof which rises to 4m above the existing patio or 4.4m above ground level. At the north and south sides of the new office, the roof will be some 1.5m above the gutter. It should be possible to climb onto the roof and use a suction hose to clear out the gutter. It will not be possible to repair any defect. If, during construction of the roof, anything should be dropped into the gutter or against the wall, it will not be possible to repair the damage to the gutter or brickwork (without removing the roof).

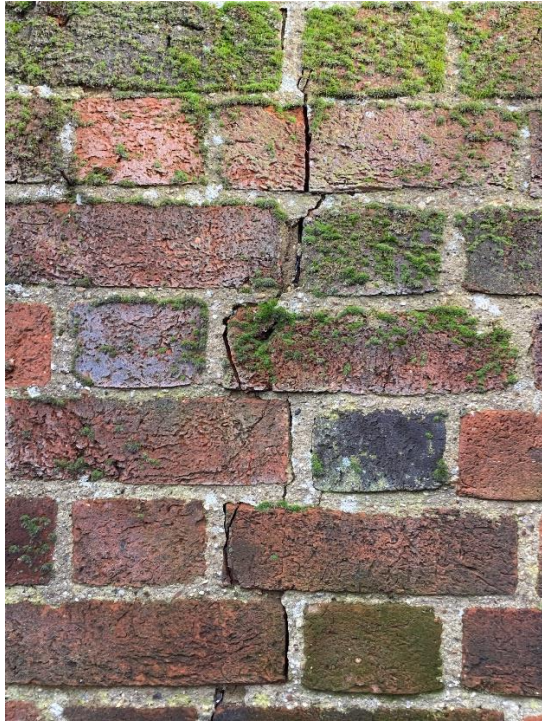
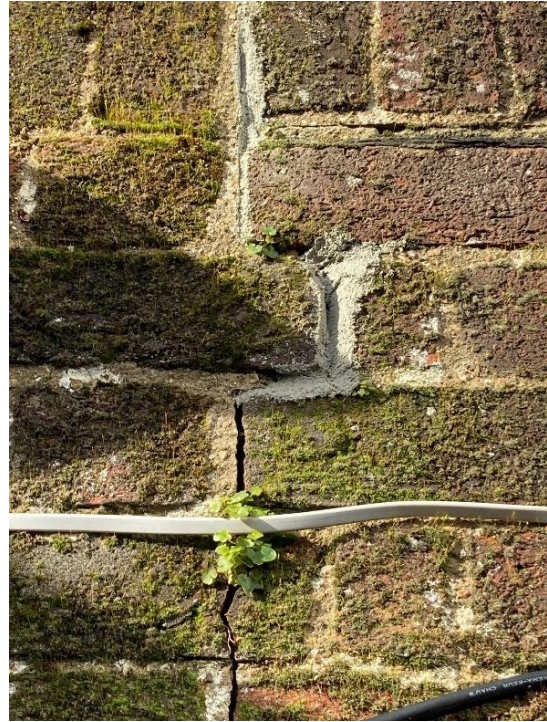
Developing cracks on the east side of the east boundary wall. The office and lead gutter would be attached to the other side of this wall. However water could still penetrate into the void. This wall could be repointed from the east side, but not from the west side, after completion of the office.

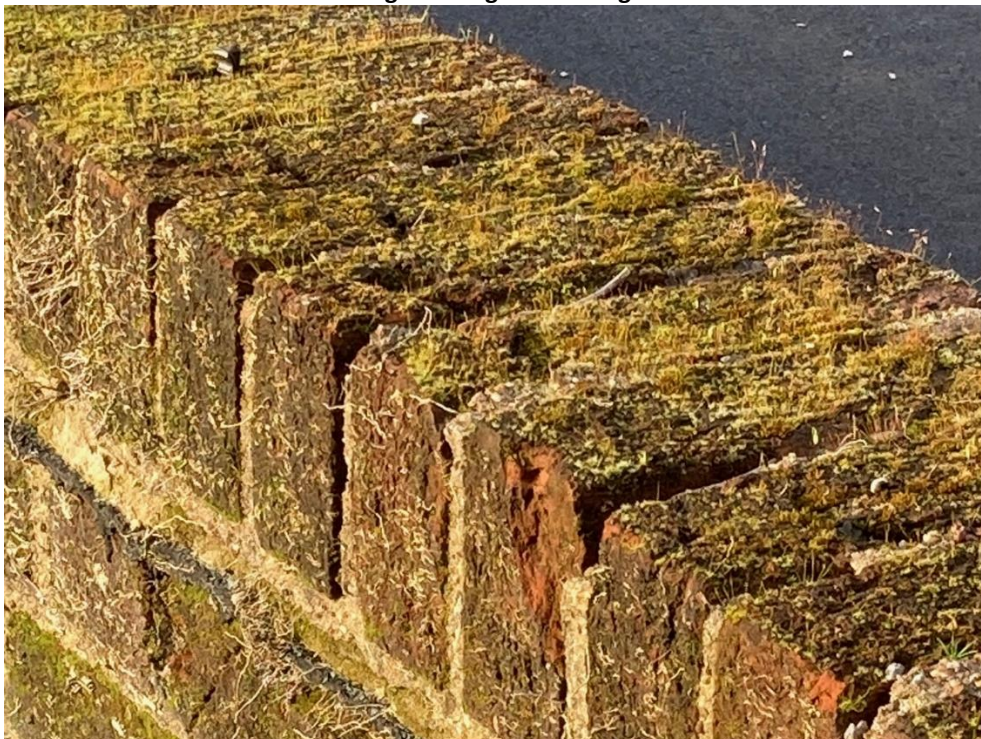
Existing boundary walls have been affected by frost damage and some of the bricks are moist and soft. The new office will create narrow gullies above the lead gutter, and these will accelerate the deterioration of the brickwork. This will also affect neighbouring outbuildings.

The boundary walls are not in perfect condition. They date back at the minimum to the 1960s. They have been affected by frost damage and some of the bricks are moist and soft. There are two bricks missing from the top course and developing cracks in some walls. Water could penetrate into the voids from the other sides (from any or all of the neighbouring properties). At some point, extensive repair work will be needed. It will not be possible to carry this out without demolition of the office or removal of its roof.

The very narrow and deep gullies created by the new office immediately above the lead gutter will in themselves increase the dampness of the bricks and the amount of moss that can survive on them. This will accelerate the rate of decay.
