# **BUILDING SURVEY REPORT**

This is a general Building Survey report on the property and not a Schedule of Condition which would list every minor defect. The building survey is to accompany a Viability Assessment which is to be submitted as part of the full Planning Application.

Northaw House, Coopers Lane, Northaw, Potters Bar, EN6 4NG

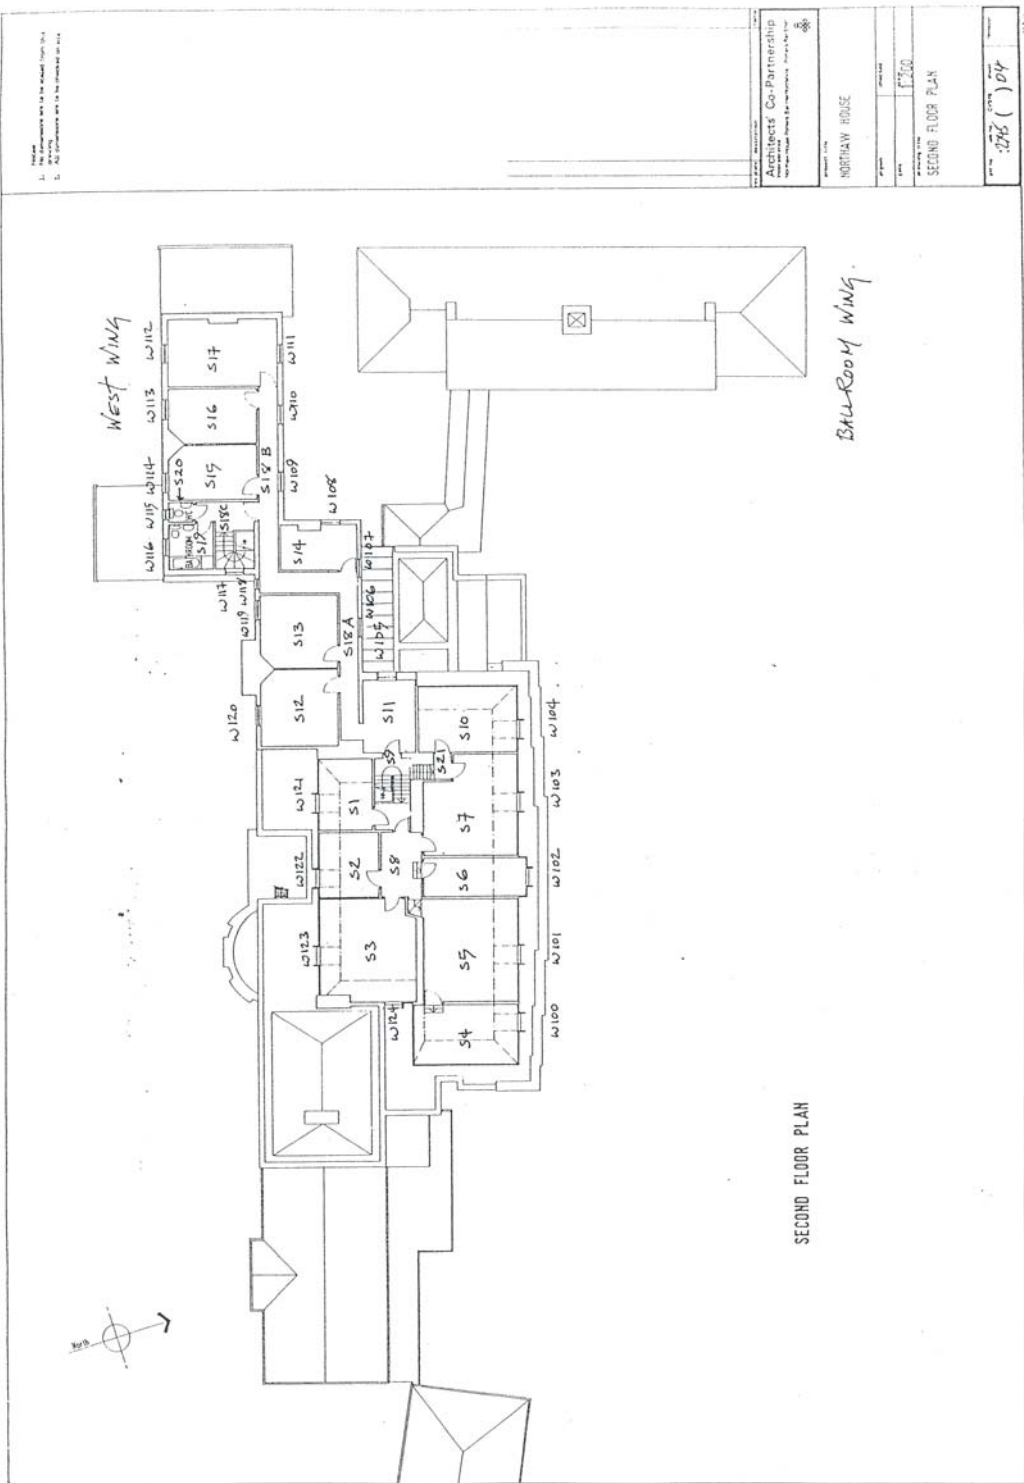
Architects Co-Partnership Architects Co-Partnership 1000 Northway House, Northway House	
PROJECT NAME	NORTHWAY HOUSE
DATE	1960
ARCHITECT'S TITLE	SECOND FLOOR PLAN
SCALE	1/8" = 1'-0"
DATE	1960
