# **BUILDING SURVEY REPORT**

This is a general Building Survey report on the property and not a Schedule of Condition which would list every minor defect. The building survey is to accompany a Viability Assessment which is to be submitted as part of the full Planning Application.

Northaw House, Coopers Lane, Northaw, Potters Bar, EN6 4NG

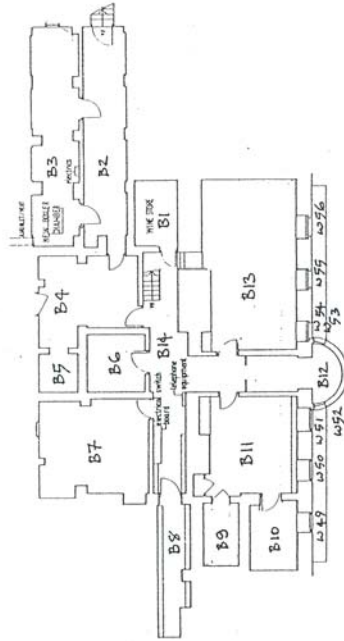
Architects' Co-Partnership	
NORTHWAY HOUSE	
DATE	1/200
BASEMENT PLAN	
SCALE	1/8" = 1'-0"

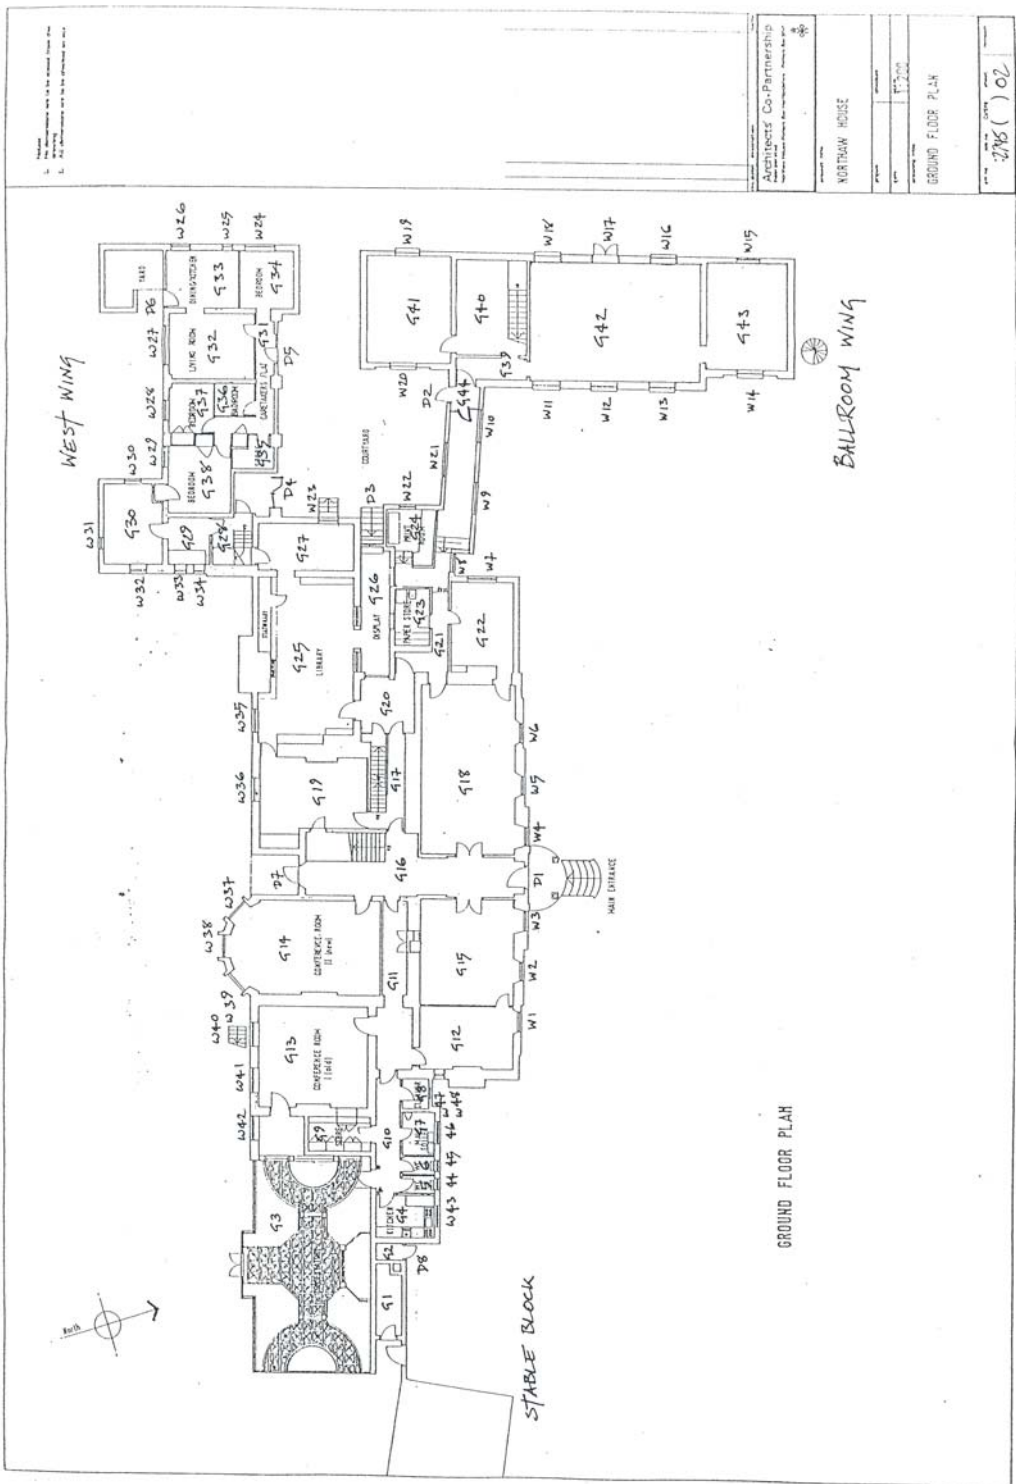
Architects Co-Partnership	
NORTHWAY HOUSE	
DATE	1978
SCALE	1/4" = 1'-0"
GROUND FLOOR PLAN	
NO.	20 ( ) 288

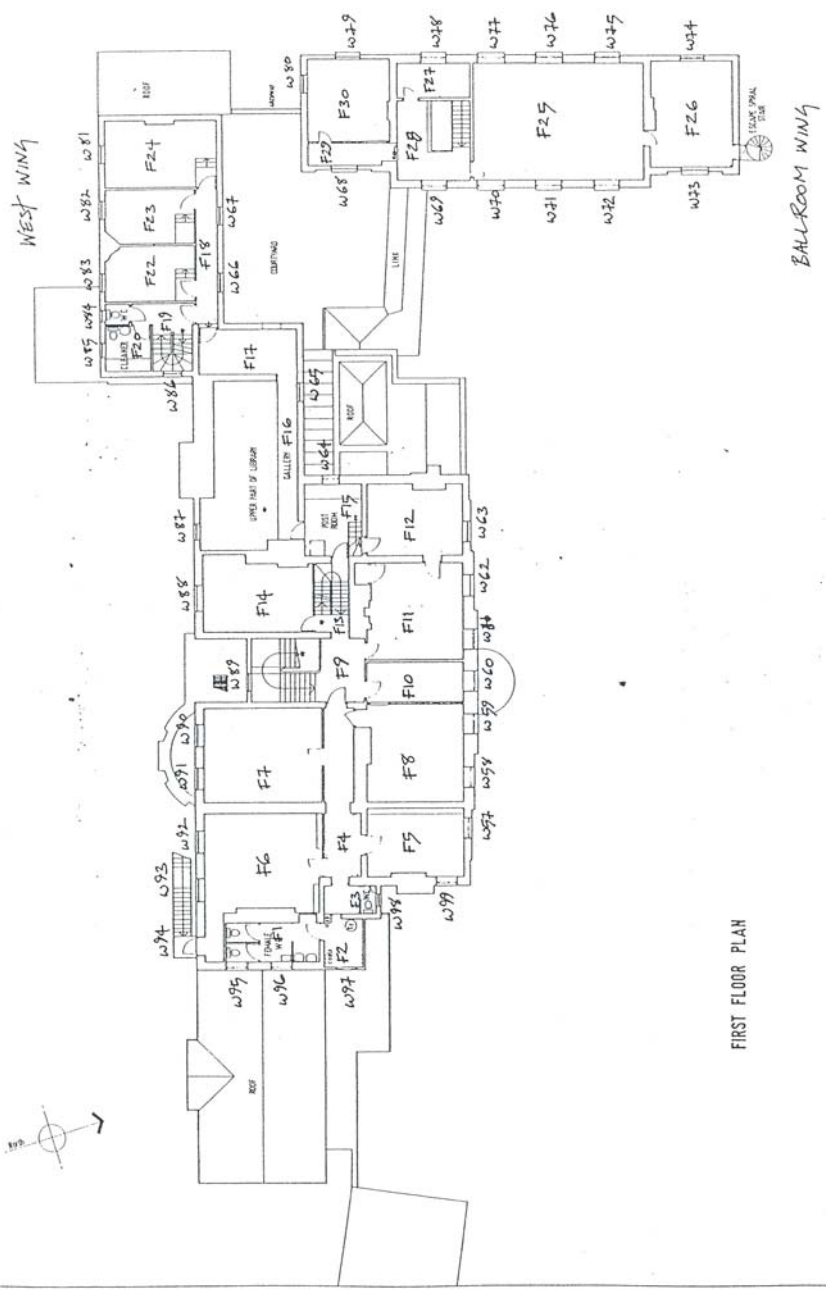
Architects Co-Partnership 100 Northam Street, Northam, Western Australia	
PROJECT NAME	NORTHAM HOUSE
SCALE	1:100
DATE	
FIRST FLOOR PLAN	
PROJECT NO.	1748 (105)
