Document: DRAFT Ground Investigation Report

Project: Stanborough Park North

Reference No.: GL22715

Prepared For: Welwyn Hatfield Borough Council

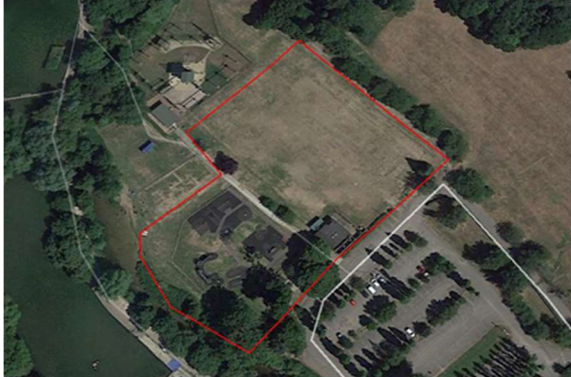
<p>Subject Site Area</p>	<p>The area under investigation forms park of Stanborough Park North which is given over to recreational usage. The approximate postcode for the site is AL8 6DF. The approximate site area is detailed below detailed accurately by the Conisbee drawings detailed in section 1.2.</p>
