YMCA Hostel

Pear tree Lane, Welwyn Garden City

Drainage Design Information

Date: 20.12.22
Project No. 203905
Report Reference: 203905-SWH-ZZ-01-S-RP-0001
Revision: 01

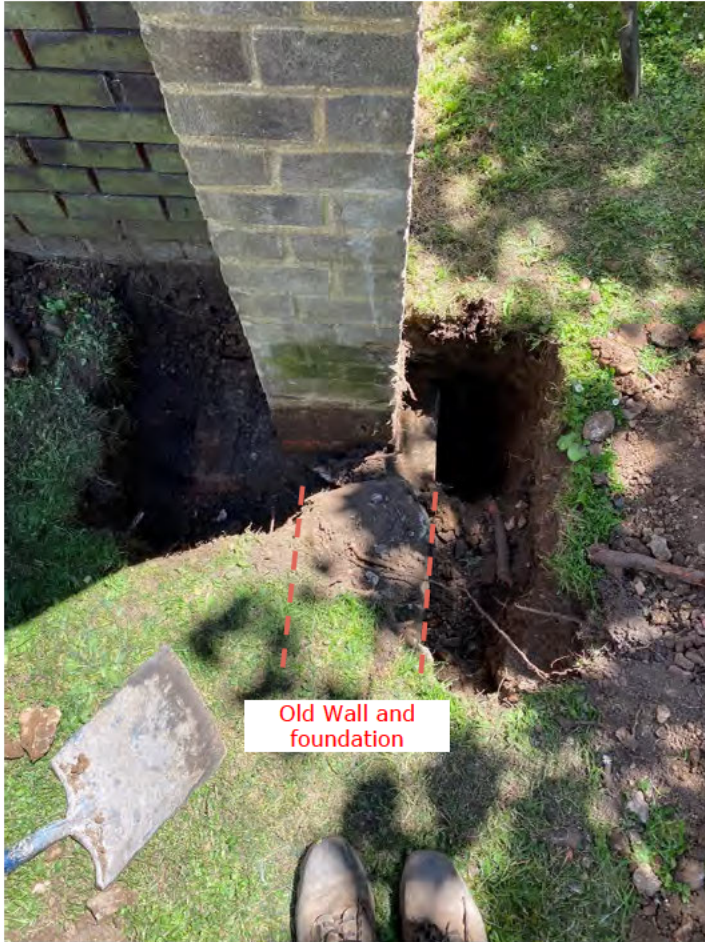
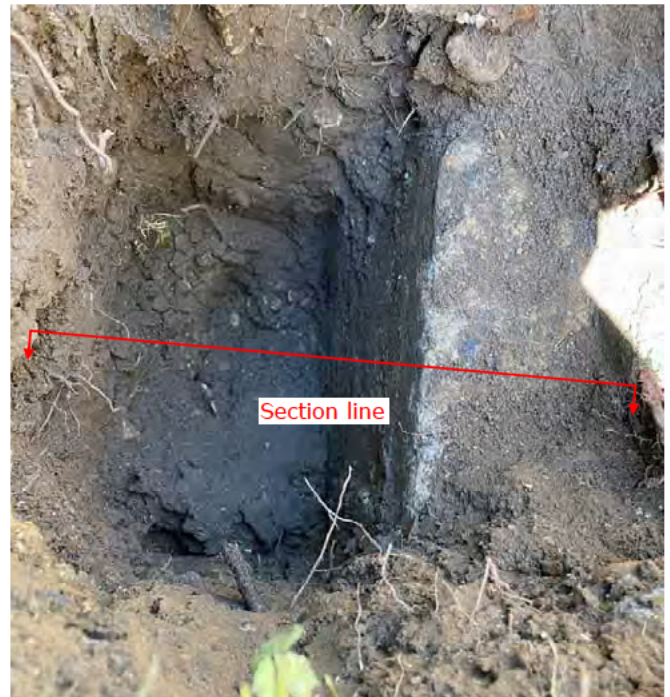
Site & Location:	One YMCA, 90 Peartree Lane, Welwyn Garden City, Hertfordshire AL7 3UL	Trial Pt No: TP1 (2 of 2)
Client:	One YMCA	Report No: 10637/AOC
Engineer:	AKS Ward

PHOTOGRAPHS

D = small disturbed sample, E = environmental sample (glass jar and tub), HV = hand shear vane test (kPa), pp = pocket penetrometer (kg/cm²)

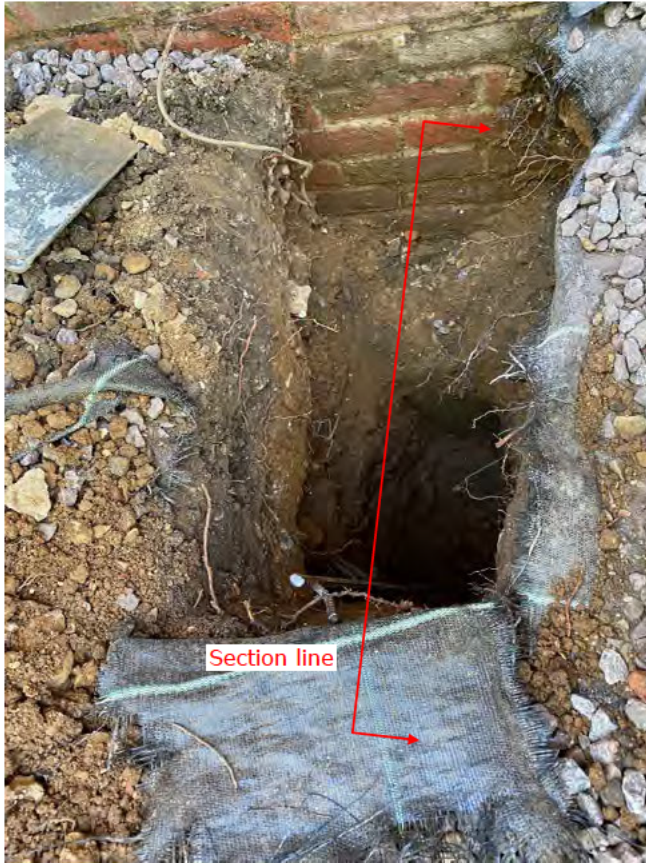
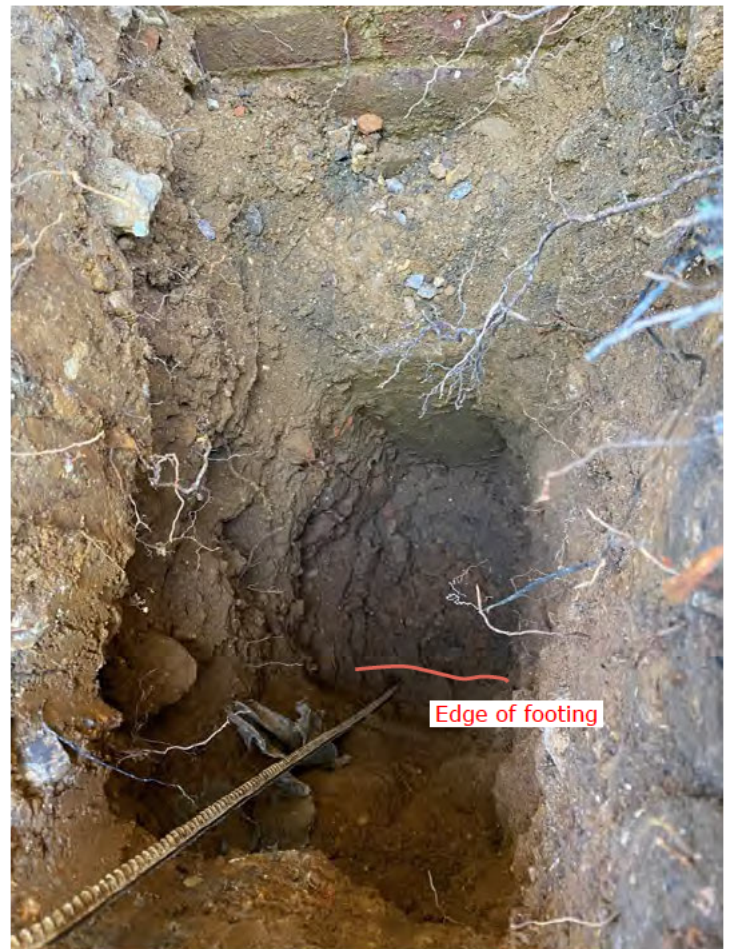
Site & Location:	One YMCA, 90 Peartree Lane, Welwyn Garden City, Hertfordshire AL7 3UL	Trial Pt No: TP2 (2 of 2)
Client:	One YMCA	Report No: 10637/AOC
Engineer:	AKS Ward

PHOTOGRAPHS

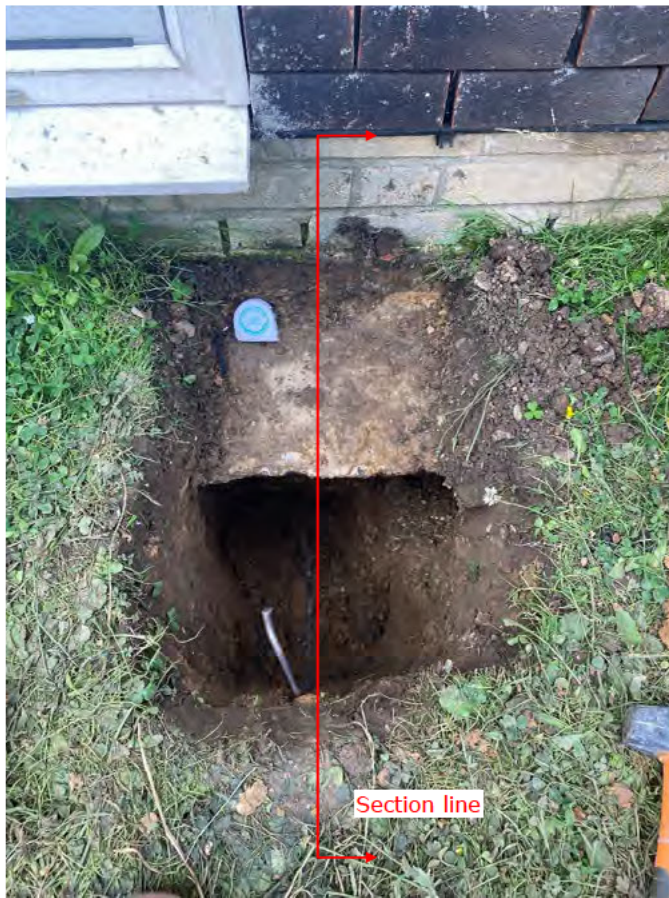
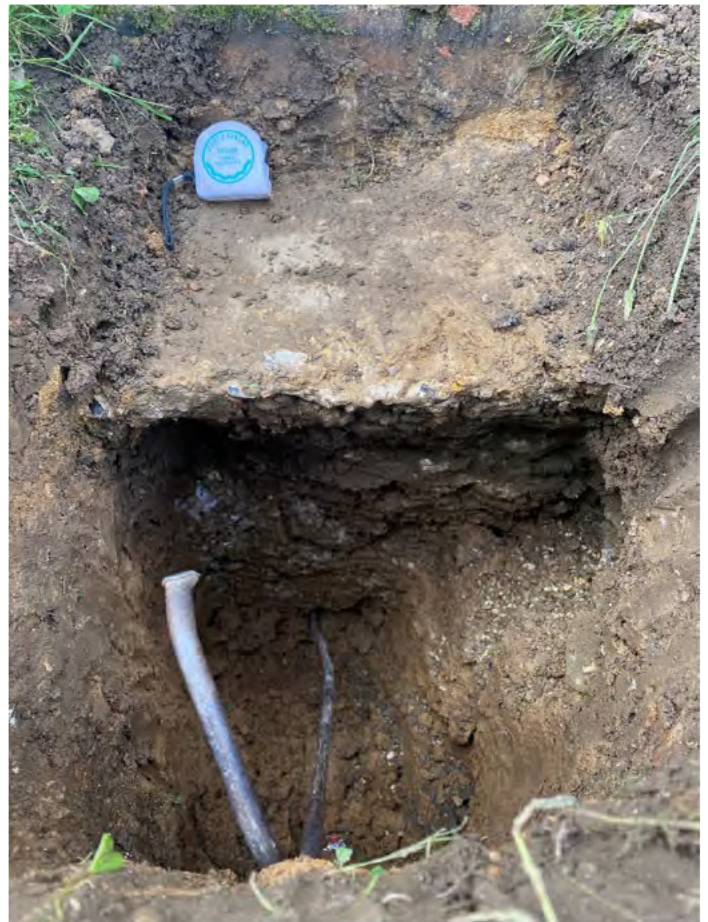
Site & Location	One YMCA, 90 Peartree Lane, Welwyn Garden City, Hertfordshire AL7 3UL	Trial Pt No: TP3 (2 of 2)
Client:	One YMCA	Report No: 10637/AOC
Engineer:	AKS Ward

PHOTOGRAPHS

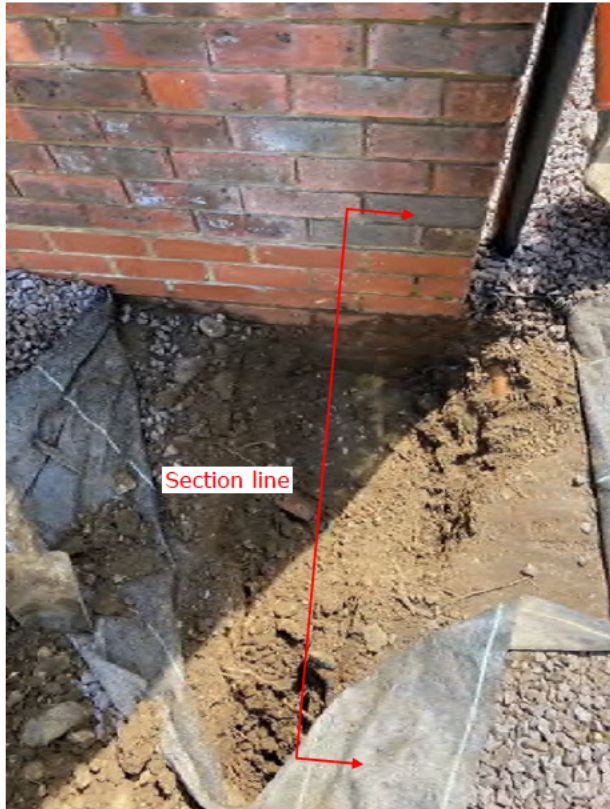
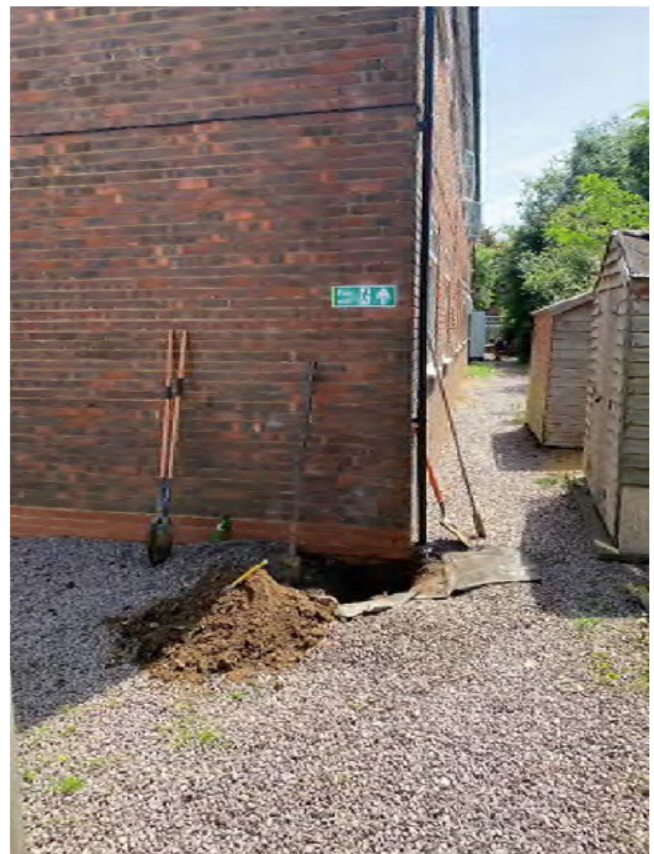
Site & Location	One YMCA, 90 Peartree Lane, Welwyn Garden City, Hertfordshire AL7 3UL	Trial Pt No: TP4a (2 of 2)
Client:	One YMCA	Report No:
Engineer:	AKS Ward	10637/AOC

PHOTOGRAPHS

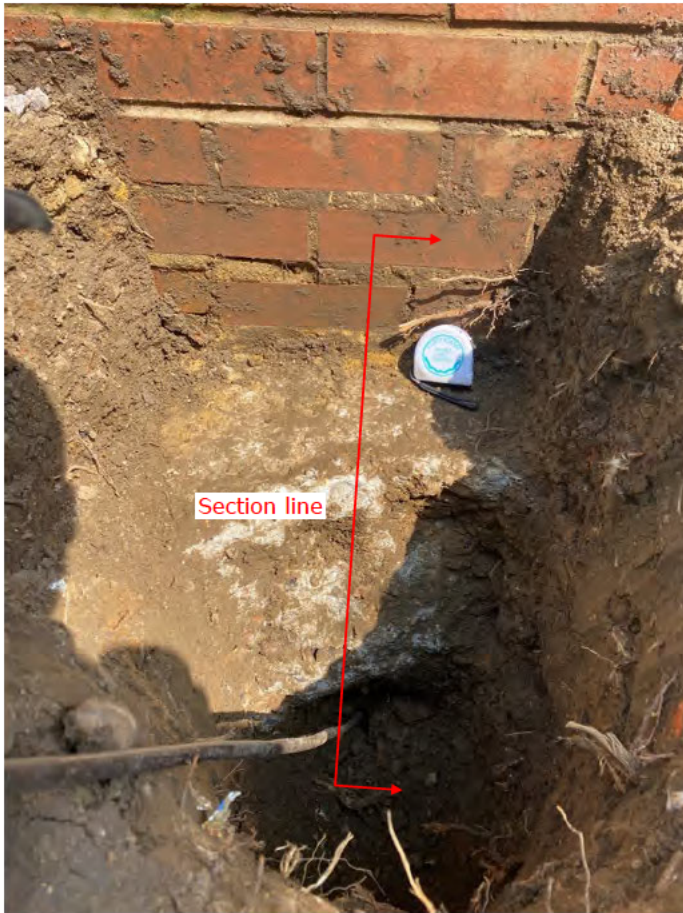
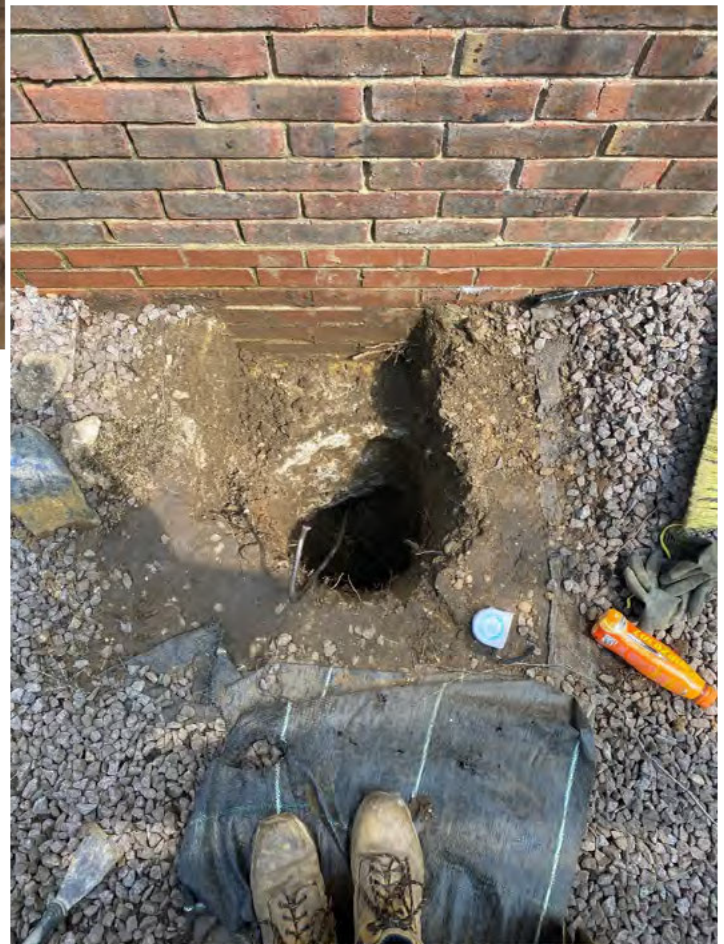
Site & Location	One YMCA, 90 Peartree Lane, Welwyn Garden City, Hertfordshire AL7 3UL	Trial Pt No: TP4b (2 of 2)
Client:	One YMCA	Report No:
Engineer:	AKS Ward	10637/AOC

PHOTOGRAPHS

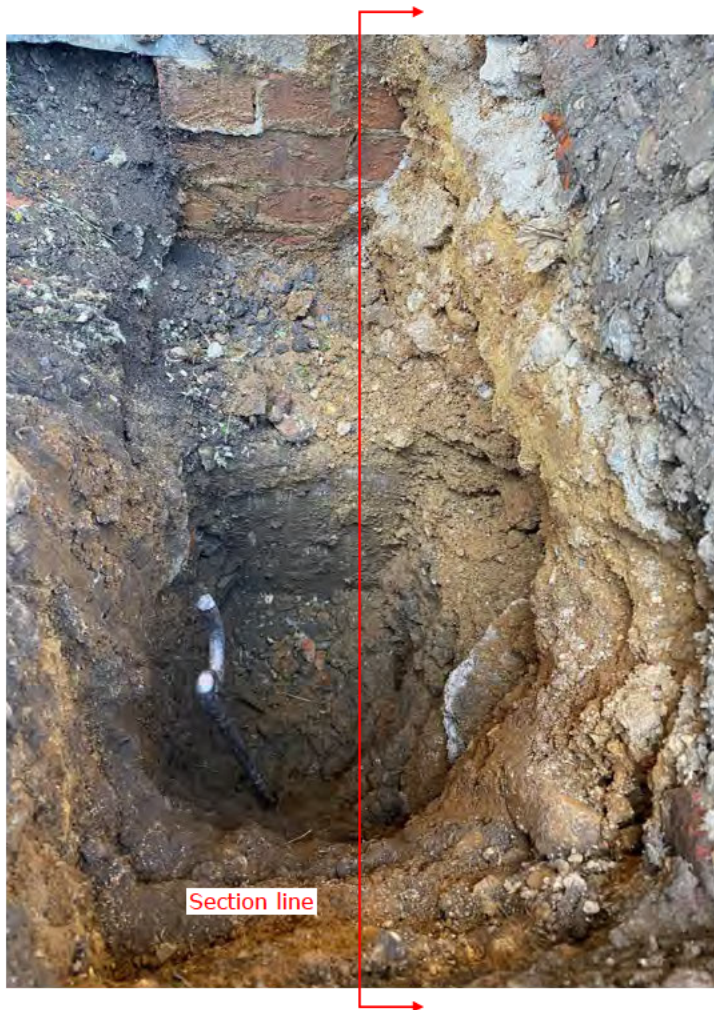
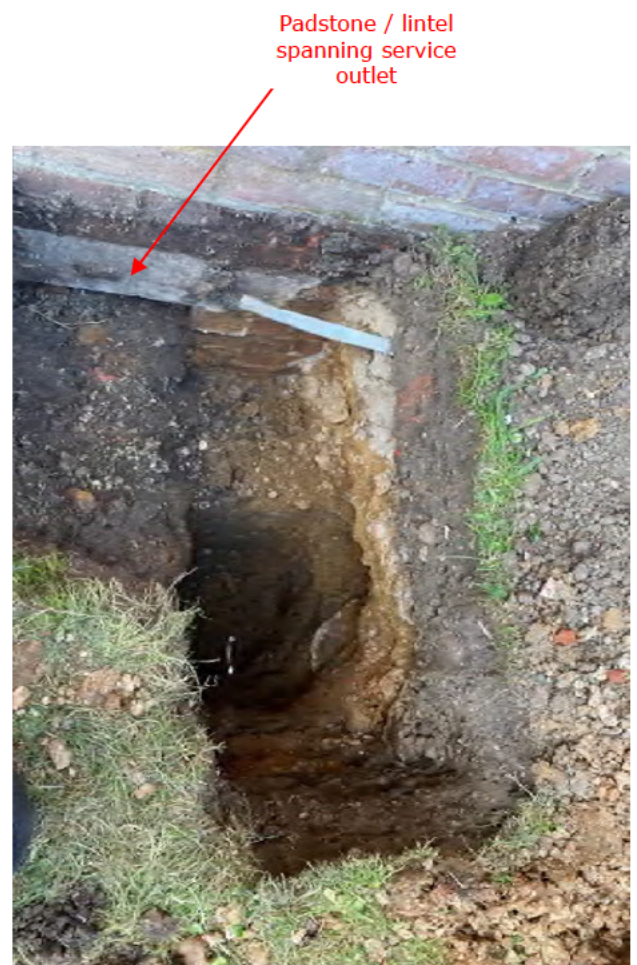
Site & Location	One YMCA, 90 Peartree Lane, Welwyn Garden City, Hertfordshire AL7 3UL	Trial Pt No: TP 5 (2 of 2)
Client:	One YMCA	Report No: 10637/AOC
Engineer:	AKS Ward

PHOTOGRAPHS

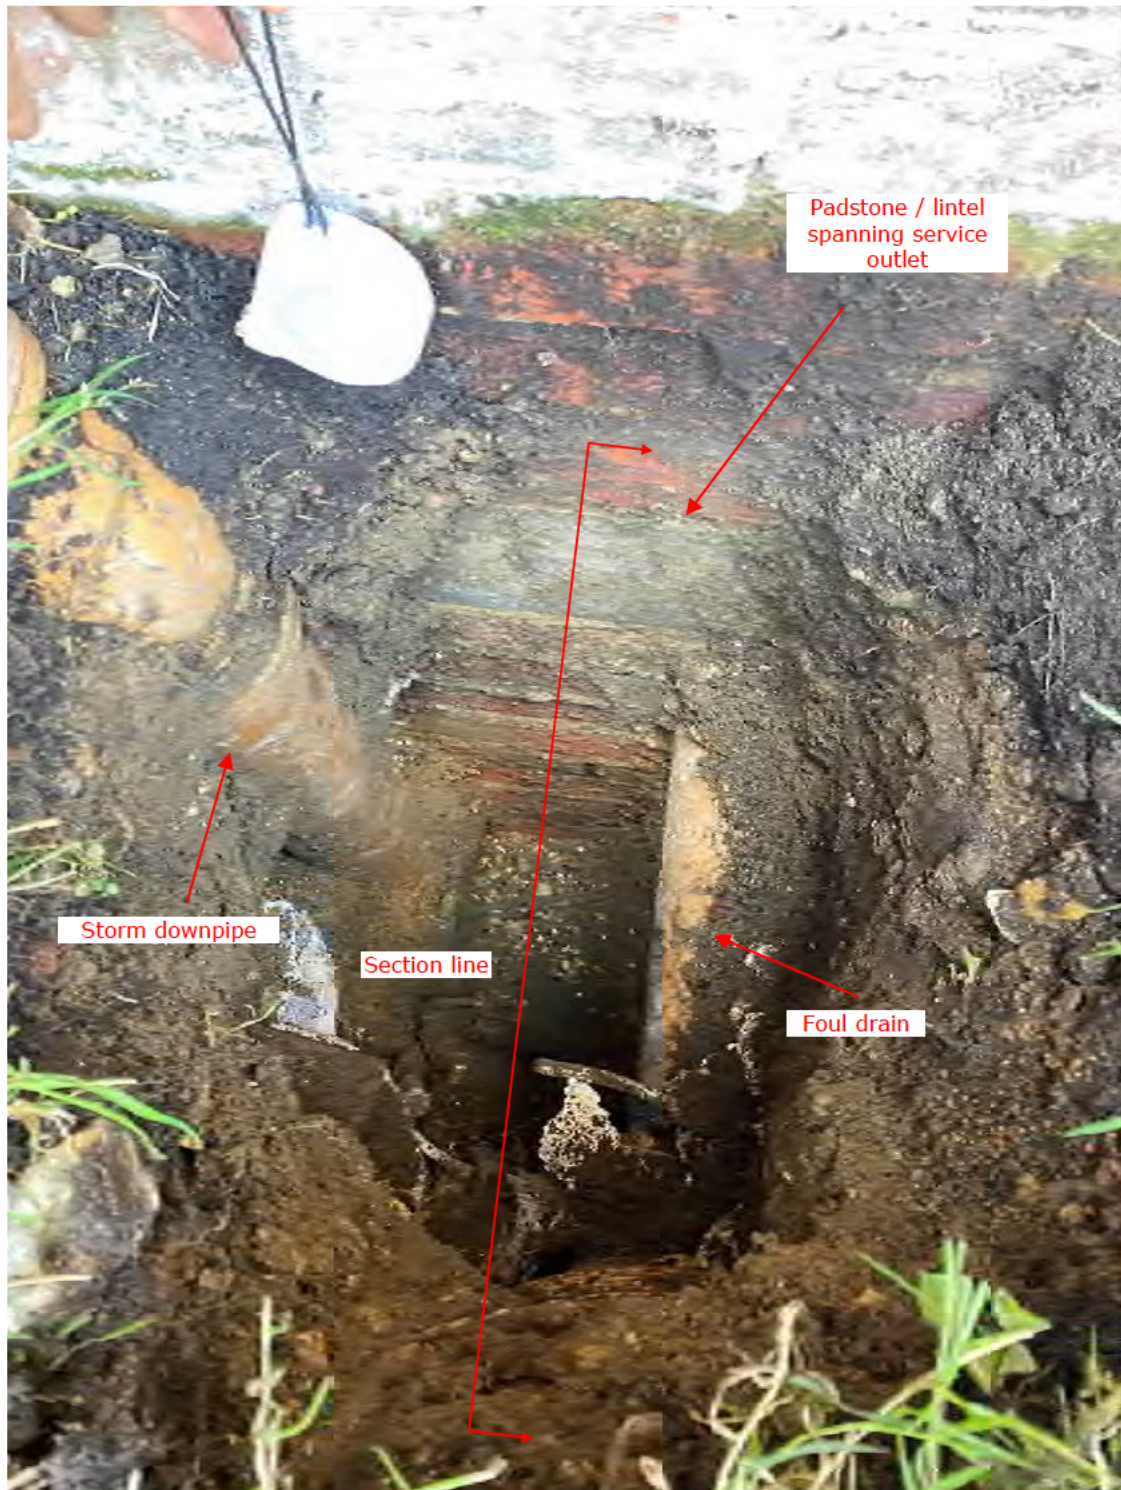
Site & Location	One YMCA, 90 Peartree Lane, Welwyn Garden City, Hertfordshire AL7 3UL	Trial Pt No: TP6a (2 of 2)
Client:	One YMCA	Report No:
Engineer:	AKS Ward	10637/AOC

PHOTOGRAPHS

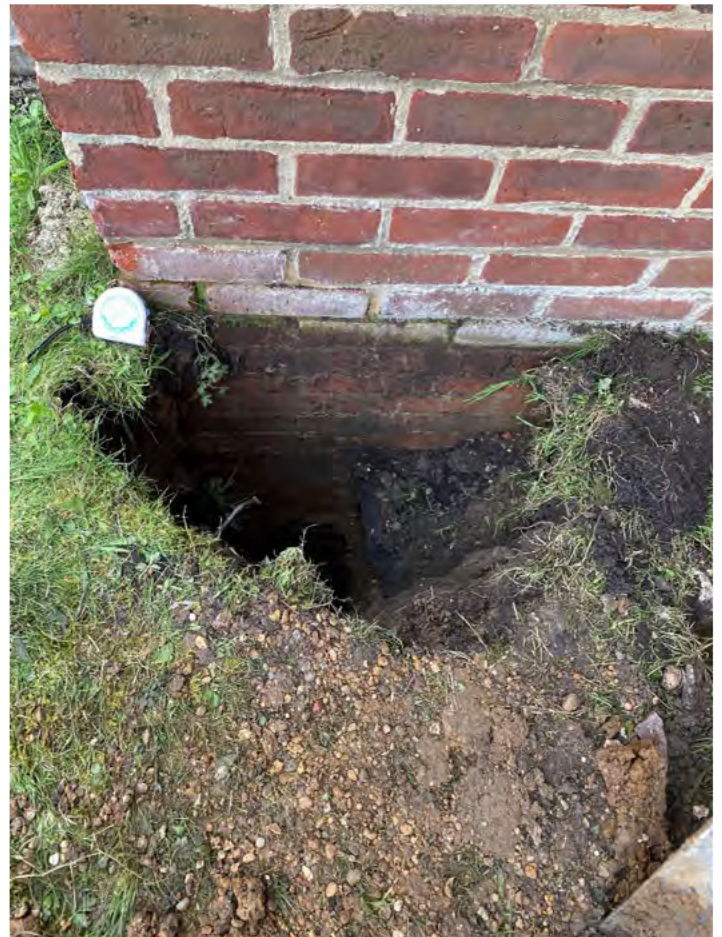
Site & Location:	One YMCA, 90 Peartree Lane, Welwyn Garden City, Hertfordshire AL7 3UL	Trial Plot No: TP6b (2 of 2)
Client:	One YMCA	Report No: 10637/AOC
Engineer:	AKS Ward

PHOTOGRAPHS

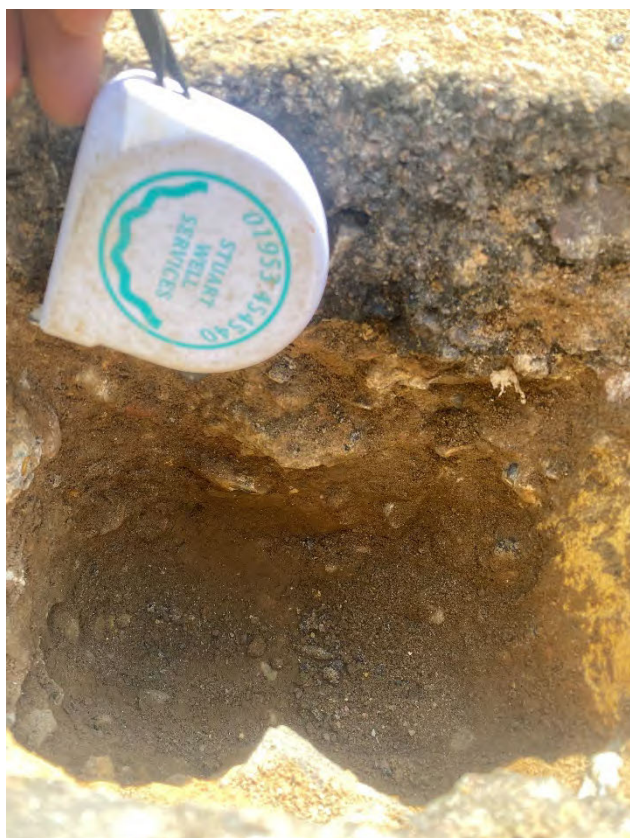
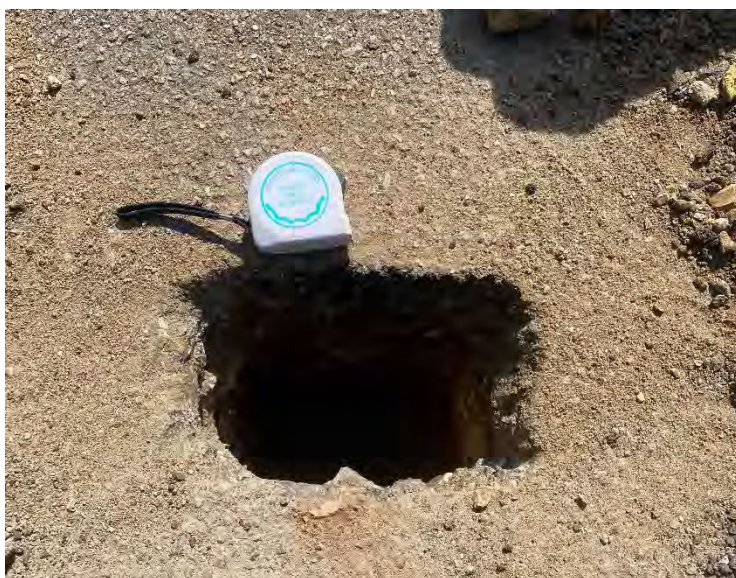
Site & Location	One YMCA 90 Peartree Lane, Welwyn Garden City, Hertfordshire AL7 3UL			Trial Pit No:	P1
Client:	One YMCA	Coords: 524389E 212651N		Report No:	10637/AOC
Engineer:	AKS Ward	Level: +84.39mOD

Depth (m)	Strata description	Samples/tests		
		Depth (m)	Type	Test results
GL to 0.10m	Asphalt			
0.10m to 0.15m	MADE GROUND: yellow brown slightly silty sandy gravel (sub-base). Gravel is fine to coarse angular to subangular flint and brick.			
0.15m to 0.26m	MADE GROUND: orange brown slightly clayey gravelly silty sand. Gravel is fine to coarse subangular to rounded flint with rare brick.	0.25m	E	PID at 0.25m = 0.4ppm

Date of excavation:	15 th June 2021	Groundwater:			
Equipment:	Handheld breaker				
Stability:	Stable	Logged by:	AOC	Checked by:	SCW
Remarks: Coordinates and ground level data extrapolated from topographical survey provided by Malcolm Hughes (Ref: 53948-1)

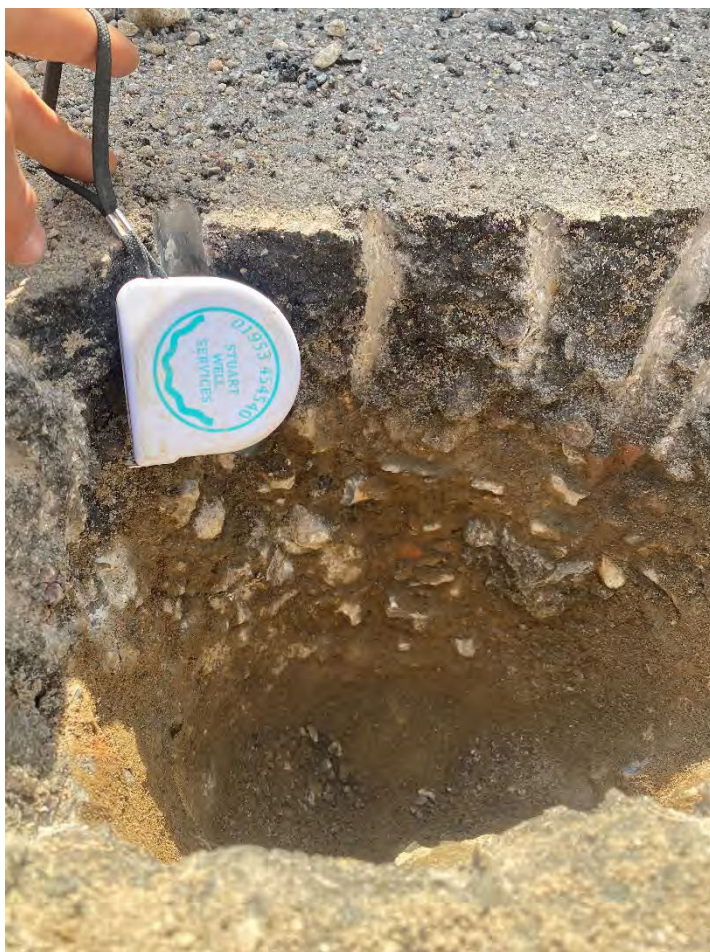
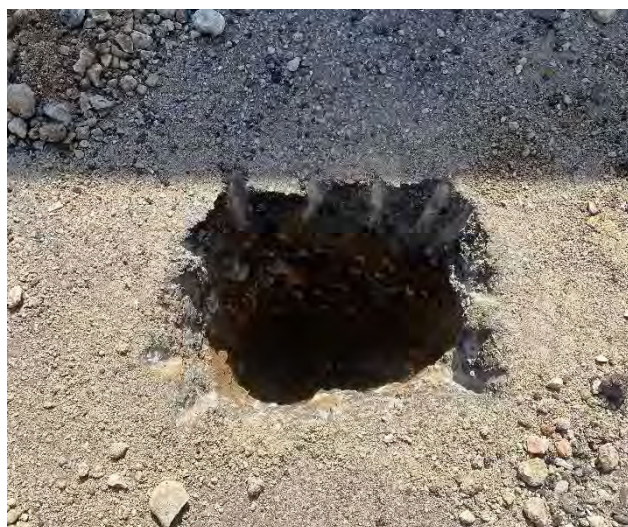
Site & Location	One YMCA 90 Peartree Lane, Welwyn Garden City, Hertfordshire AL7 3UL		Trial Pit No:	P2
Client:	One YMCA	Coords: 524404E 212635N	Report No:	10637/AOC
Engineer:	AKS Ward	Level: +83.80mOD

Depth (m)	Strata description	Samples/tests		
		Depth (m)	Type	Test results
GL to 0.05m	Asphalt – fine aggregate			
0.05m to 0.10m	Asphalt – coarse aggregate			
0.10m to 0.30m	MADE GROUND: brown slightly silty sandy gravel (sub-base). Gravel is fine to coarse angular to subangular concrete, brick and flint.			
0.30m to 0.32m	MADE GROUND: brown slightly clayey gravelly sand. Gravel is fine to coarse angular to subrounded flint and brick.	0.31m	E	PID at 0.31m = 0.2ppm

Date of excavation:	15 th June 2021	Groundwater:			
Equipment:	Handheld breaker				
Stability:	Stable	Logged by:	AOC	Checked by:	SCW
Remarks: Coordinates and ground level data extrapolated from topographical survey provided by Malcolm Hughes (Ref: 53948-1)
