77 Brookmans Avenue, Brookmans Park

PART 1 BS5837 TREE SURVEY, PART 2 ARBORICULTURAL IMPACT ASSESSMENT AND METHOD STATEMENT.

Demolition of the existing building with replacement of a new detached property

Tree Survey, Arboricultural Impact Assessment and Method Statement. 77 Brookmans Avenue, Brookmans Park. AL9 7QG

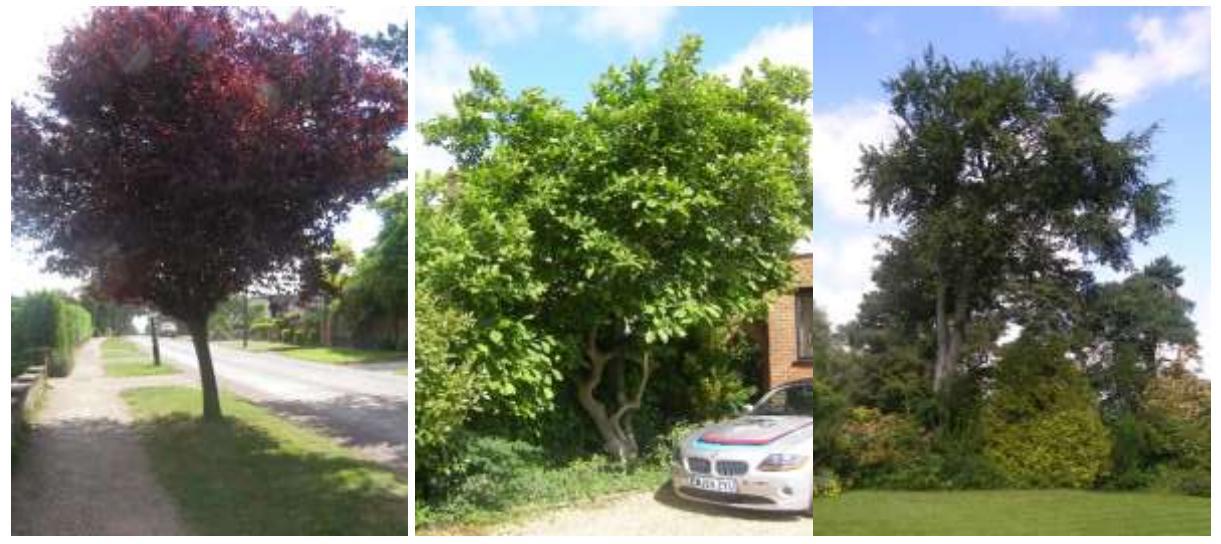
Above left - the purple leaved plum (T1) (Street tree). **Above centre**- the twin stememd magnolia (T2). **Above right** -the beech tree (T3). Below left the juniper. Below centre - the immature Bhutan pine (T5). Below right bounday laurel hedging withint he side garden of 75 Brookmans Avenue.

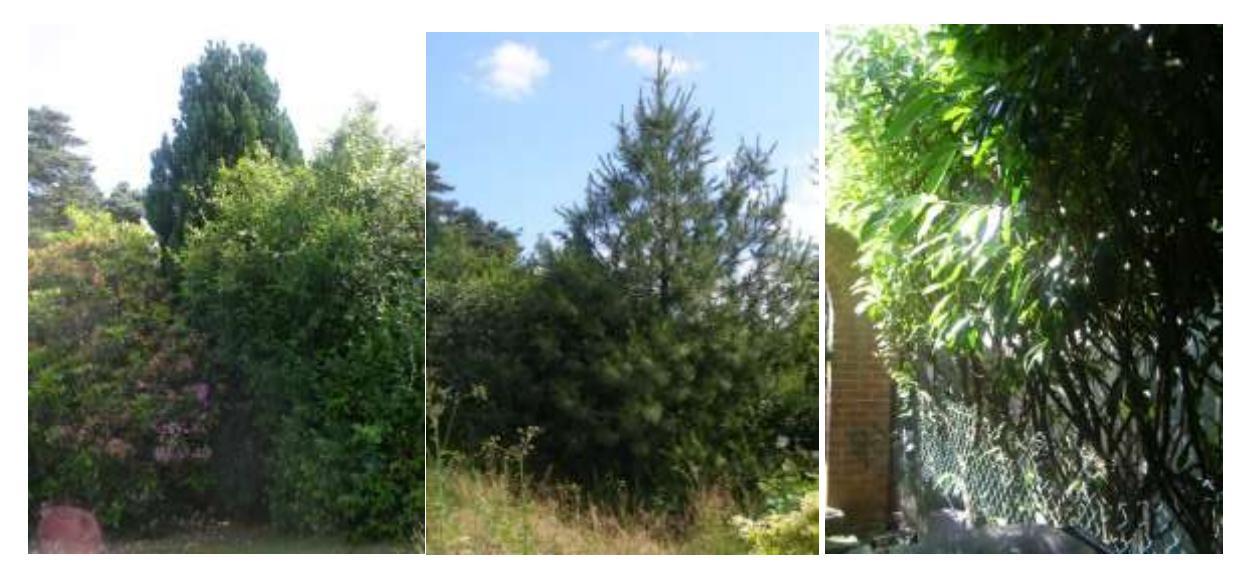
Bottom left- the grup of confier (G2) formed as a high hedge, with laurels (H2). **Bottom right** -the yew hedge (H1) along the eastern side of the front garden

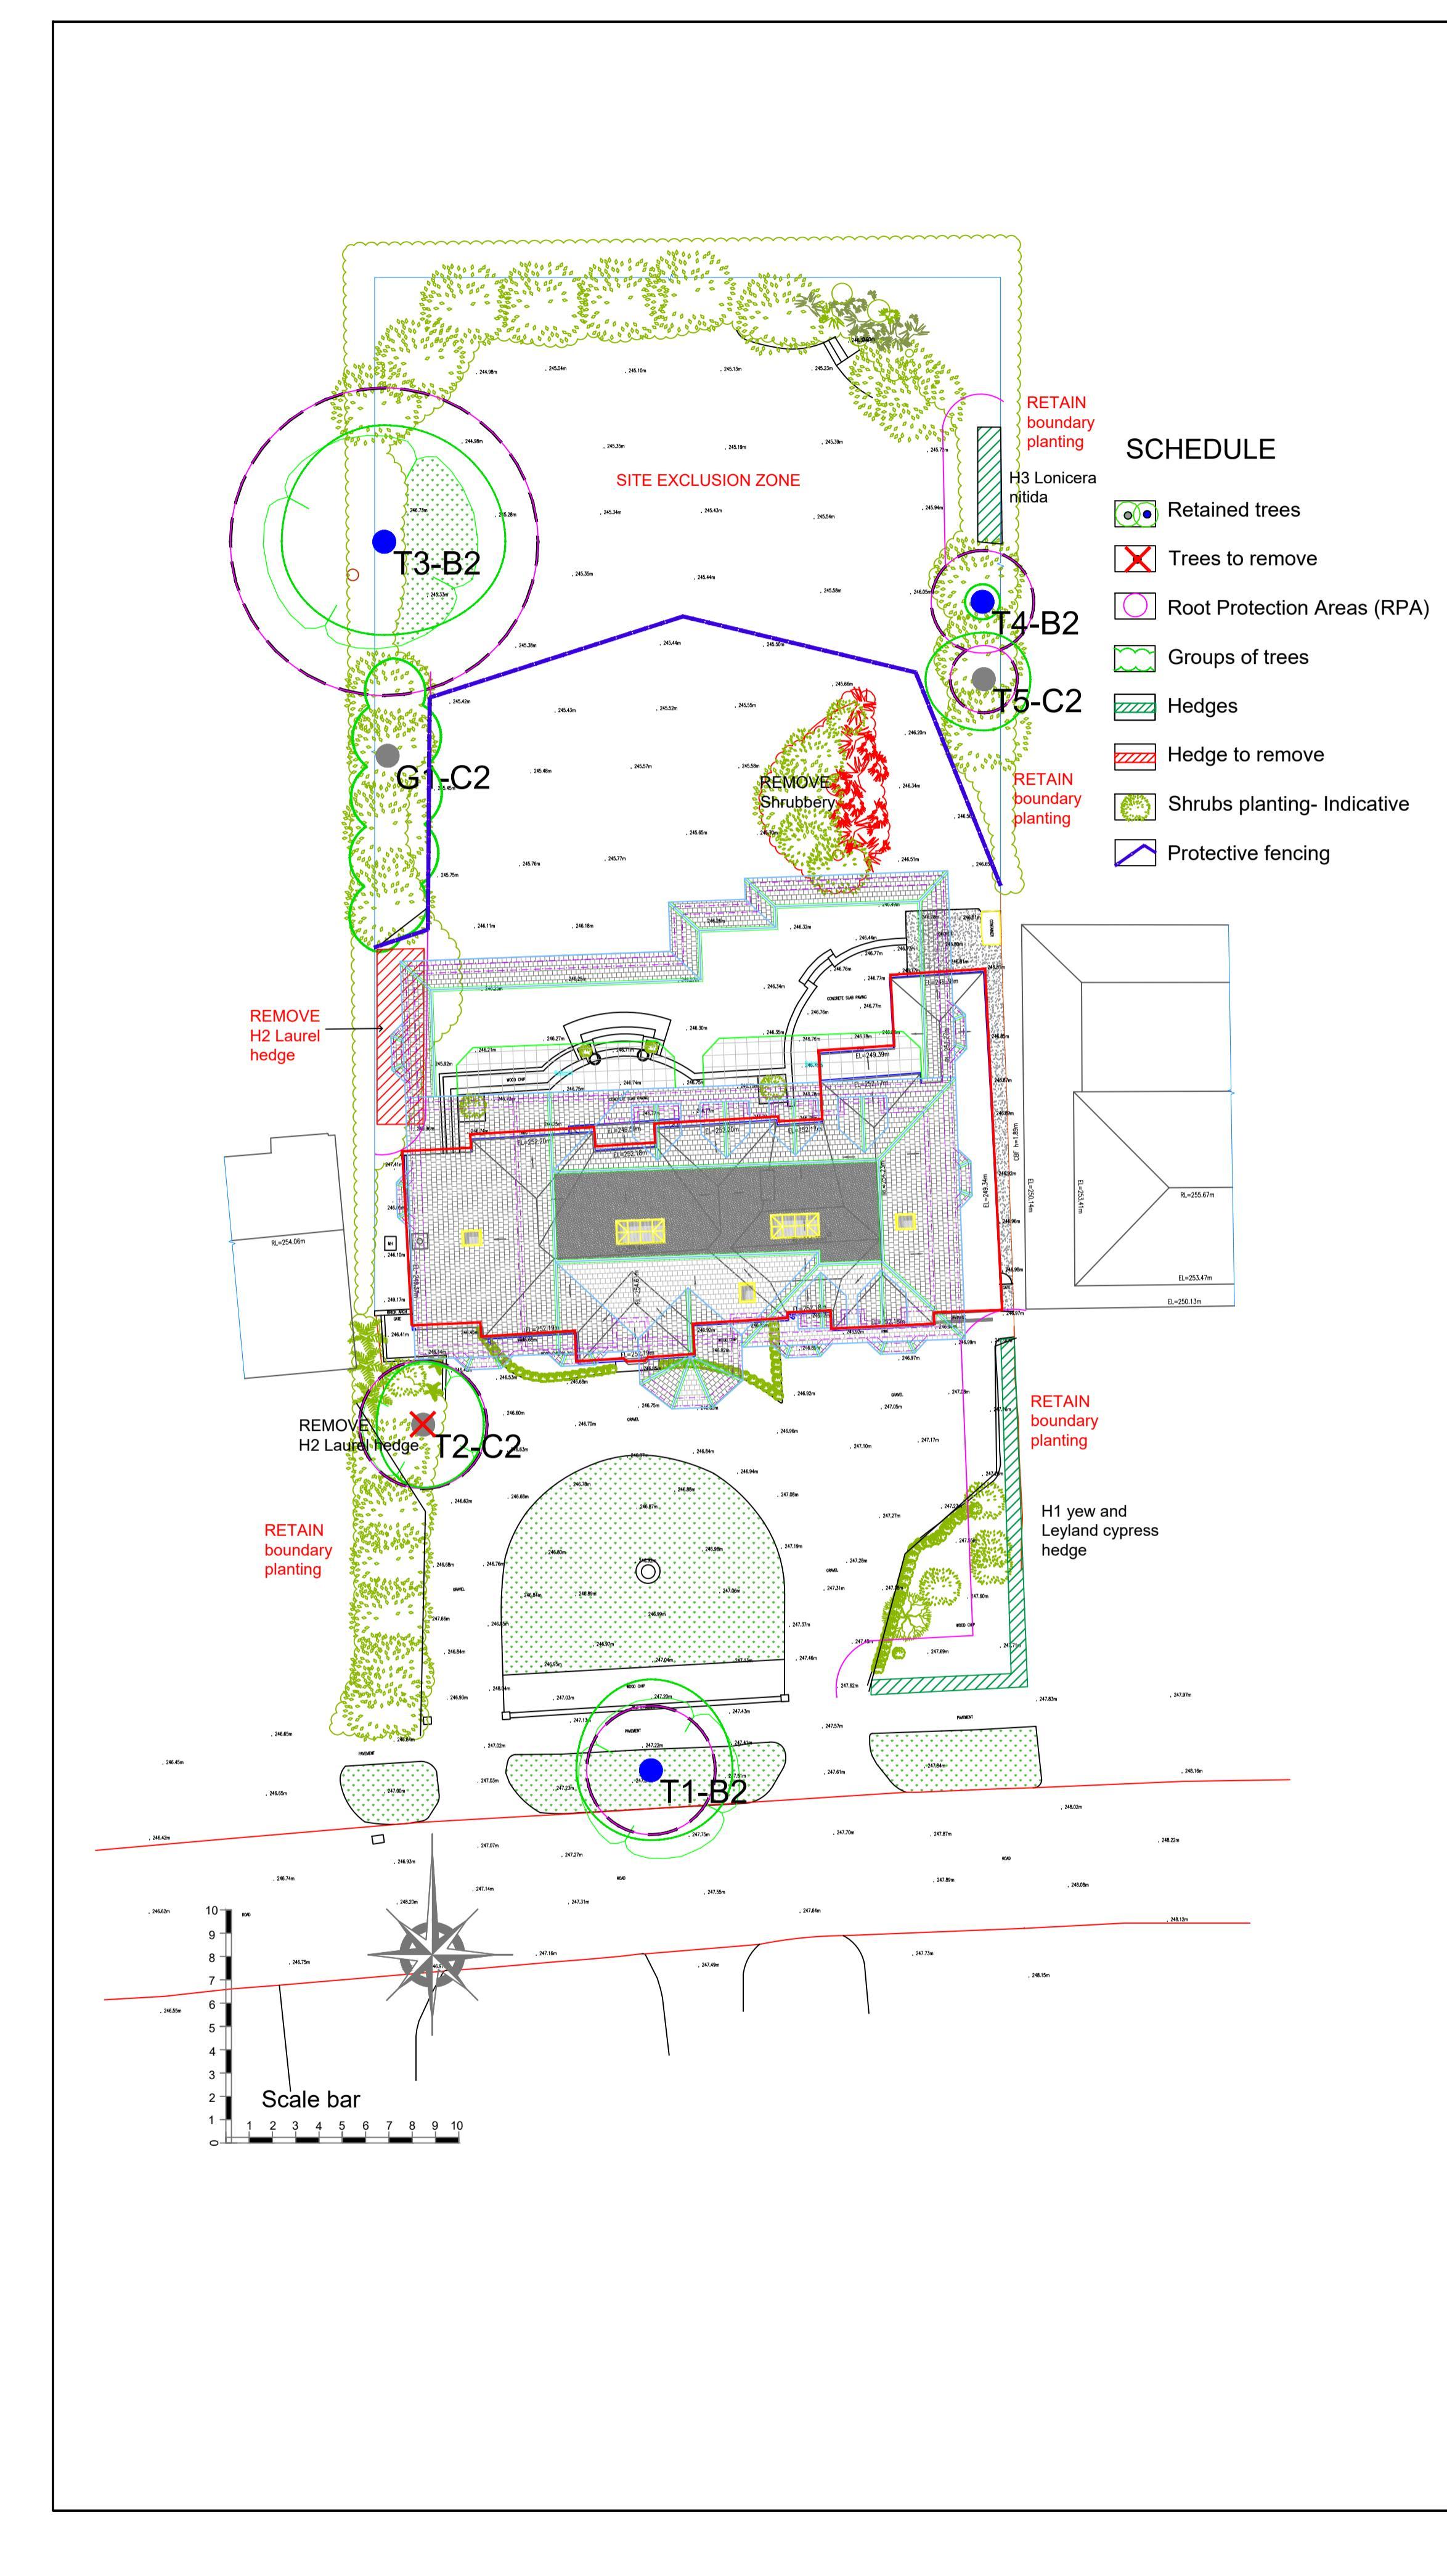
Appendix G: Plan 820.16.2 Tree Removal and Protection Plan

Protective Fencing/Protective Barrier

Details of the fencing are to comply with British Standard recommendations. All weather notices are to be affixed to this fencing with signage "CONSTRUCTION EXCLUSION ZONE - NO ACCESS".

Within root protection areas all excavation should be hand dug. A trench should be hand dug near the trees to ascertain whether roots are present. If roots over 50mm are found these should, where possible, be bridged, and surrounded by sand- roots under this dimension should be cut to a clean cut and surrounded by sand. No roots are to be left exposed but covered with damp sand or hessian. The surface level of the path may need to be adjusted to retain these roots.

If on investigation of the hand dug trench there are no roots present mechanical excavation may be possible if a banksman is supervising the excavation to ensure that if roots are unearthed they can be protected and clean cut and surrounded by sand. Hand digging may need to be resumed to complete the excavation.

This would include exploratory excavation by hand for the foundations of the paths and new hard surfacing within the root protection area of the trees
