TREE SURVEY REPORT

In accordance with British Standard 5837 2012 'Trees in Relation to design, demolition and construction – Recommendations'

> **Project** 54 Bridge Road, Welwyn Garden City, AL8 6UR

Project reference: DS30091303

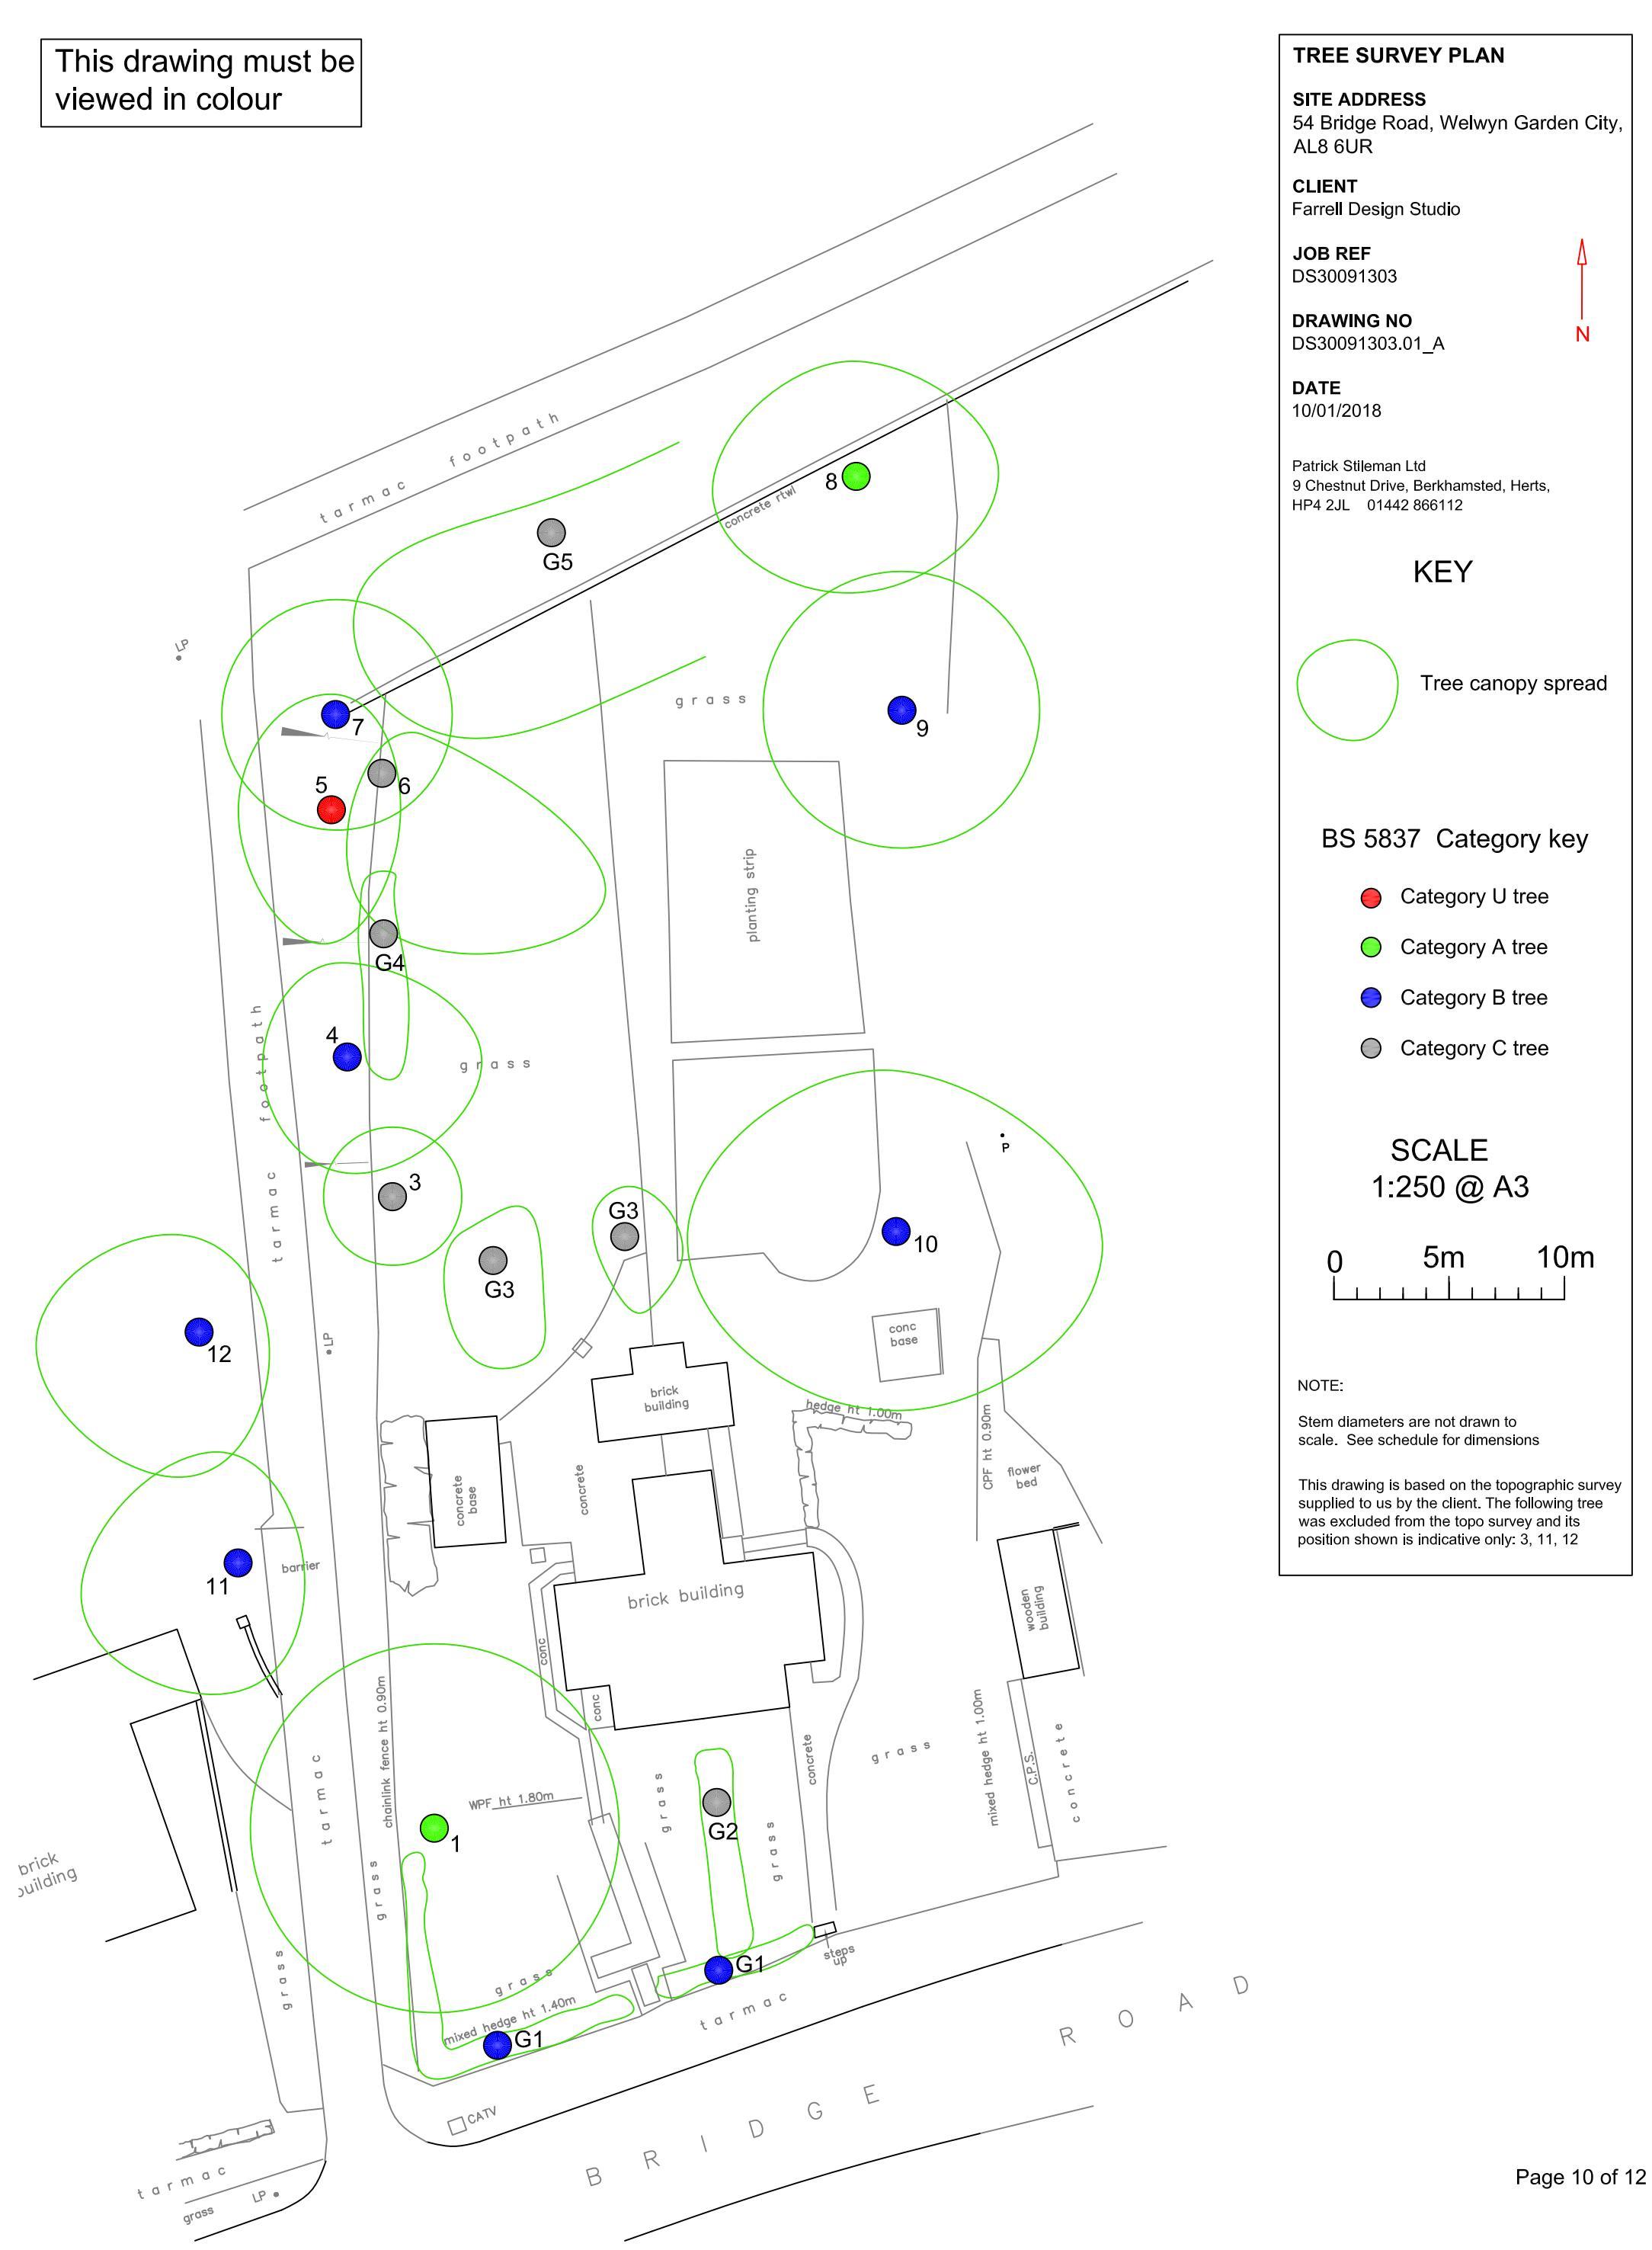
- 2.1 **Tree identification:** Individual trees have been allocated a number, and groups of trees have been allocated a number prefixed by the letter G. Their approximate locations are shown on the Tree Survey Plan drawing no: DS30091303.01-A, included on Page 10 of this report. Data pertaining to each tree is included in the Tree Survey Data on Pages 8-9 of this report.
- 2.2 **Tree data:** In carrying out the survey I assessed the following for each tree and group of trees:
 - Dimensions (height, crown spread, stem diameter, and height of crown base).
 - Root protection area, based on stem diameter (See 4.6).
 - Life stage and physiological condition.
 - Structural defects of significance, and general condition. Assessment of the value that the tree provides from a wider landscaping perspective.
 - An assessment of the likely remaining useful contribution in years.

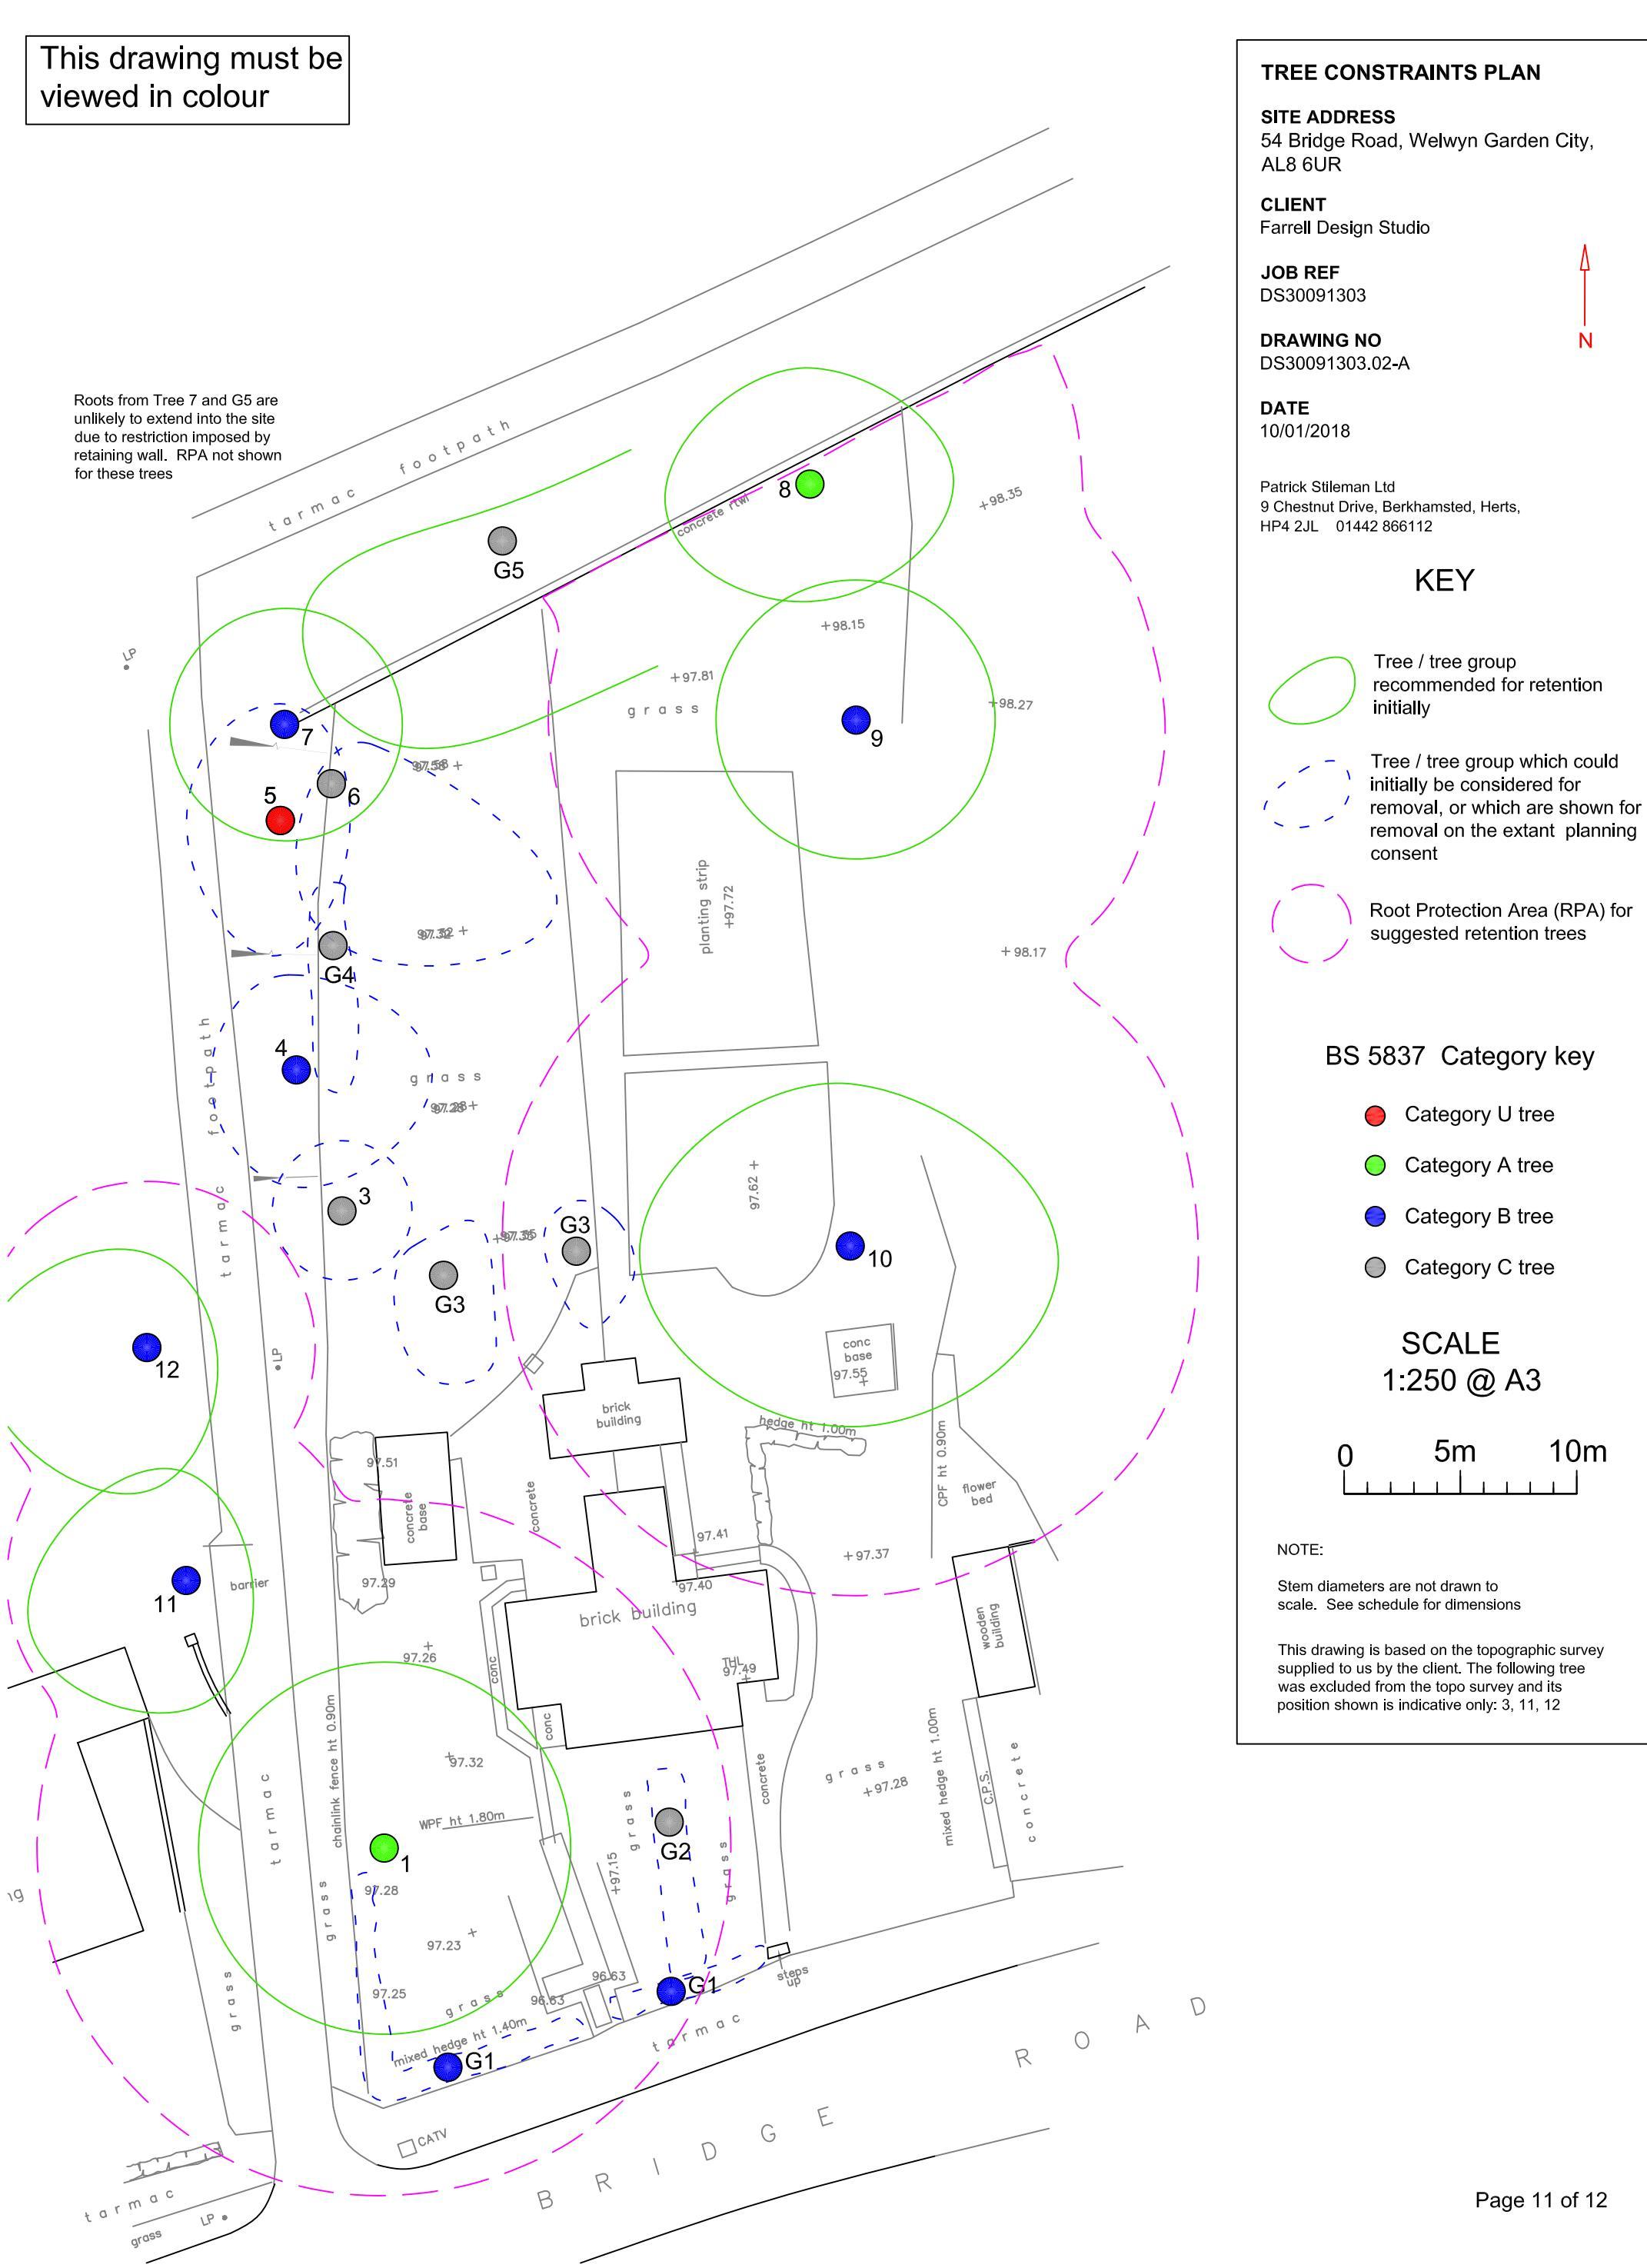
- 4.1 Based on the information obtained by the tree survey I have prepared a tree constraints plan (TCP), drawing no: DS30091303.02-A included as Page 11 of this report.

- 4.2 On the TCP, I have used different colours indicating tree crowns to distinguish between trees which could defensibly be removed in order to facilitate development (broken blue); and trees with a higher retention priority which should, initially, be considered for retention (solid green). The TCP has been prepared as a working drawing and the suggested tree retention / removal balance is not definitive.

- 4.6 The TCP shows the position of the Root Protection Area (RPA) for trees with a higher retention priority as broken pink lines. BS5837 (Section 3.7) defines the RPA as a 'layout design tool indicating the minimum area around a tree deemed to contain sufficient roots and rooting volume to maintain the tree's viability, and where the protection of the roots and soil structure is treated as a priority'. In other words, the RPA represents the **minimum** area around each tree in which the ground should remain largely undisturbed. The RPA is an area based on a circle with a radial distance of 12x the stem diameter at 1.5 metres in the case of single-stemmed trees, or 12x the combined stem diameter (calculated in accordance with a formula set out in BS5837) for trees with more than one stem. In situations where the site conditions clearly prevent consistent rooting around the tree (for example the presence of roads or buildings within the notional RPA circle) I modify the shape of the RPA to take this into account. At this site I have adjusted the RPA shape for Tree 7 and G5 which are constrained by the 2m height retaining wall beyond which the trees are growing.
