Former Hazel Grove School Playing Fields Site, Filbert Close Hatfield

Arboricultural Survey Report

August 2019 RE70091V002B Ð

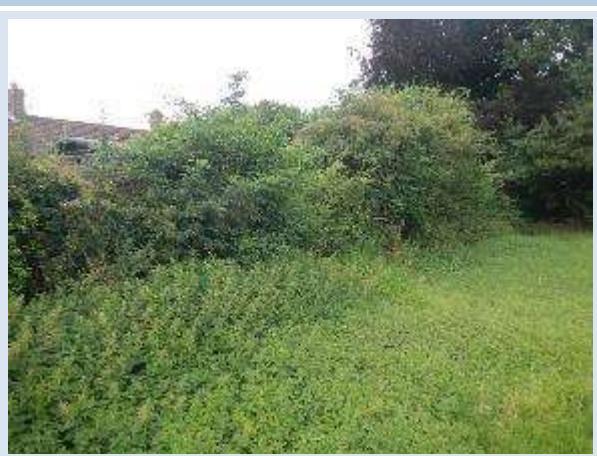
Category B red oak T10

T10 (red oak) has been placed into this category due to its arboricultural merits and is the only example of its species within the Site. One broken limb has been identified that may be of value to roosting bats.

T10	Oak, Red	Quercus rubra	22	1	750		Radius: 9.0m. Area: 254 sq m.	9	9	9	9	3			Some broken branches. Possible habitat for foorsting bats.	B1
T12	Ash	Fraxinus sp.	18	7	400		Radius: 12.7m. Area: 507 sq m.	8	8	8	8	1	1	Mature		C2
T15	Maple, Field	Acer campestre	15	5		100, 100, 120, 120, 230,	Radius: 3.8m. Area: 45 sq m.	4	4	4	4	1	2	Semi Mature		С

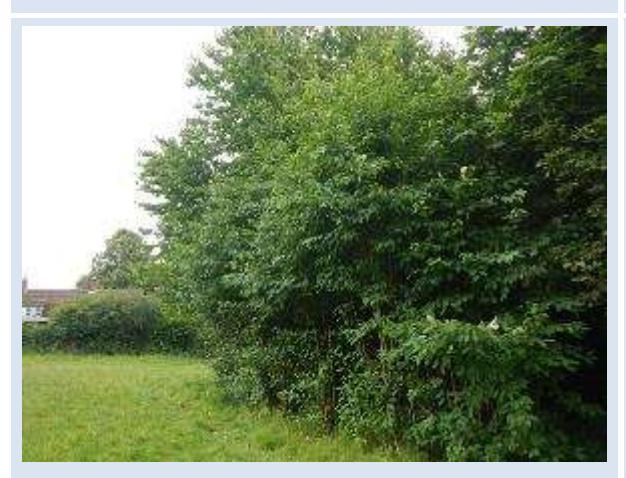
G49 and T09 cherry suckers

G01 is a hedgerow forming the boundary between the eastern edge of the Site and residential gardens

G14, G22, and G49 are mixed species groups generally dominated by cherry suckers, field maple, ash, and dogwood. Individual trees of note within these groups have been outlined above in Section 4.4.

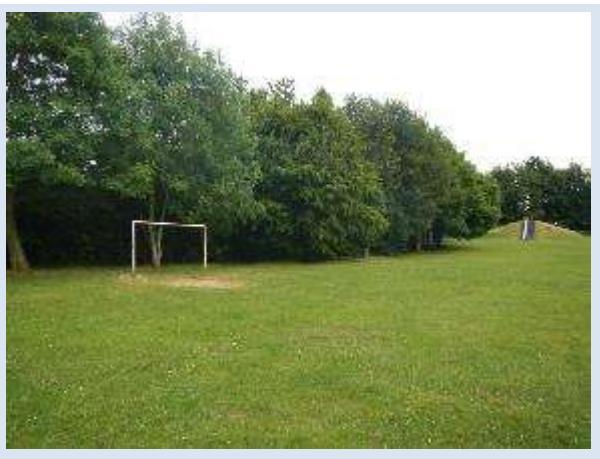
Row of Category A and Category B off-site trees adjacent to the southern boundary of the Site

Eleven off-site Category A trees have recorded growing within the park to the south of the Site. These trees are of good structure and are providing a visual screening between the Site and the park. Many of these trees have branches that overhang the Site and the RPA of several also cross the scheme boundary.

T36, T42 and T47 are off-site trees within proximity to the southern boundary of the Site.

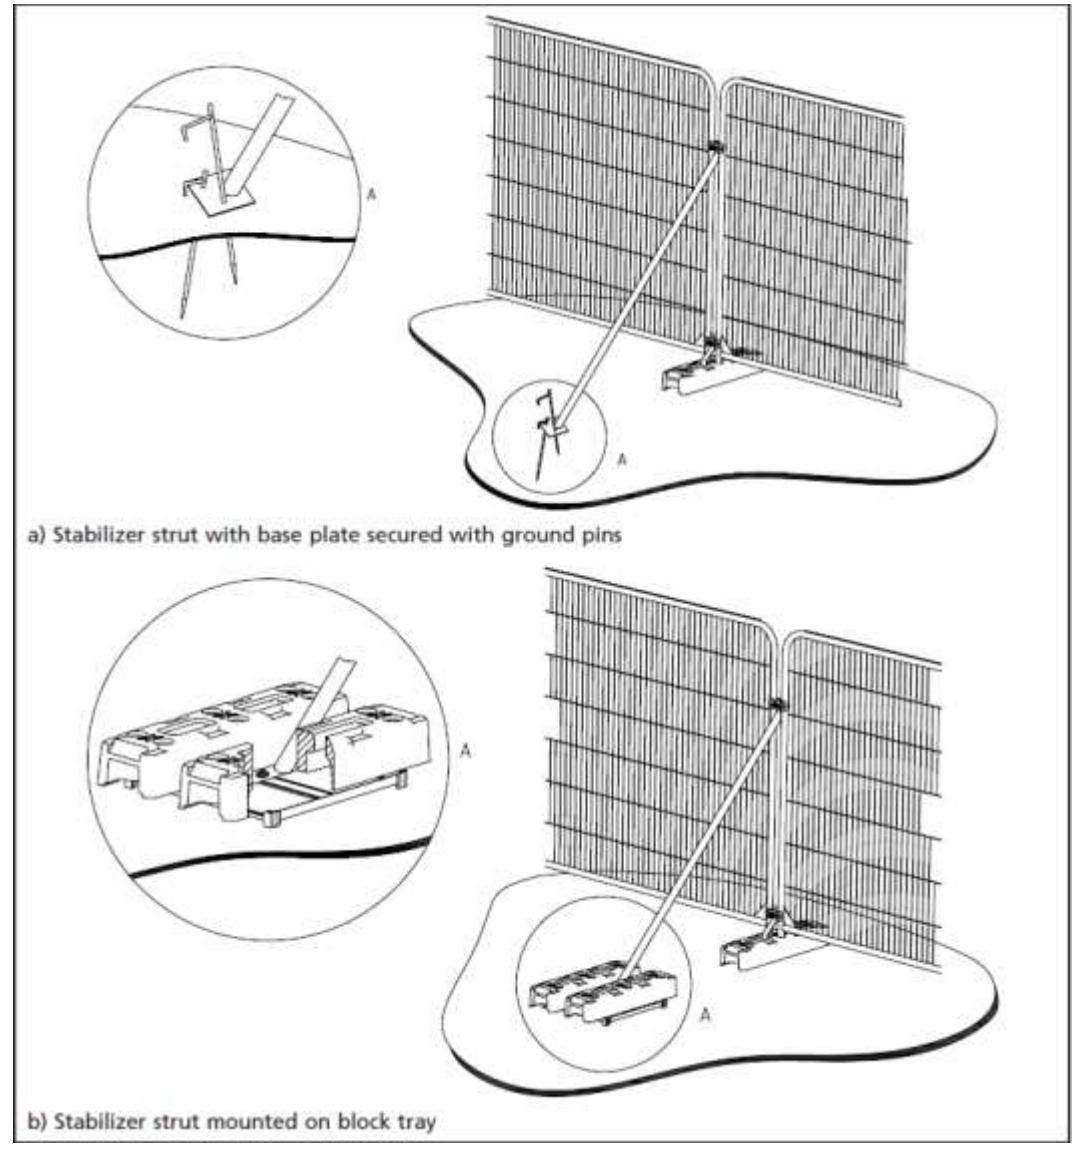
All barriers should conform to the standard specified in BS 5837:2012 and are shown in Figure 3 below.

The protective barriers should comprise a scaffold frame from which "heras" type fencing (or similar) should be firmly attached. The barrier must be strong enough to protect the trees from the expected level of construction activity and should be constructed so that it cannot be easily moved.

Once the exclusion zone has been protected by barriers and/or ground protection, construction work can commence. All weather notices must be erected on the barriers stating "Construction Exclusion Zone KEEP OUT". It is recommended that the protective fencing is erected under the supervision of an arborist to ensure that adequate protection is provided.

The location of protective barriers will need to be shown on the TPP. Once the protective fencing is in place it should be inspected by the project arborist, who should then inform the local authority tree officer that the erection work has been completed.

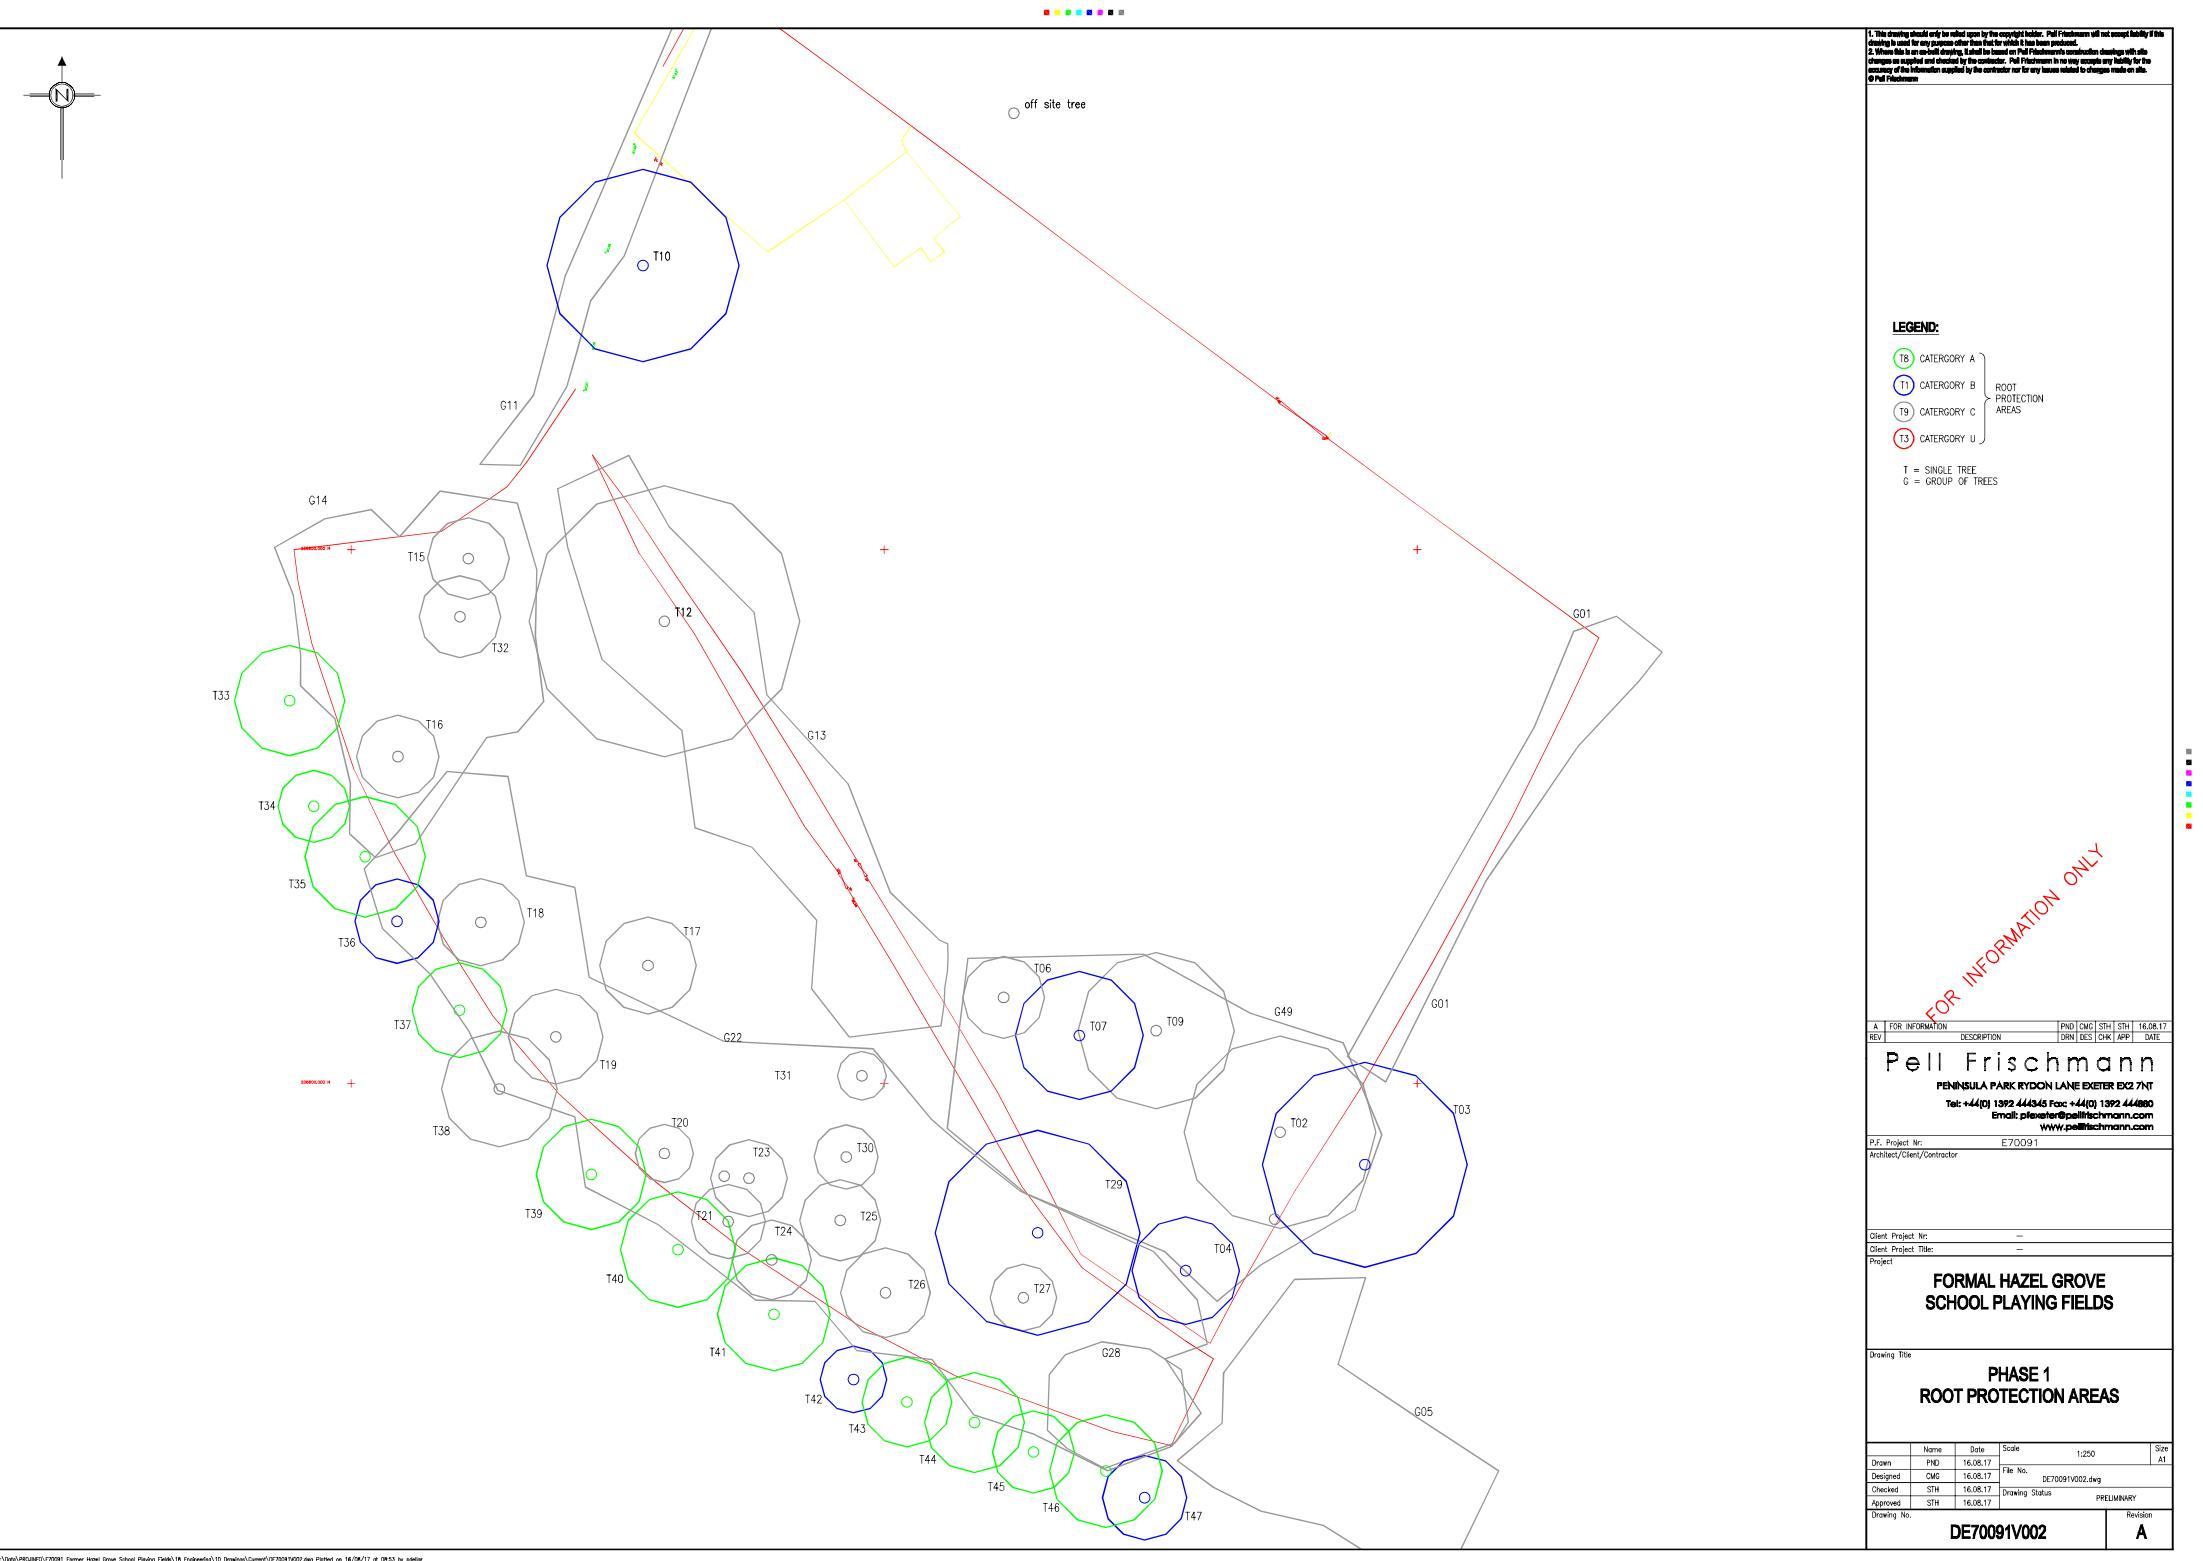
## Appendix C Tree Constraints Plan

BS 5837 states that all retained trees or groups of trees should be protected by RPAs marked by the erection of a protective barrier. The Tree Constraints Plan and the Tree Survey Schedule shows the RPA for each tree or group of trees.
