Client **J D Wetherspoon**

Title **Topographical & Utilities Survey**

Project **Proposed Pub/Restaurant Hatfield Hertfordshire**

Drawing No.	3618/10/001	Rev.	-

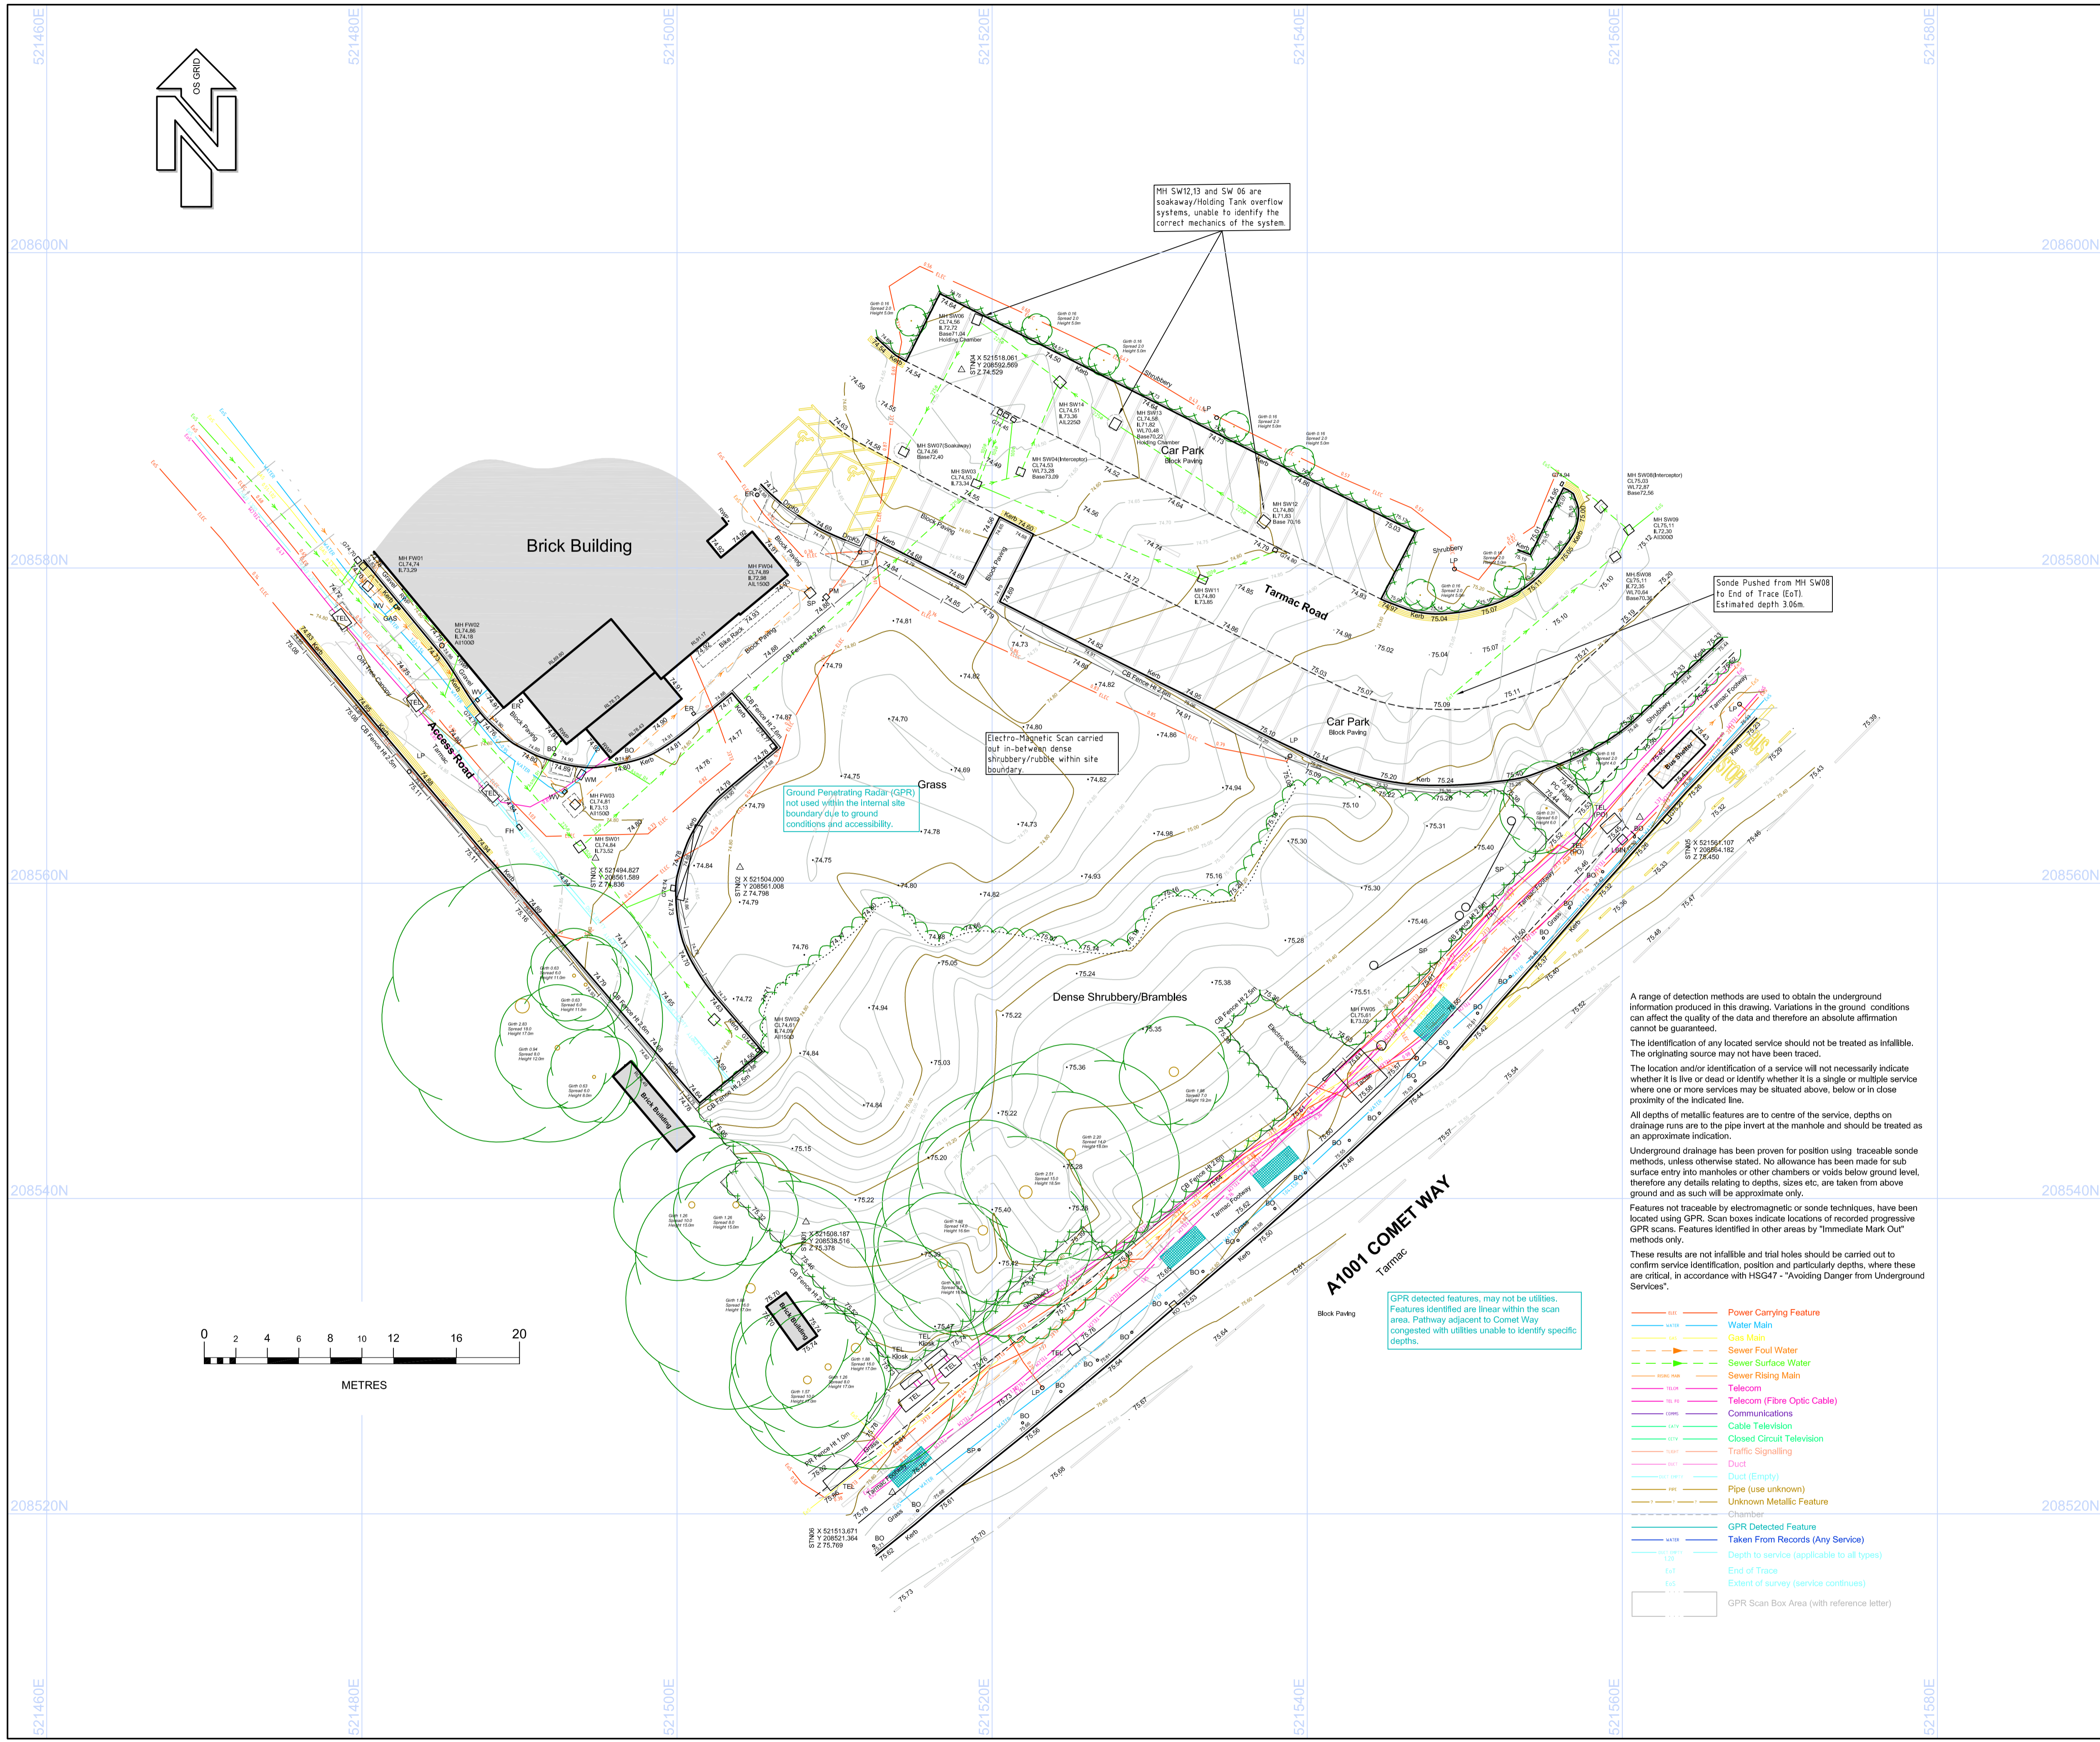
MH SW12.13 and SW16 are soakaway/holding tank overflow systems, unable to identify the correct mechanics of the system

Sande Pushed from MH SW08 to End of Trace (EoT). Estimated depth 3.06m.

Electro-Magnetic Scan carried out in-between dense shrubbery/rubbers within site boundary.

Ground Penetrating Radar (GPR) not used within the internal site boundary due to ground conditions and accessibility.

These results are not infallible and trial holes should be carried out to confirm service identification, position and particularly depths, where these are critical, in accordance with HSG47 - "Avoiding Danger from Underground Services".
