[04] Proposed Hand-Drawn Plan and Section Barn Details @12

[05] Proposed Barn Walls & Roof Upgrade Details

[01] Hand Drawing of Proposed North-West Barn Elevation @1:50

[02] Hand Drawing of Proposed South-West Barn Elevation @1:50

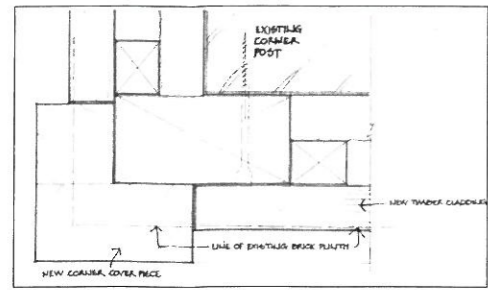
[04.4] Proposed Pine Cladding Corner Detail (Plan) @12

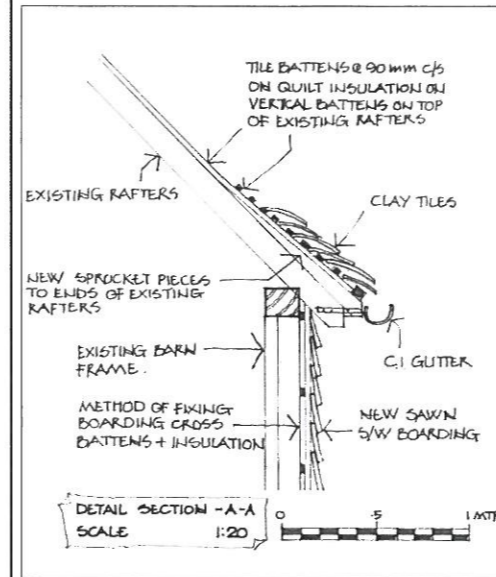
[05.1] Proposed Wall to Roof Junction Detail (Section) @120

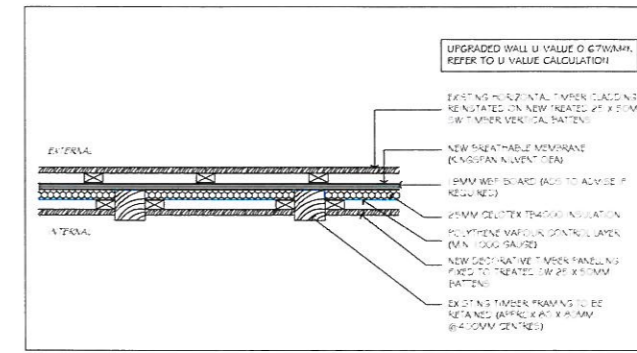
[05.4] Proposed Barn Wall Upgrade Detail (Plan) @110

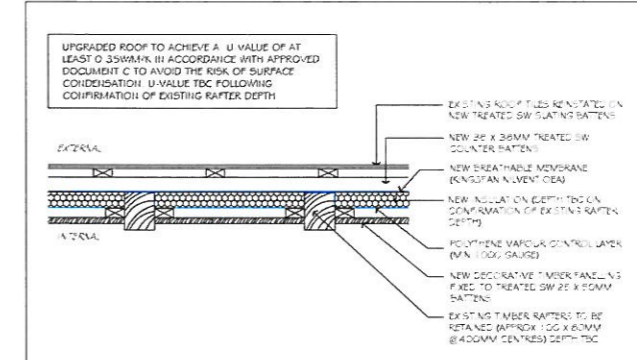
[05.2] Proposed Barn Roof Upgrade Detail (Plan) @110

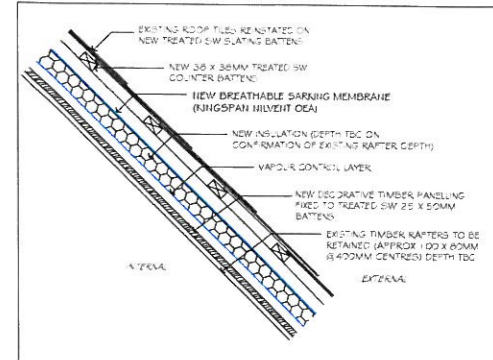
[05.3] Proposed Barn Roof Upgrade Detail (Section) @110

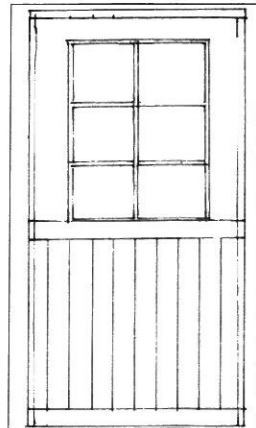
[03.2] External Elevation @1:20

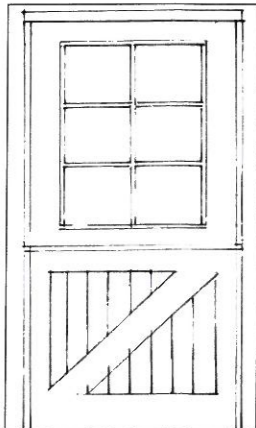
[03.1] Internal Elevation @1:20
