Arboricultural Method Statement

Plot 4100,
Gypsy Moth Avenue,
Hatfield Business Park,
Hatfield,
AL10 9SN.

12 January 2018

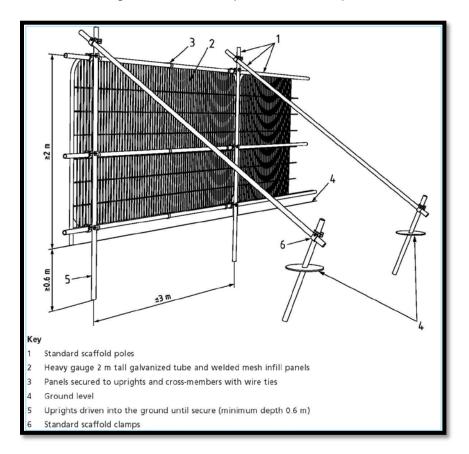
Figure 2: BS5837:2012 - Figure 2, Default specification for protective barriers.

<u>Default specification:</u> To comprise either 2.4m wooden site hoarding; or a 2.3m high scaffold framework, well braced to resist impacts, with uprights to be spaced at a maximum of 3.0m intervals and driven into the ground by a minimum of 600mm. On to this, standard anti-climb welded mesh panels are to be securely fixed to each other with at least two scaffold clamps and to the scaffold frame work with wire.

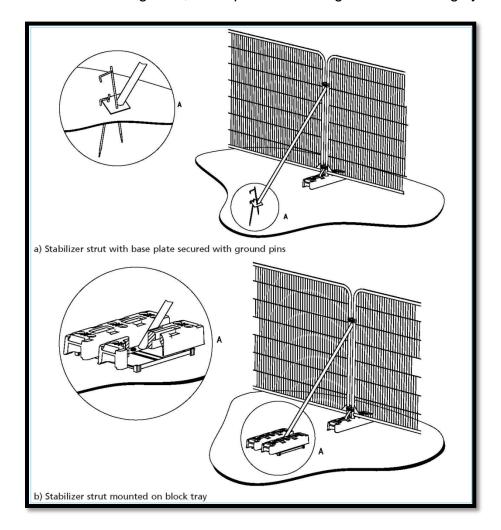
<u>Secondary specification:</u> To comprise of 2m tall welded mesh panels on rubber or concrete feet. Panels are to be joined together using a minimum of two anti-tamper couplers, installed so that they can only be removed from inside the fence. The panels should be supported on the inner side by stabiliser struts, which should be attached to a base plate and secured with ground pins.
