**RE: SUPPLEMENTARY GEO-ENVIRONMENTAL INFORMATION PERTAINING TO THE DISCHARGE OF PLANNING CONDITION 20 ASSOCIATED WITH PLANNING REF: S6/2011/1994/MA**

**RSK 2011 'hotspot' locations in relation to proposed end-use layout**

<b>Client:</b>	Gascoyne Cecil Estates	<b>Figure No:</b>	1
<b>Site:</b>	Old Hatfield	<b>Job No:</b>	27975
<b>Scale:</b>	NTS	<b>Source:</b>	Henshall Green drawing 010_002

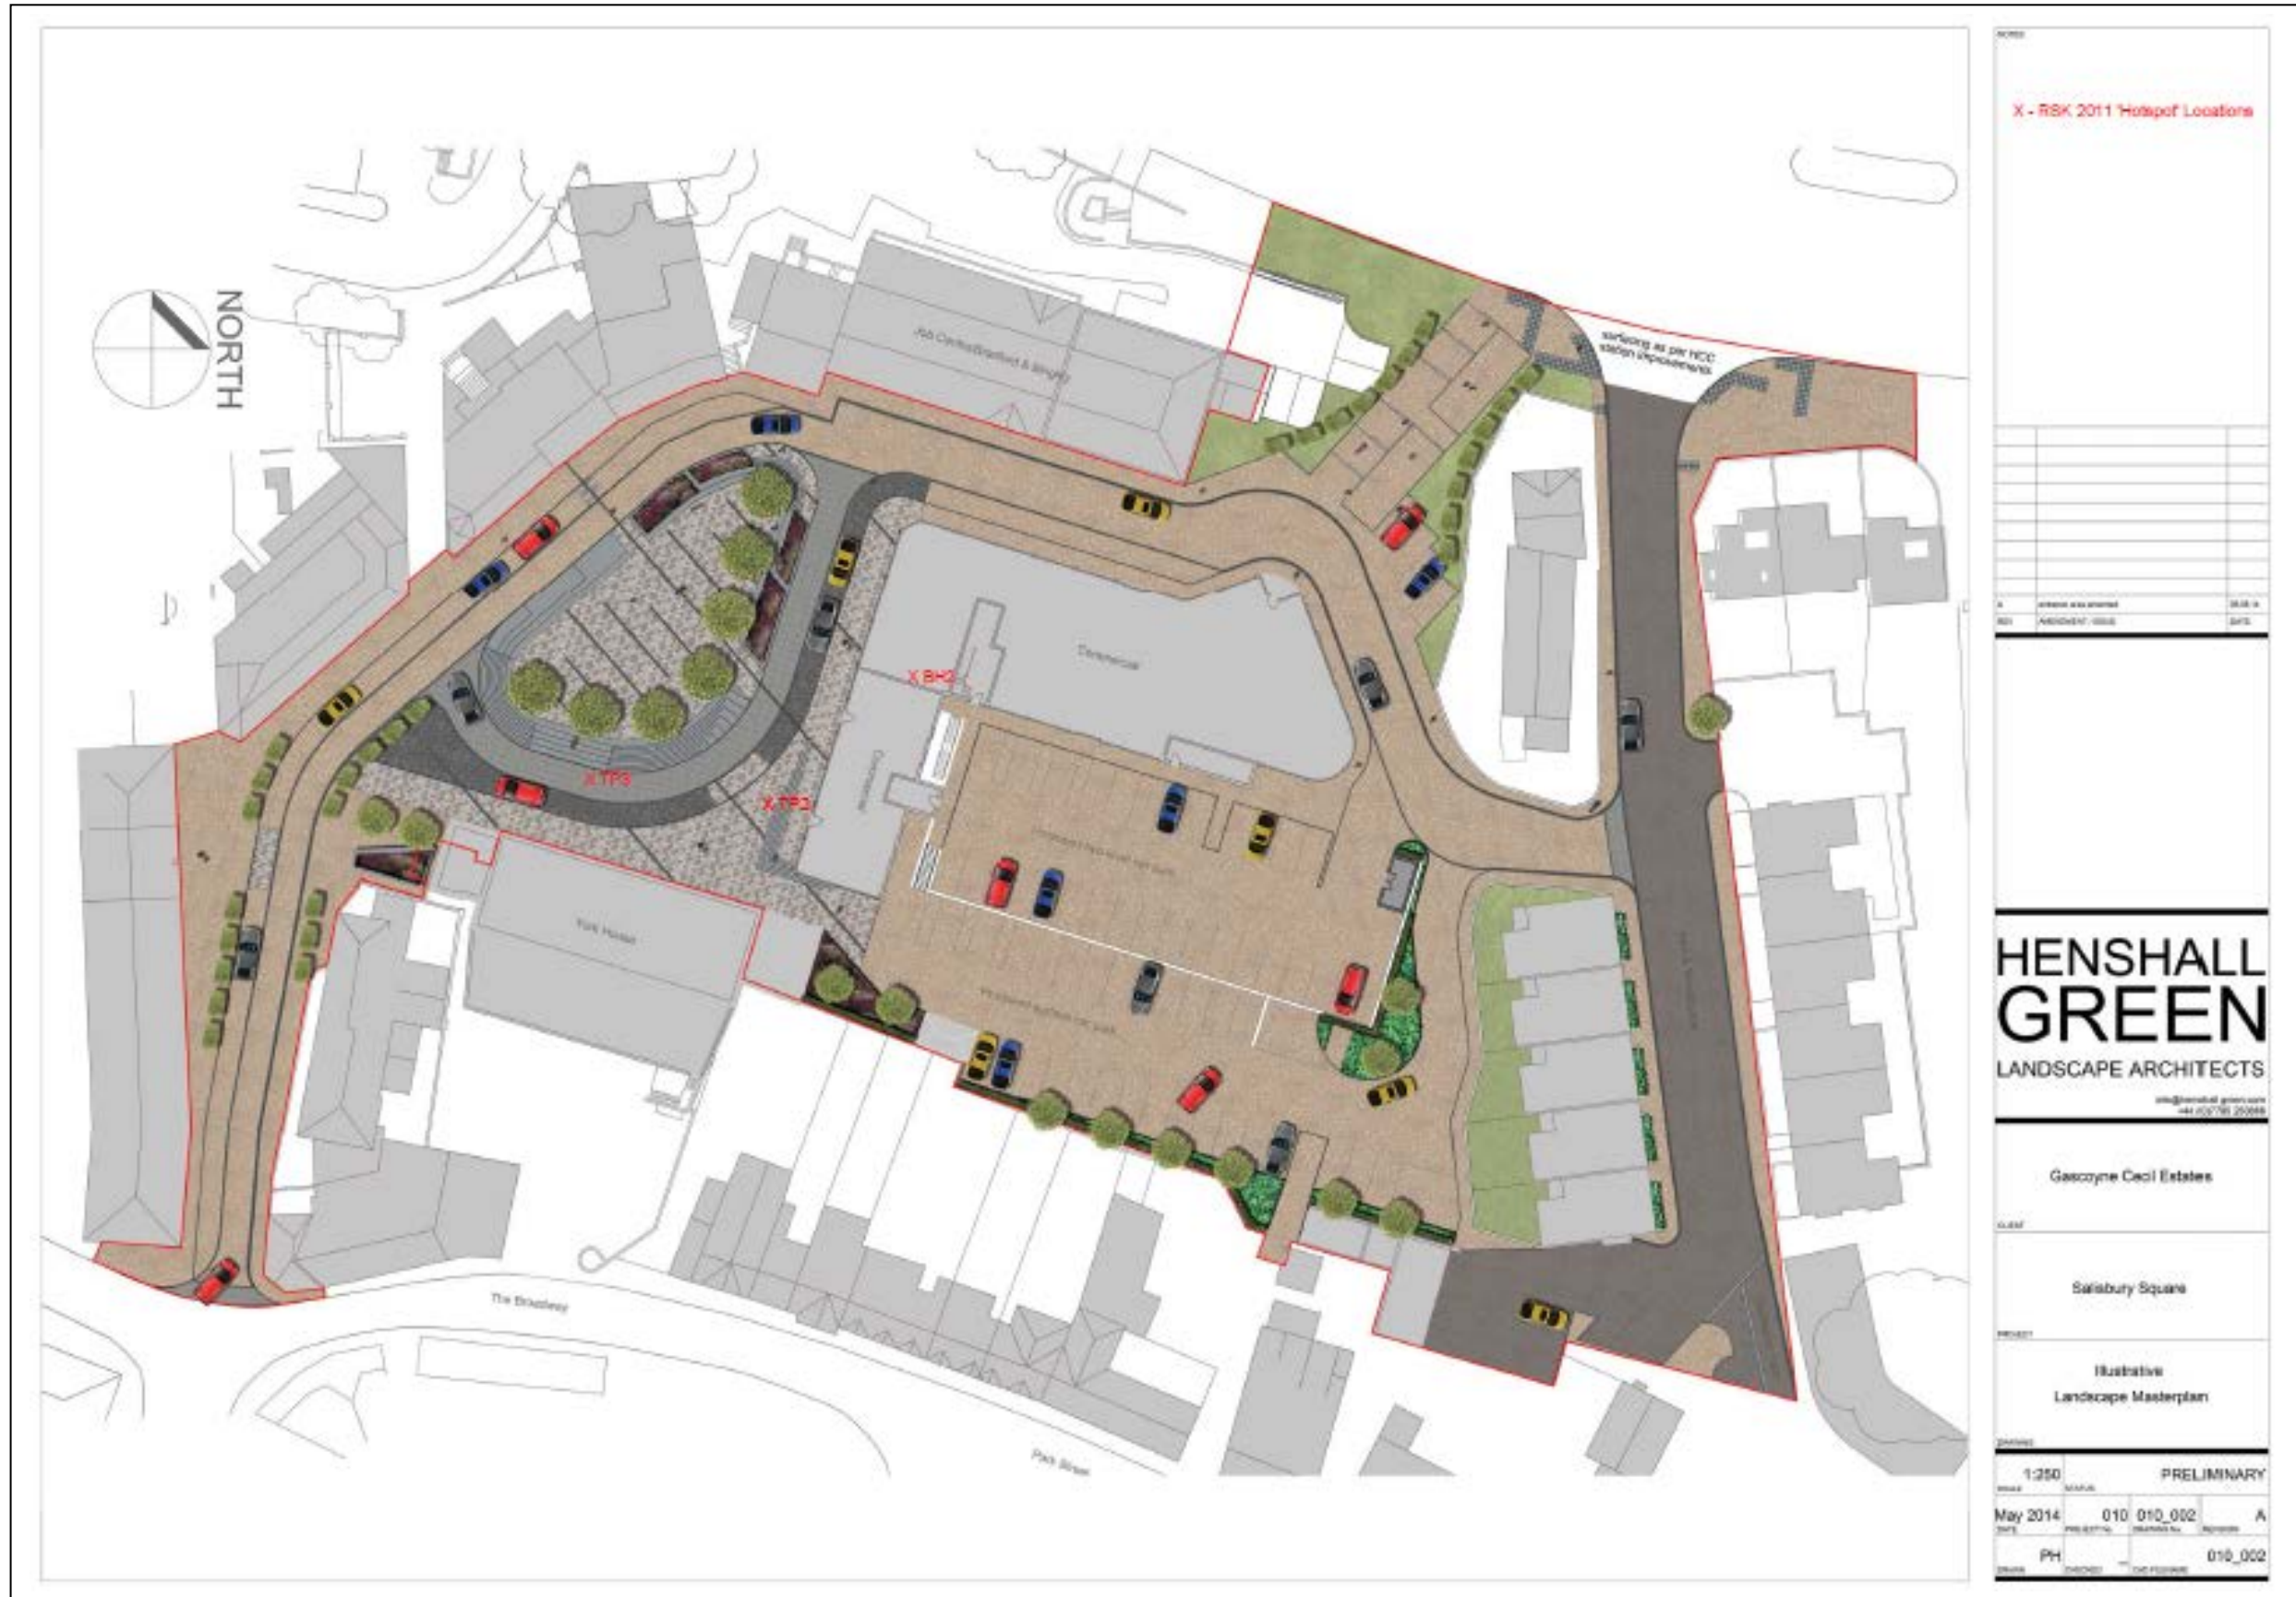
- Figure 1            Henshall Green Ltd Drawing 010\_002 (Revision A, 2014) showing location of RSK 2011 sampling locations.  
Appendix A        RSK Service Constraints

The 2011 investigation compared the results from the environmental samples collected from the southern portion of the site (which includes sample locations TP2, TP3 and BH2) to GACs for residential developments without plant uptake. Based on the aforementioned drawing, sample location TP3 now falls within a shared surface carriageway treated with granite setts, TP2 falls within an area of granite paving, and BH2 would underlie a mixed commercial and residential development (as shown on Figure 1, enclosed). As such the Conceptual Site Model (CSM) for the site can be further refined.

RSK is satisfied that the three sample locations that recorded exceedences of the relevant GACs in 2011 do not require further investigation given the proposed end use/ surface cover at these locations on latest version of the 'Illustrative Landscape Masterplan'. The contamination sources and potential pollutant linkages identified in the initial investigation (RSK, 2011) and discussed in Section 9 of the 2011 RSK report (Conceptual Site Model and Contamination Alleviation Measures) have essentially been 'designed out' by the use of hardstanding and, as such, will pose no risk to human health.
