St. Thomas' Church, Northaw, Hertfordshire

STATEMENT OF NEED

Boiler room demolition.

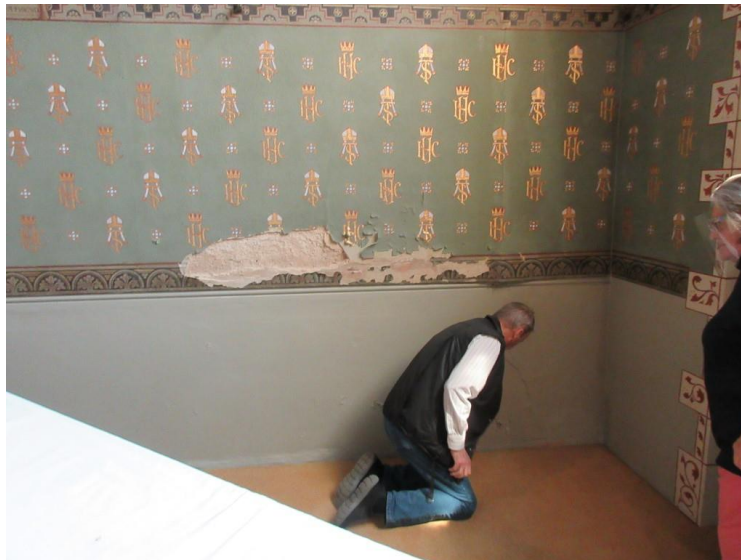
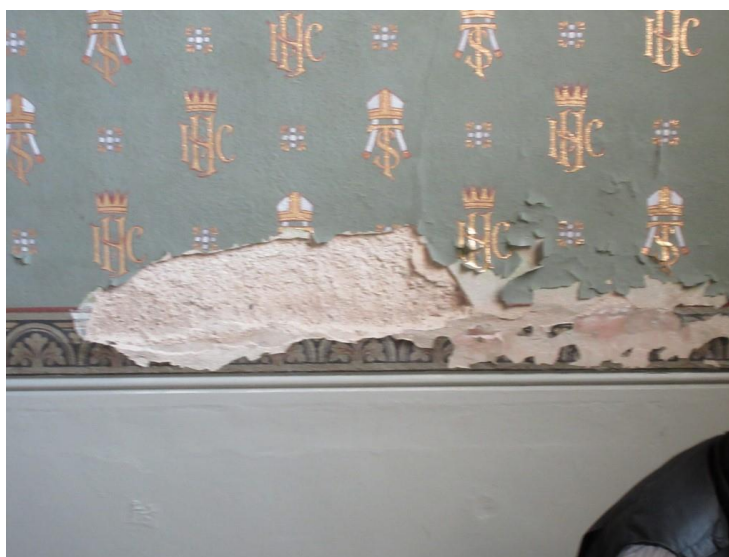
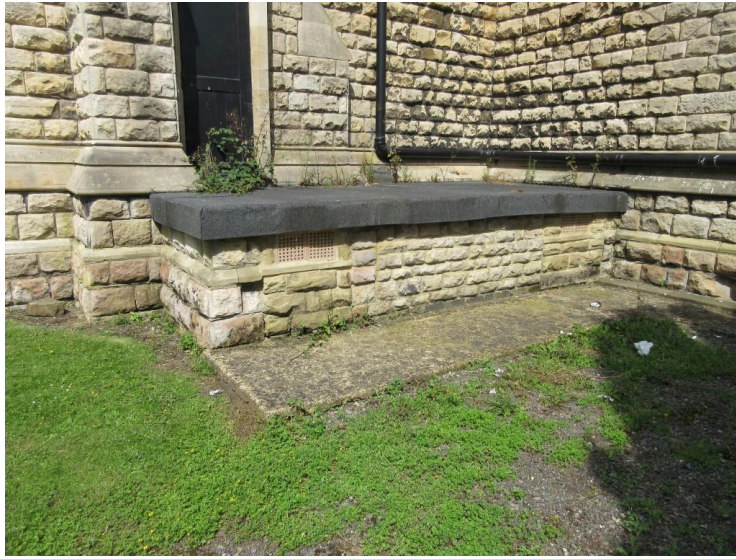
In the south chapel, the decorative scheme is being continuously harmed by the abutment of the cover slab of the redundant external boiler room. It is understood that the parish have renewed the decorations in this area several times previously.

There proposals are to remove the cover slab, back fill the boiler room and reinstate the churchyard.
