# Shredded Wheat Factory South Site Piling Risk Assessment

Curtins Ref: 067358-CUR-00-XX-RP-GE-002-V02

Client Name: Metropolitan Development Services  
Client Address: The Grange, 100 High Street, Southgate, N14 6PW  
Site Address: Broadwater Road Site, Welwyn Garden City, AL7 3BQ

## Piling Risk Assessment

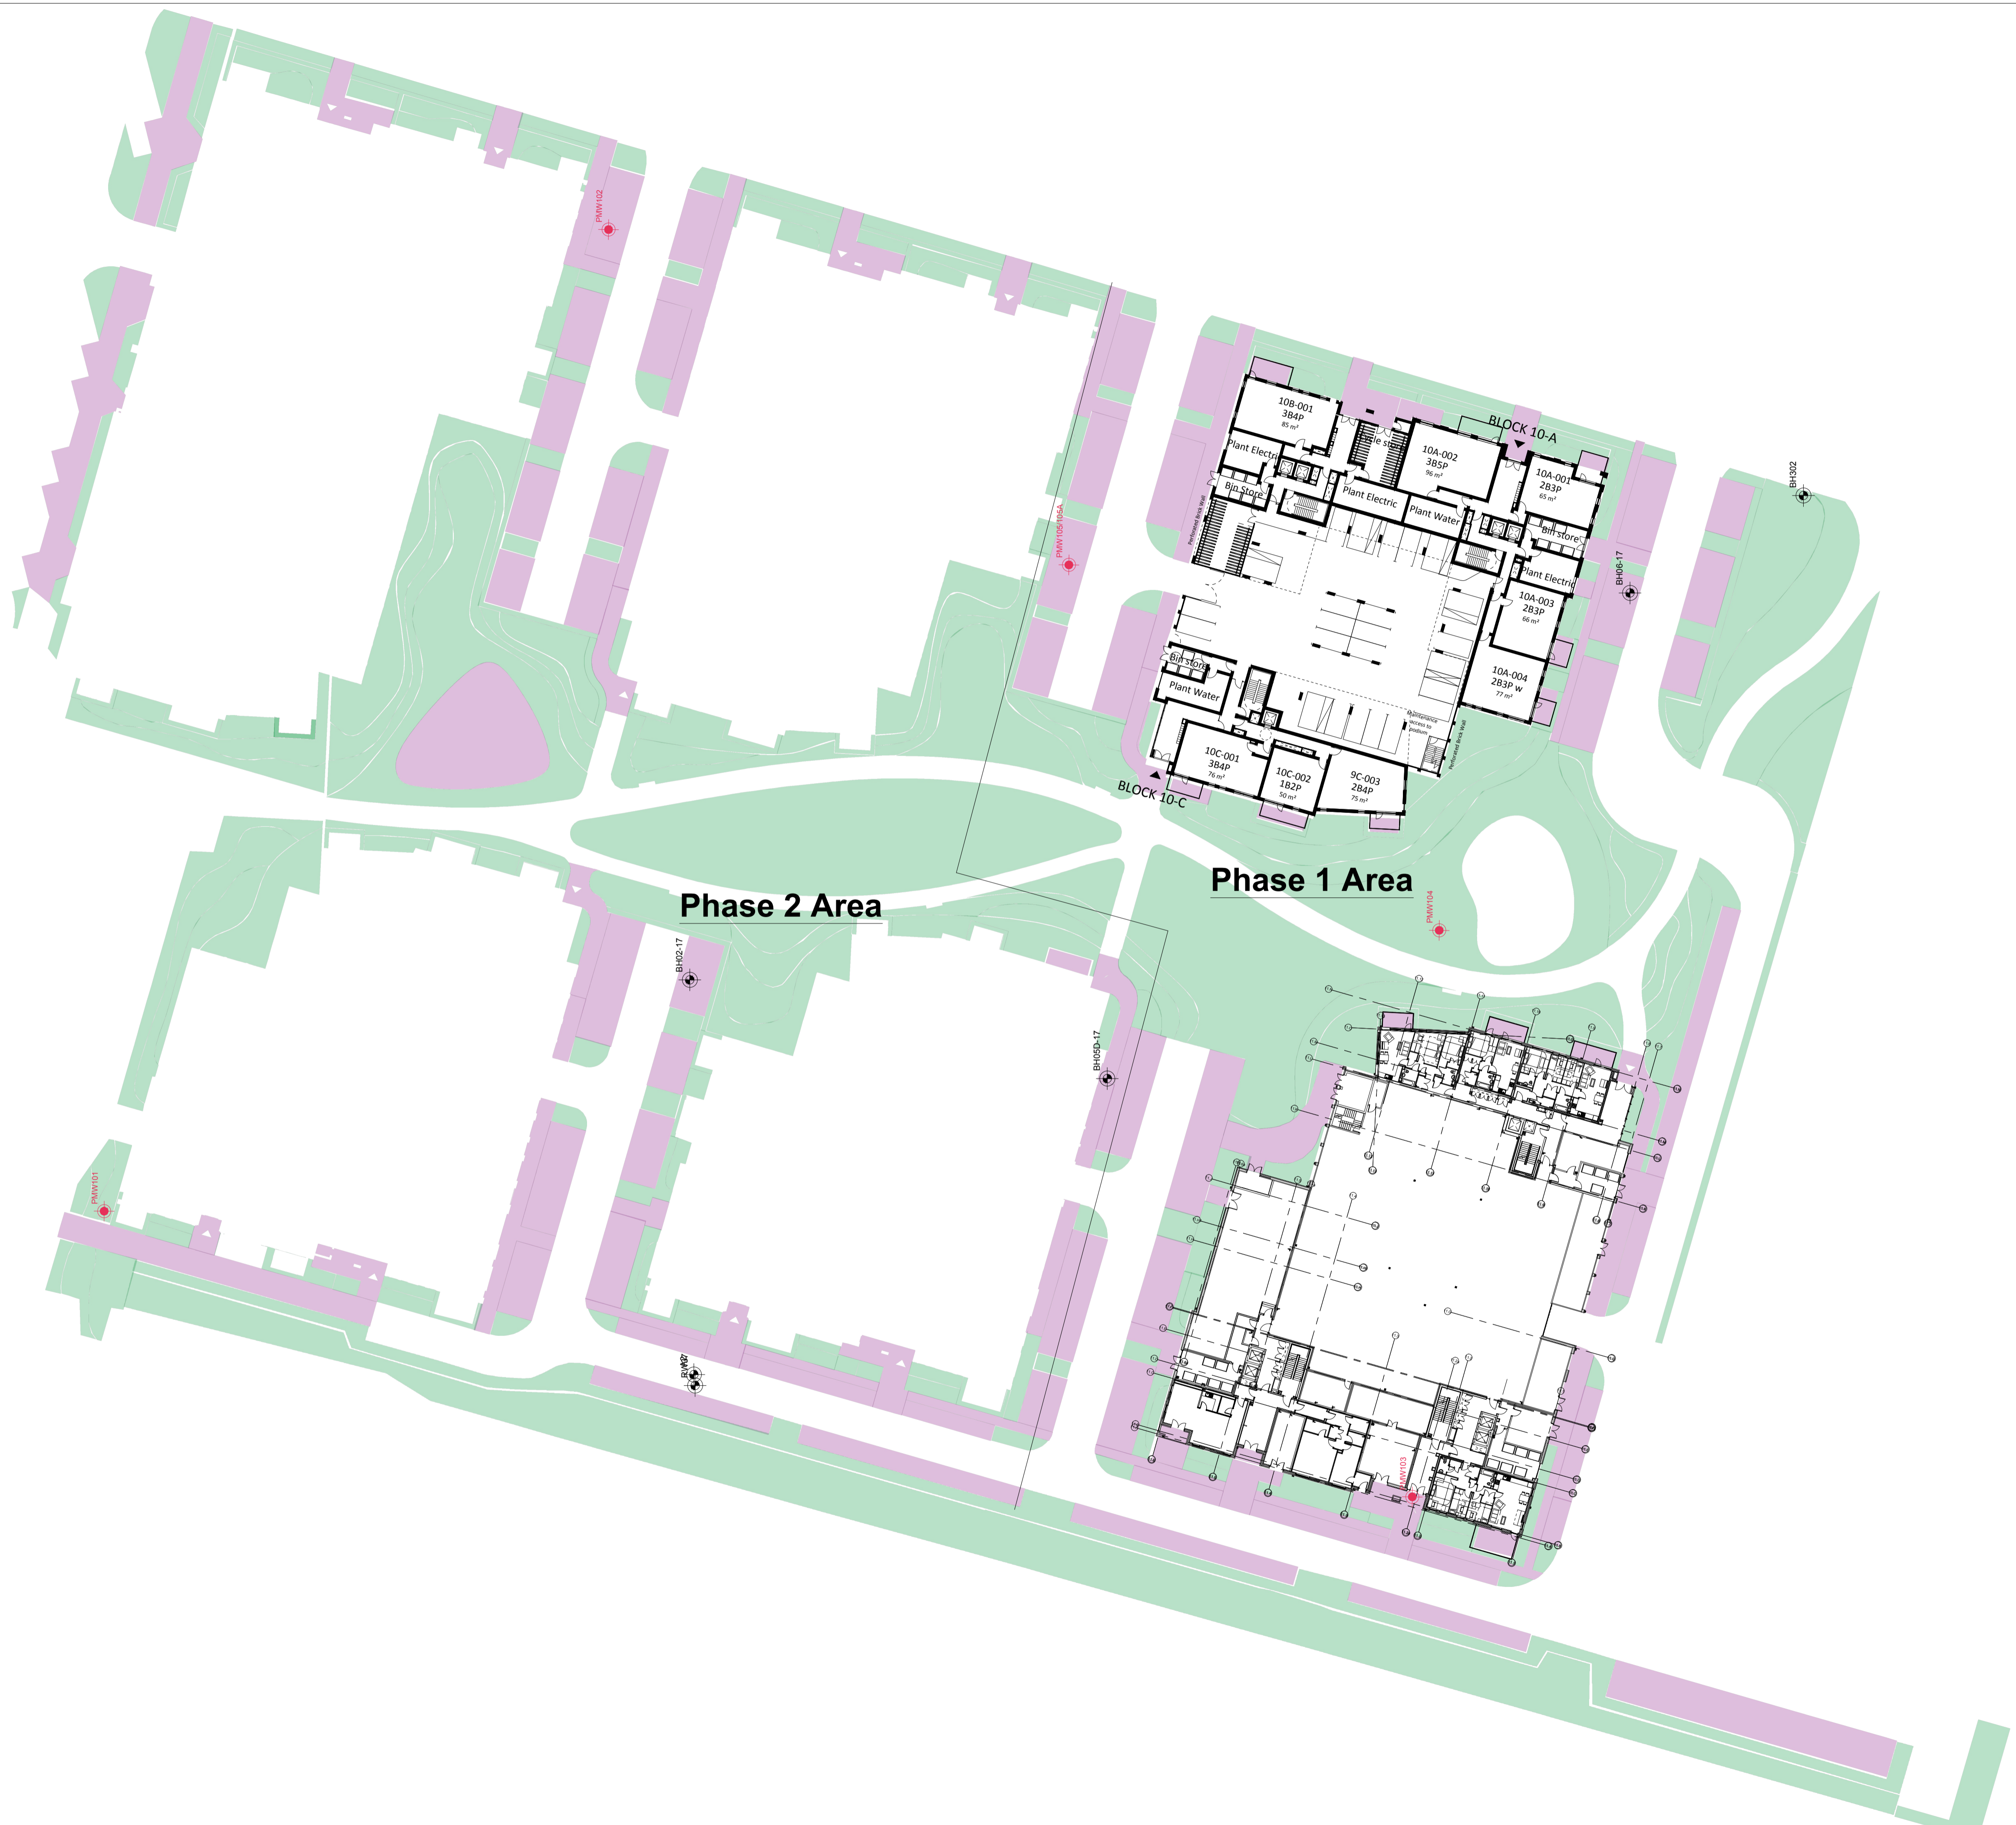
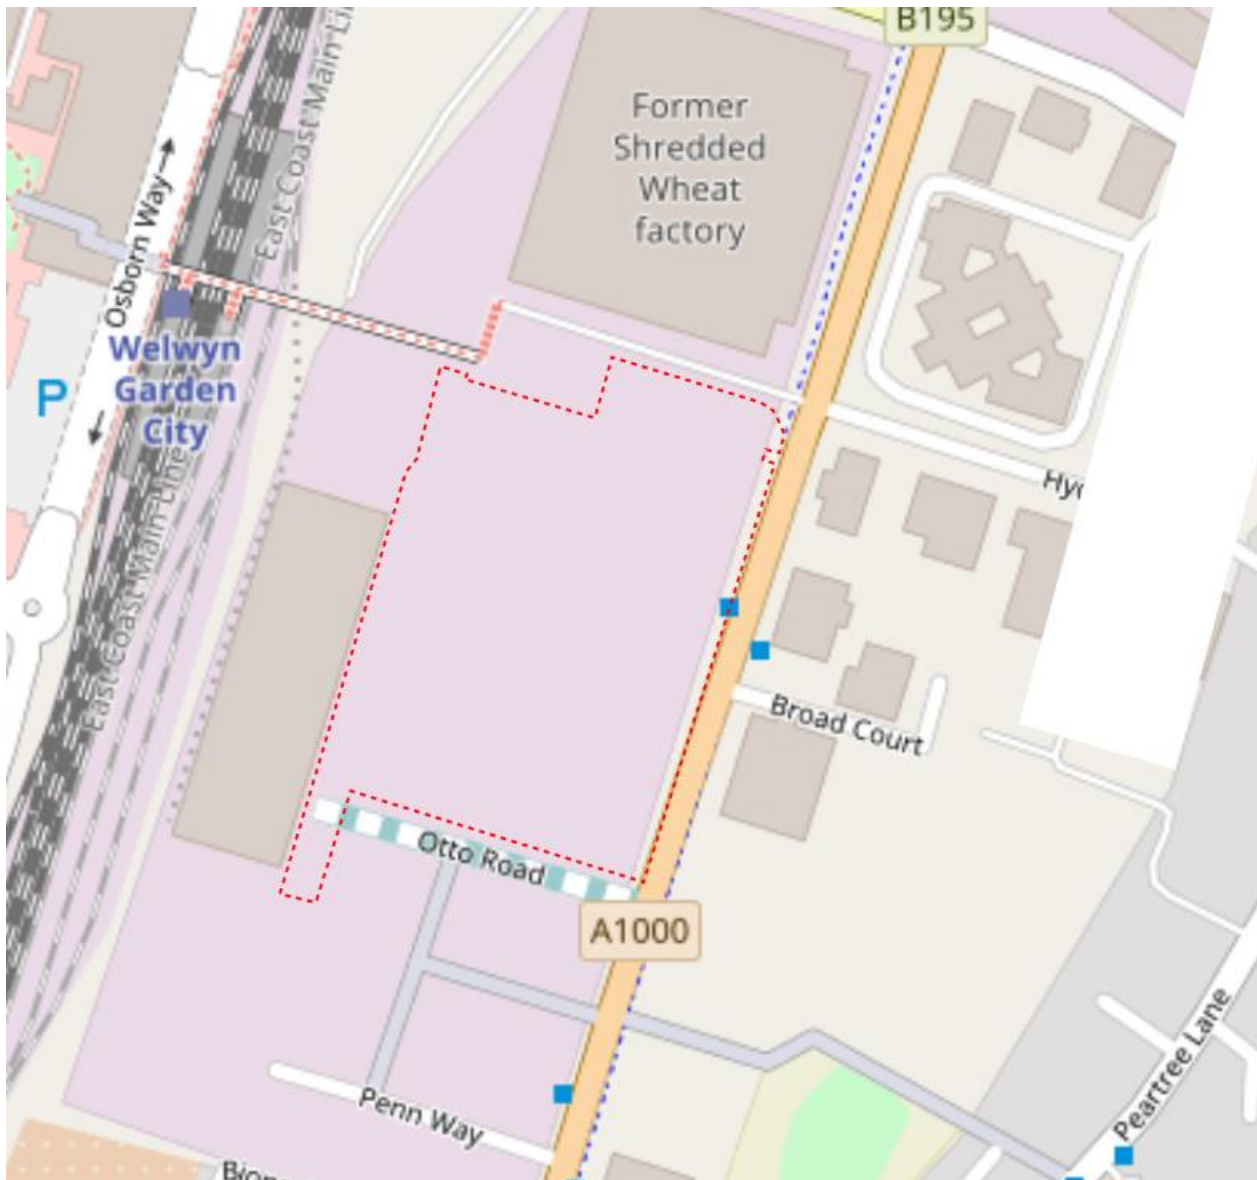
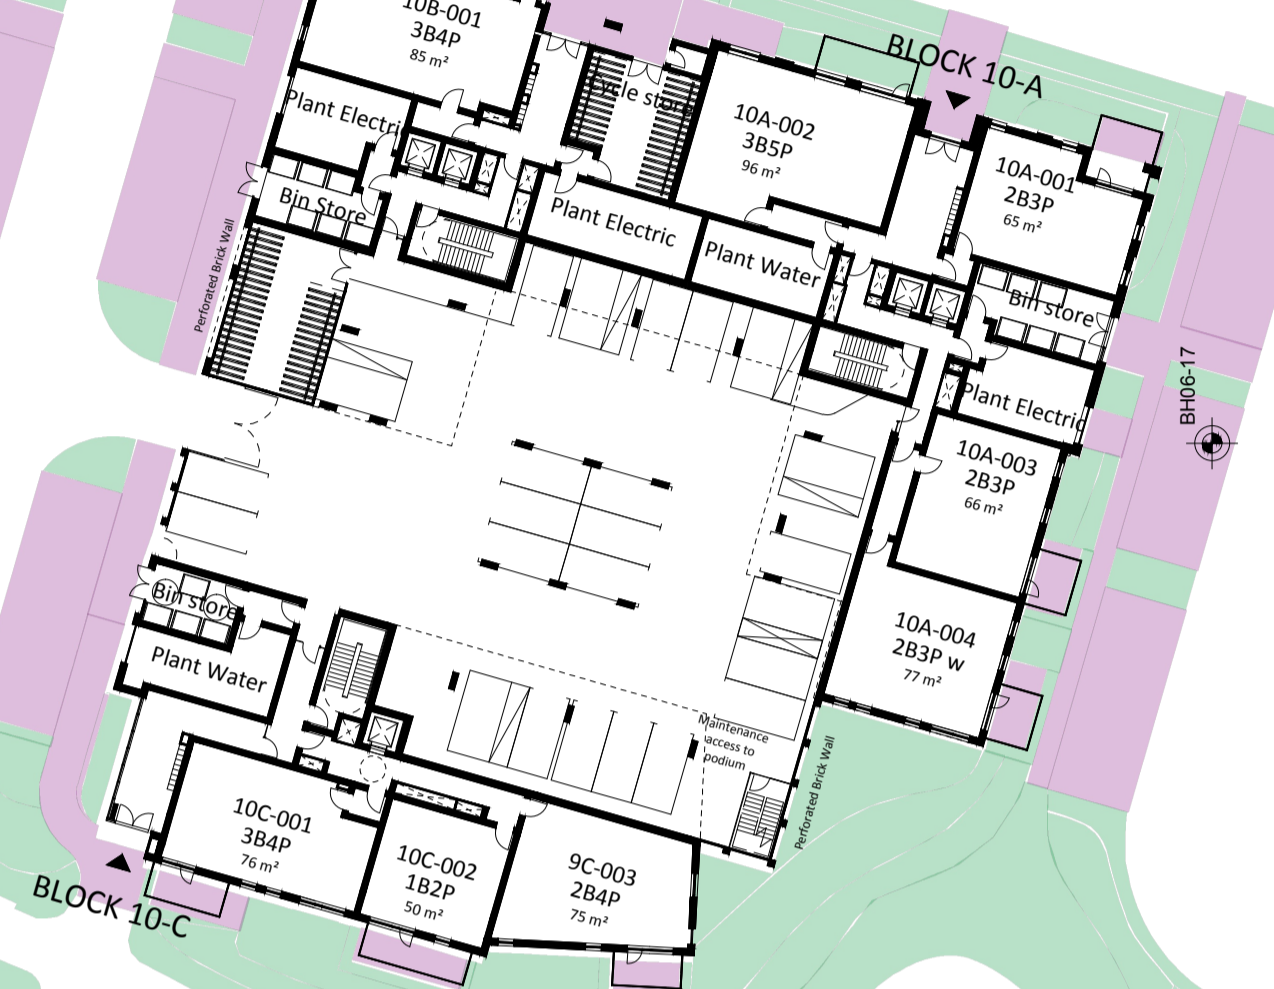
## Appendix A – Site Plan

- PMW Piling Monitoring Well (Curtins) to be monitored during piling works on-site
- Existing Environmental Monitoring Wells (EAME) to be monitored as part of the ongoing long term verification works.

Phase 2 Area

Phase 1 Area

Curtins previously undertook two phases of supplementary ground investigation on-site to aid the civil and structural design of the development. However, as part of these works' groundwater monitoring installations (a total of 5) within the underlying chalk aquifer were constructed, to aid the monitoring of groundwater during the piling process and satisfy the Environment Agency requirement for greater coverage across the development site. The piling monitoring installations are located in areas outside of proposed building footprints (with the exception PMW103). Following completion of the piling programme in Block 11, PMW103 will be decommissioned in line with the pre-agreed specification and planning Condition 4. PMW103 is located in the south-western corner of the site and was constructed to monitor groundwater quality within this area during the piling programme of Block 11. Consequently, post completion of the piling programme in Block 11, the installation is no longer required to monitor groundwater quality and is suitable for decommission. The locations of the piling monitoring wells in the Phase 1 and Phase 2 development areas are presented in Appendix A.
