**Phase I Environmental Assessment,
Former Shredded Wheat Factory, Broadwater
Road, Welwyn Garden City**

**For
Spen Hill Developments Ltd**

Delta-Simons Project No. 2342.17 V2

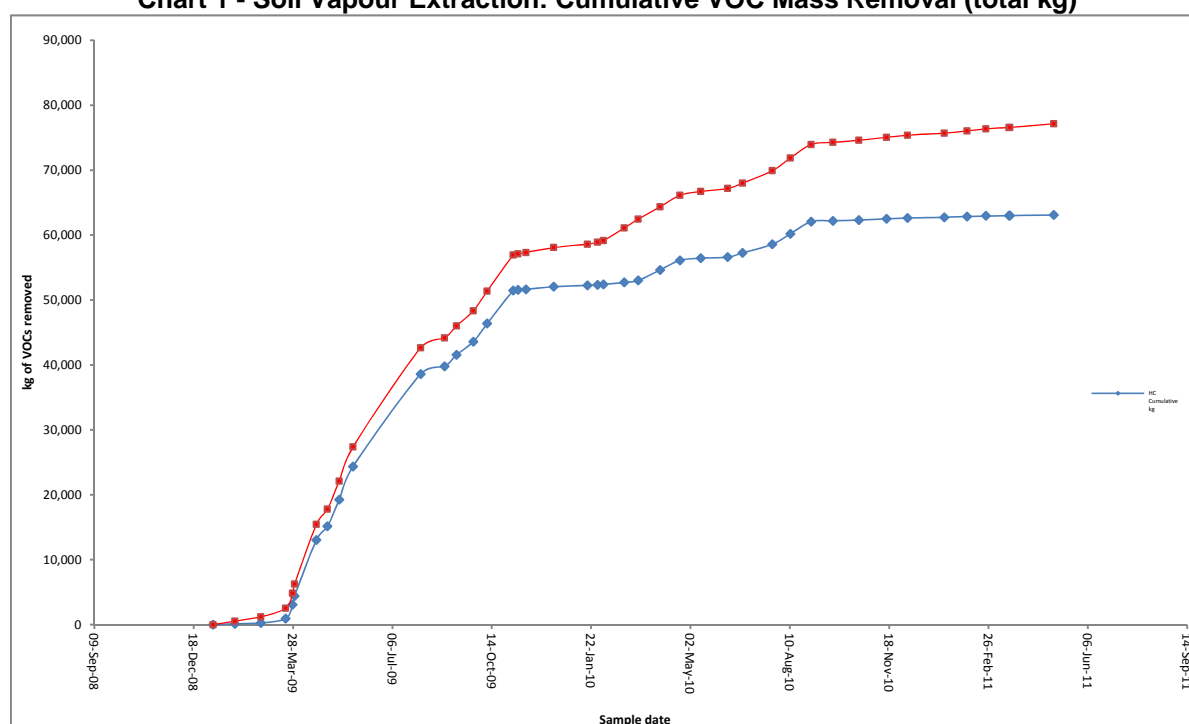
Chart 1 - Soil Vapour Extraction: Cumulative VOC Mass Removal (total kg)

Due to the highly volatility of the free product it was calculated that 70 tonnes of hydrocarbons were removed in the gas phase, as shown in Chart 1.

As Chart 1 shows, a significant volume of VOC was removed in the gas phase, with the bulk of the contamination removed between March and November 2009, with negligible recovery from August 2010 indicating that the remediation scheme had reached a steady state and further operation of the plant was not required.
