# Draincare

## Inspection pictures

| Place :<br><b>Welwyn Garden city</b> | Road :<br><b>Campus West Car park</b> | Date :<br><b>21/06/2019</b> | Section number :<br><b>36</b> | PLR Suffix :<br><b>X</b> |

| Use:<br>Year laid :<br>Purpose :<br>Total length : | <b>Surface water</b><br><br><b>Routine inspection of condition</b><br><b>19.06 m</b> | Pipe shape :<br>Pipe size :<br>Pipe material :<br>Lining : | <b>Circular</b><br><b>225 mm</b><br><b>Vitrified clay</b><br><br> | |

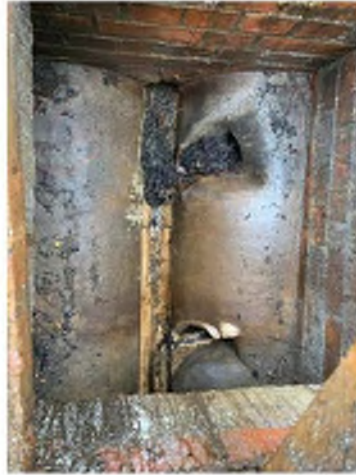
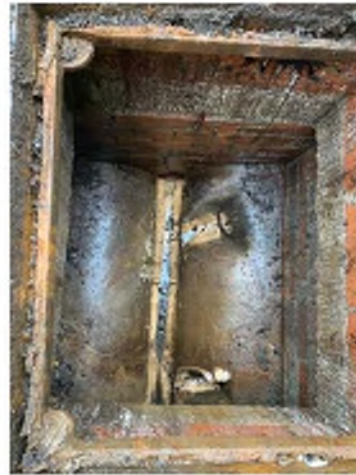
View of examples of debris / roots removed from SW drainage system
